SQ99-001

Subject: **FORD MOTOR CORPORATION
1998-1999 FORD WINDSTAR**

ALLEGED OVERHEAD CONSOLE LOOSE FAILURE

INVESTIGATION: SQ99-001
SUBJECT: Overhead Console Loose
PROMPTED BY: TSB #28-23-5
PRINCIPAL ENGINEER: Sonny Murianka

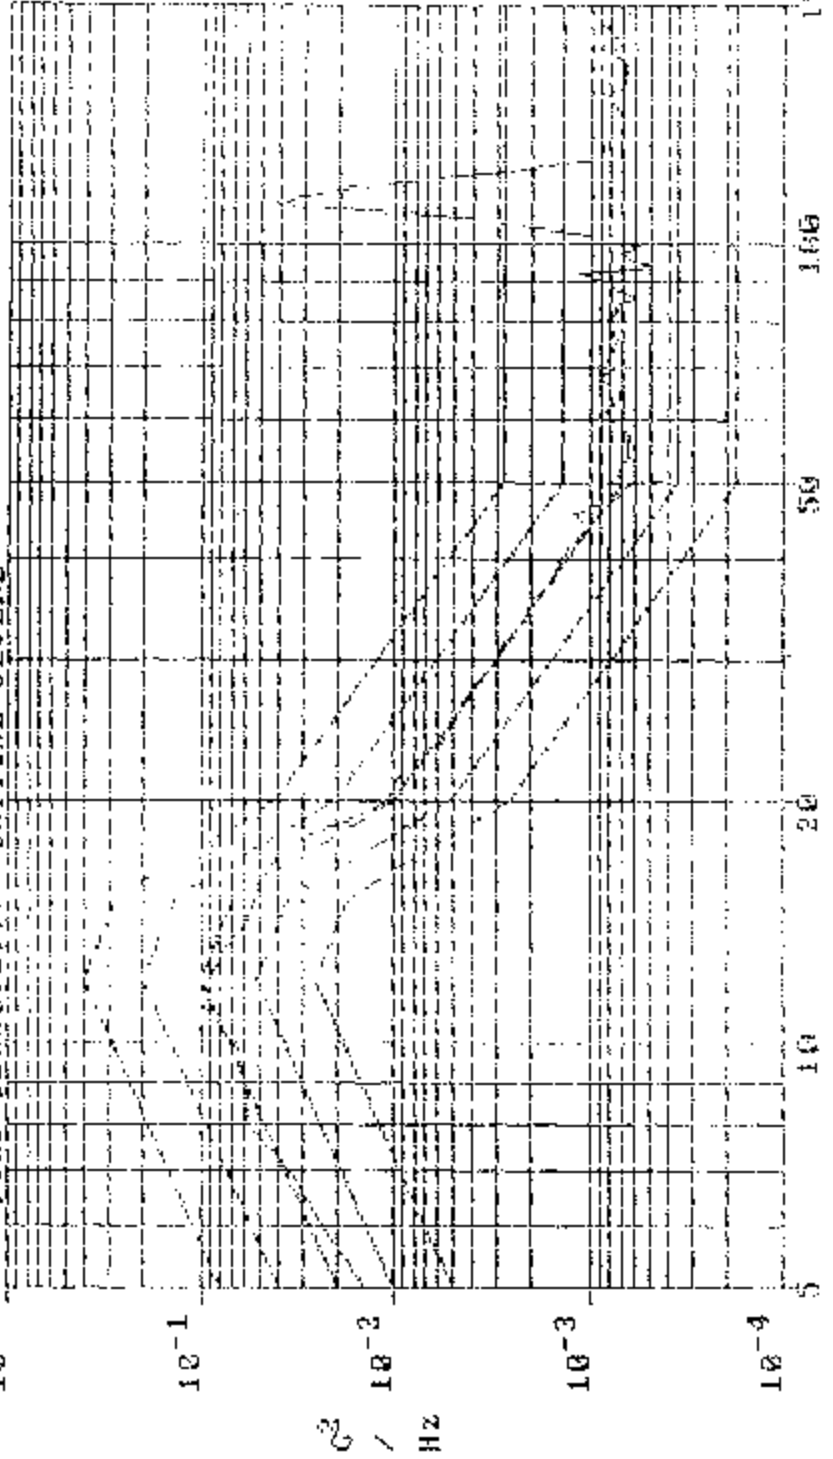
TEST RUN NAME: VERTICAL

REF RMS: 0.99 AUTO:07:12:44 STATUS: Abort, Channel 1 High RMS
CON RMS: 1.20 TOTL:07:14:55 LEVEL: 0.000B CHAN SEQ:1:2

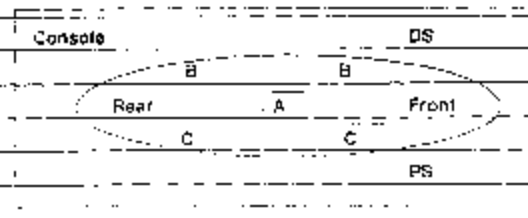
Both clips usually but not always engaged at the same time. When the engaged separately, you will notice the varying efforts readings. Retention like insertion was also attempted on each side and sometimes not always, the clips would disengage together. At no time did the Z axis clip, disengage during retention testing of remaining clips.

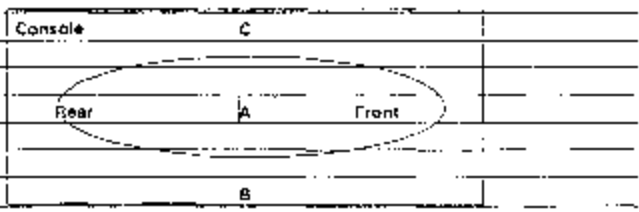
Insertion - All (6) samples were within the acceptance criteria called out for this test with insertion efforts less than 25 lb per clip.

Retention - Of the six samples and 24 clips, a total of 4 clips maintained retention of 25 lbs or more, the rest were under the specified retention required.

Thus, after having followed the specified requirements and not having met the acceptance criteria called out for this test, it is ruled: **NON - CONFORMING.**
