U.S. Department  
of Transportation  
**National Highway  
Traffic Safety  
Administration**

Investigation: EA 02-036

Subject: ABS CORROSION EXTENDS STOPPING DIST

### **ABS Hydraulic Disc Brake Tone Ring Corrosion in 1996 - 2002 Freightliner Vehicles**

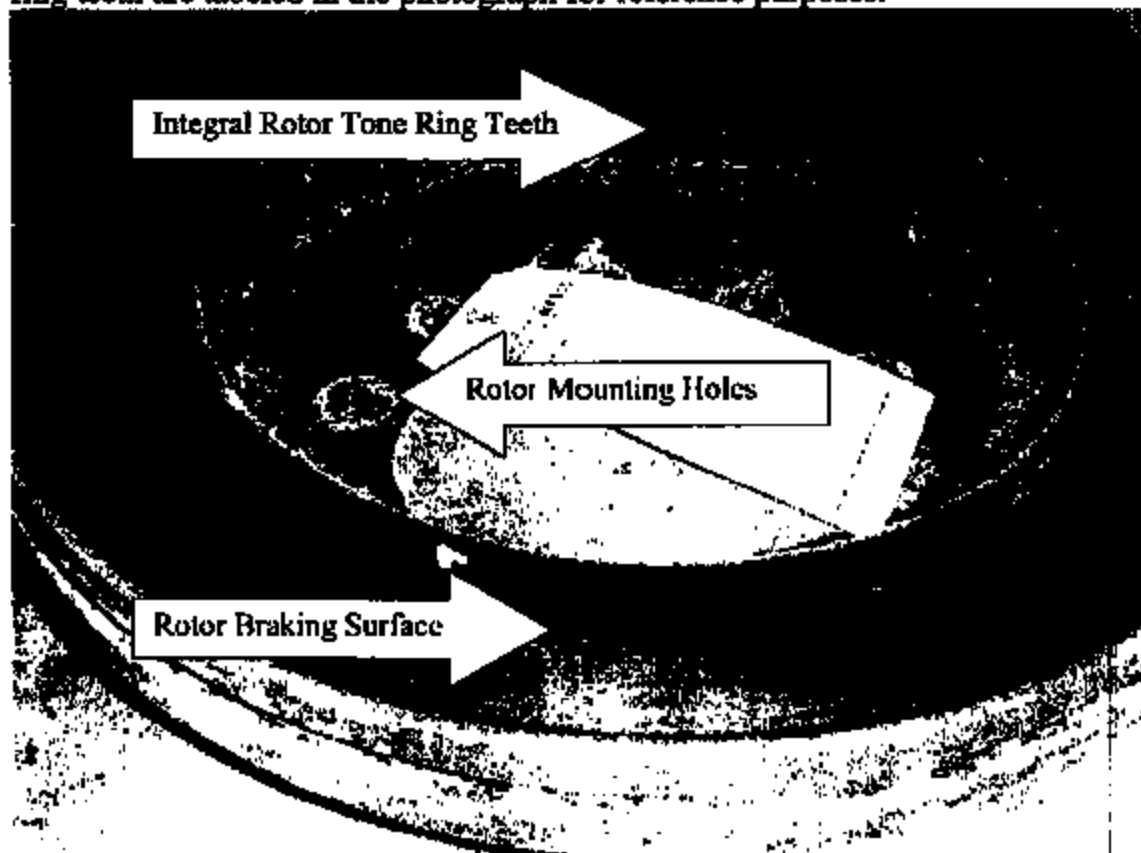
The following photograph depicts a representative uncoated disc brake rotor with the integral tone ring feature that has been removed from service. The ABS tone ring teeth are labeled in the photograph for reference purposes.

Source: Sample from rotors displayed at March 11, 2003 Review at VRTC.
