ODI RESUME

Investigation: EA 02-015
 Prompted By: PE02-021
 Date Opened: 08/01/2002 Date Closed: 01/12/2004
 Principal Investigator: Scott Yon
 Subject: Throttle sticking closed

Manufacturer: General Motors Corp.
 Products: MY 1999-2002 Silverado/Sierra/Tahoe/Suburban/Avalanche/Yukon
 Population: 3,401,467

EA02-015 SUMMARY REPORT

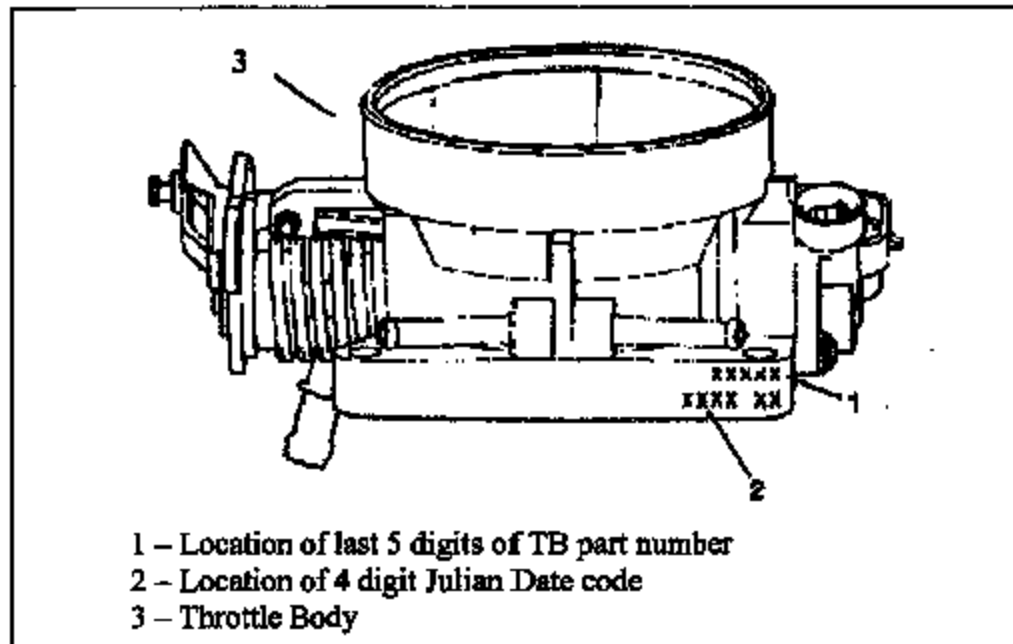
Figure 1: Throttle Body Identification

The last five digits of the TB's GM part number and manufacturing date are identified by codes stamped into the TB mounting flange, as depicted in Figure 1 below. The Julian Date code follows the format 'dddy' where 'ddd' represents the day of the year (001 to 365) and 'y' represents the digit value of the year (9 = 1999, 0 = 2000, etc). For example, a date code of '0351' indicates the TB was manufactured on the 35th day of year 01, or February 4th, 2001.

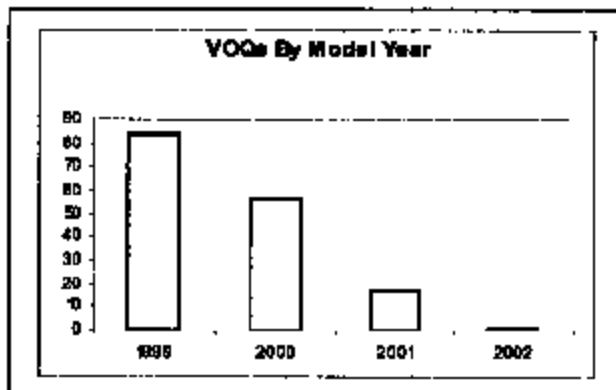
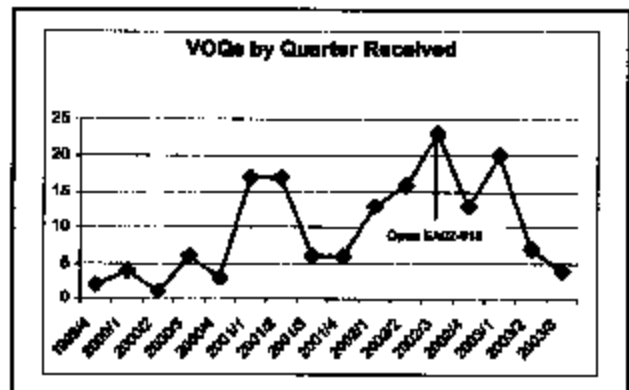
COMPLAINTS: Vehicle Owner Questionnaire (VOQ) trends by MY and quarter received are shown in the following charts.

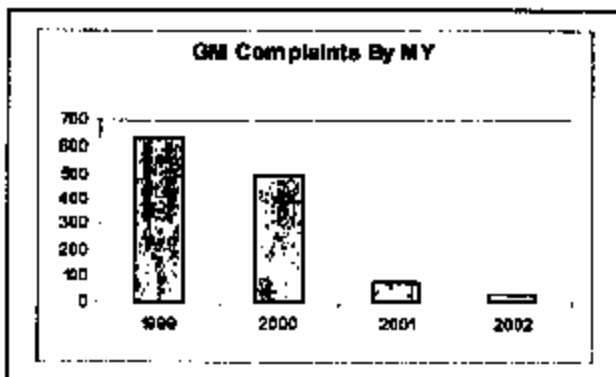
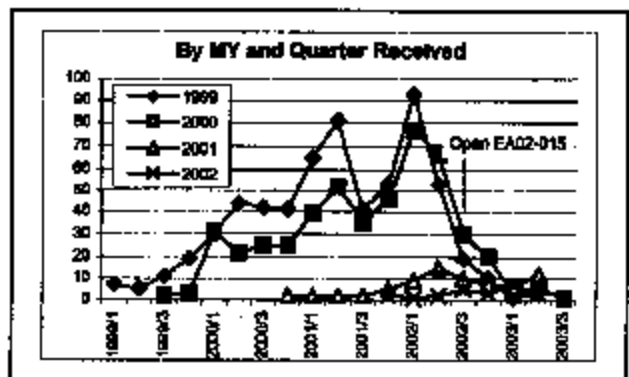
GM complaint trends by MY and by MY and quarter received are shown in the following charts.

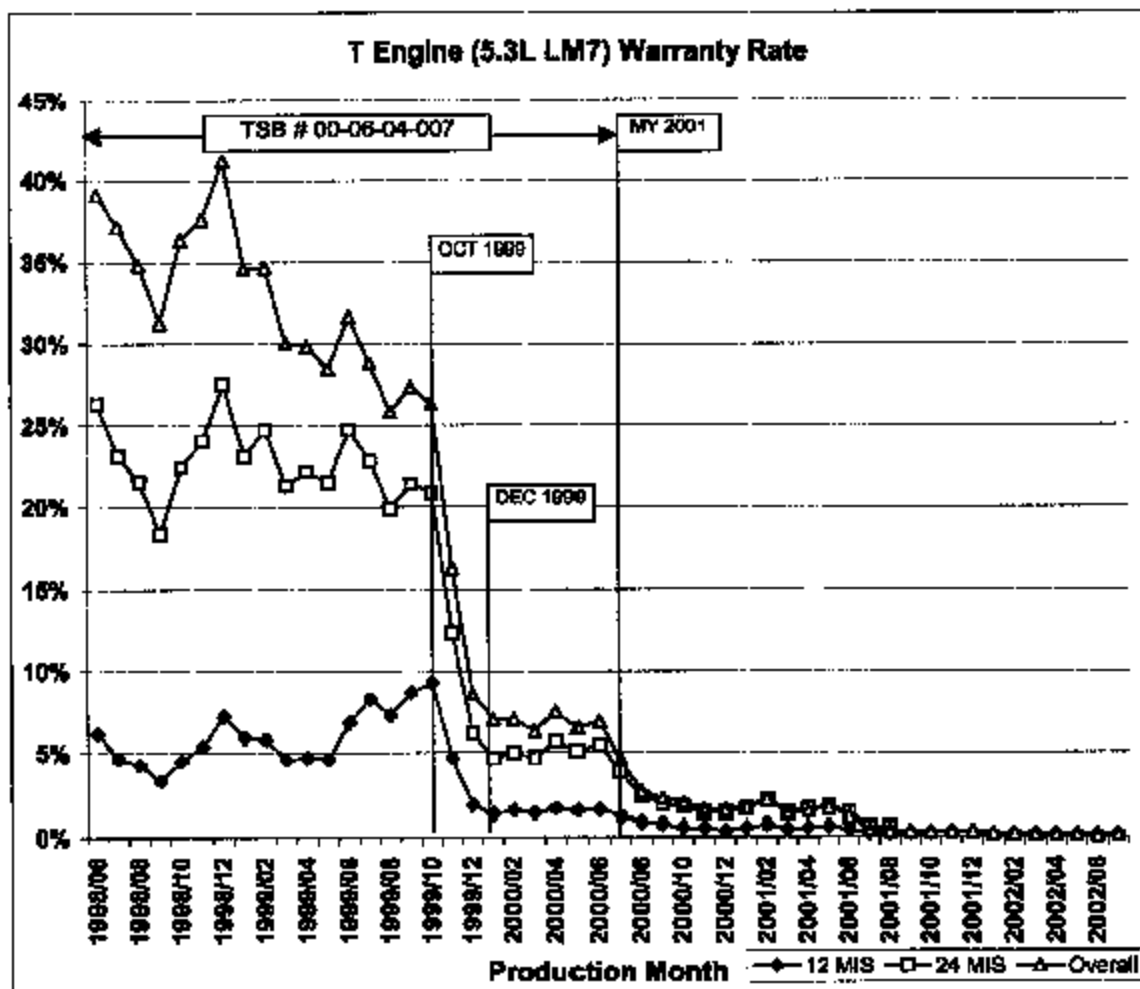
Figure 2: Warranty Rate vs. Vehicle Production Month.

Referring to Figure 2 below, warranty claim rates are significantly higher on vehicles produced from June 1998, the start of production, through October 1999. The overall warranty rate of the TB varies between 25% and 40%, and the two years in service rate varies between 20% and 25%. The warranty rates fall significantly during November 1999, and remain at lower levels through the end of the production period covered by TSB 00-06-04-007 (end of MY 2000). An annotation on Figure 2 identifies the production period covered under TSB #1. At the start of MY 2001 production, the warranty rates drop again and remain relatively low through the end of MY2002 production. Warranty analysis results are discussed further in following sections of this report.

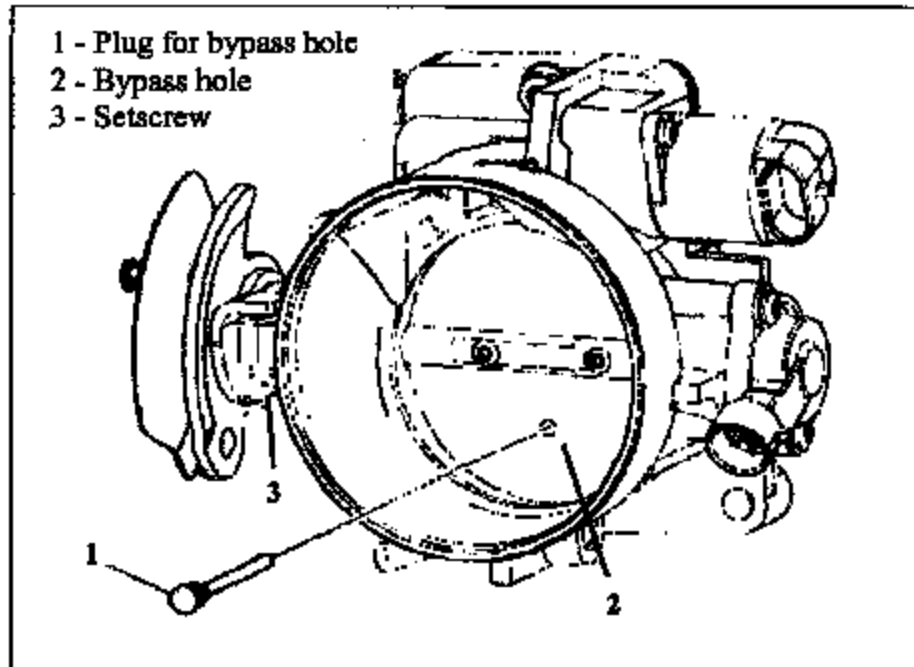
Figure 3: TSB #02-06-04-054 procedure.

TSB #3 states that deposits in the TB bore may cause a throttle stiction condition. Technicians were instructed to confirm the vehicle had a fixed orifice PCV valve installed, as described in TSB #2. After confirming a fixed orifice PCV valve was installed, the technician was instructed to first clean the TB bore and then to eliminate the air bypass hole in the throttle valve using a specially developed plug, as shown in Figure 3 below. Using GM service diagnostic tools, the technician then adjusts the shipping air setscrew to increase the closed throttle valve angle, thus compensating for lost bypass air. The setscrew adjustment increases the clearance between the throttle valve and bore, making it more difficult for engine deposits to accumulate and thereby reducing the likelihood of throttle stiction occurring.

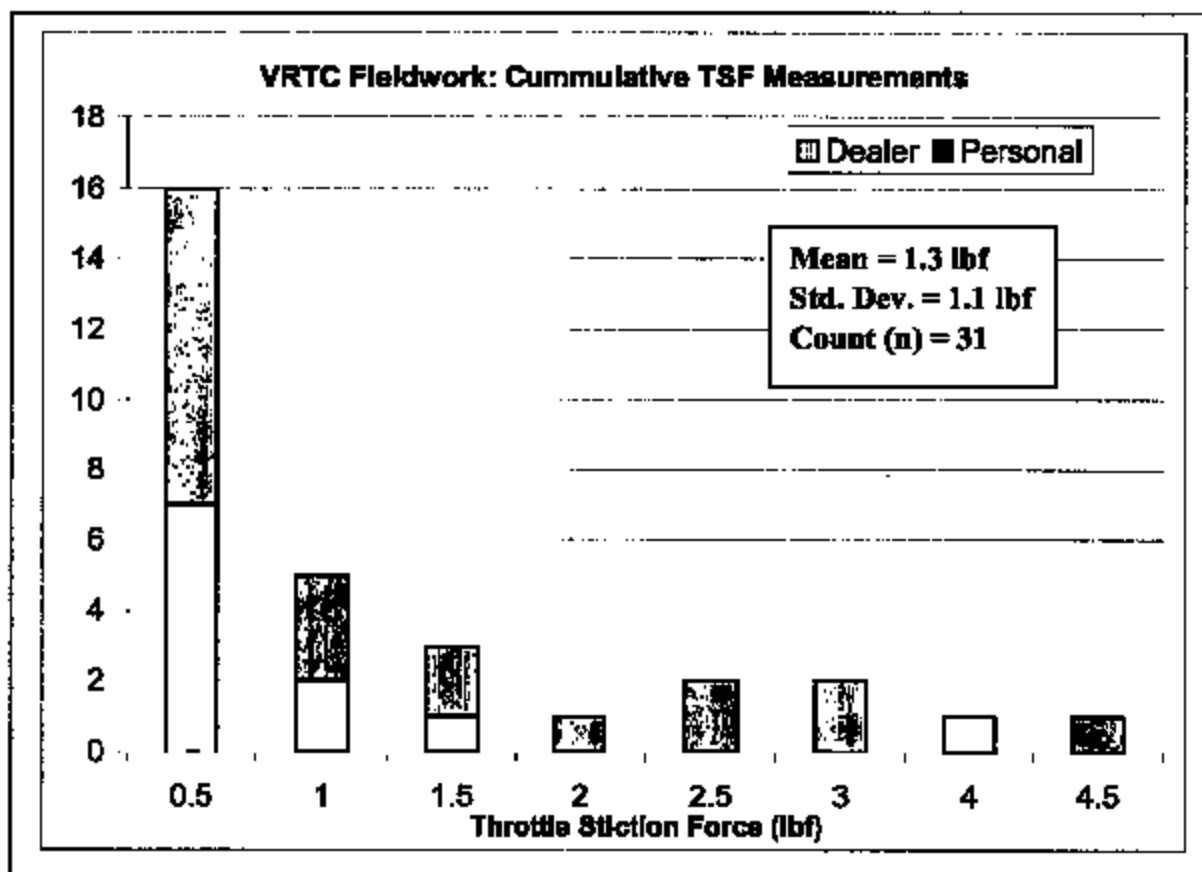
Figure 4: VRTC Fieldwork results

An analysis of the inspection data was performed. A throttle stiction force of about 0.5 pounds was present in 16 of the vehicles tested. This minimum force is considered typical of a normally operating vehicle and results from natural frictional forces that exist in the throttle control system. Fifteen of the vehicles inspected displayed throttle stiction forces higher than 0.5 lbf; 11 of the 20 (55%) personally owned vehicles, and 4 of the 11 (36%) dealer owned vehicles. A maximum throttle stiction force of 4.5 lbf. was measured in one vehicle inspection (the worst-case), a force about twice the typical pedal opening force. For the 31 vehicles inspected, an average throttle stiction force of 1.3 lbf. was found, and a standard deviation of 1.1 lbf was calculated. The results are displayed graphically in figure 4.
