ENGINEERING ANALYSIS CLOSING REPORT

SUBJECT: Speed Control Deactivation Switch Fires.

EA No: EA02-025

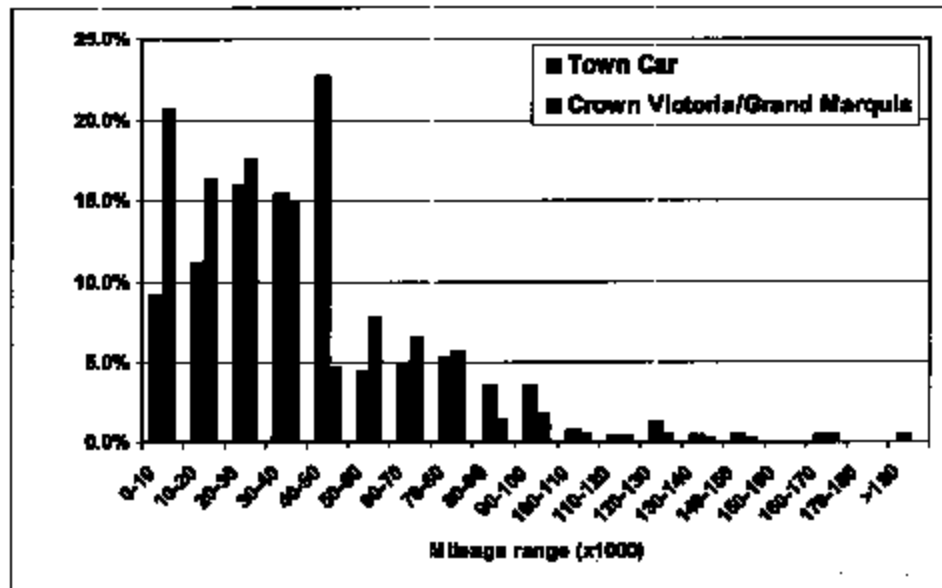
It should be noted that symptoms associated with the alleged defect typically do not occur during the warranty period. The failure mechanism takes time to develop as can be seen in the recall population, which did not experience problems with switch fires until the vehicles reached 4-6 years and 60-100 thousand miles of service. In the subject vehicles, the claim frequencies were similar for the Town Car vehicles and the Crown Victoria/Grand Marquis vehicles, despite the longer standard coverage for the Town Car vehicles. The MY 1995 vehicles had the highest claim frequencies for both populations.

Figure 3. Distribution of SCDS warranty claim data by model and mileage.

The claim rates are low, with only the MY 1995 Crown Victoria and Grand Marquis vehicles reaching a rate as high as a tenth of a percent. Many of the claims involved vehicles well beyond the standard coverage age or mileage, indicating either extended coverage or goodwill repairs. Approximately 1.3 percent of all claims involved some sort of thermal event. Six percent of the claims indicated a switch failure resulting in an open fuse and/or difficulty shifting out of PARK. Twelve percent of the claims indicated evidence of brake fluid leakage.

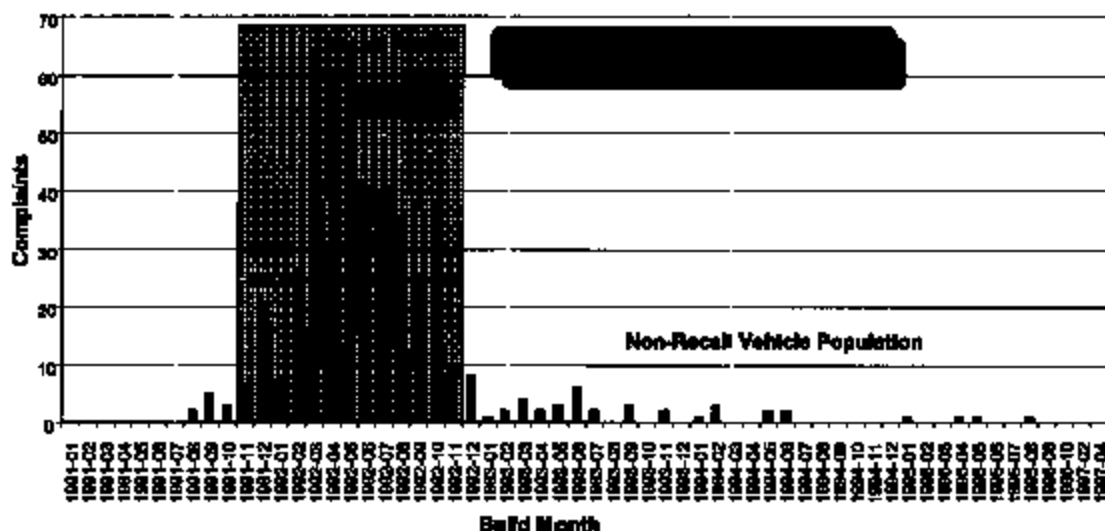
A defect trend in the speed control deactivation switch has not been identified. Ford compared the alleged incidents to those events included in the recall. Ford's comparison reveals a distinct difference in the performance of the switch in the subject vehicles to those included in the recall [Figure 7]. Ford's investigation of the

Figure 7. Ford analysis of Town Car fire experience by build month, recall range vs. pre- and post-recall ranges.

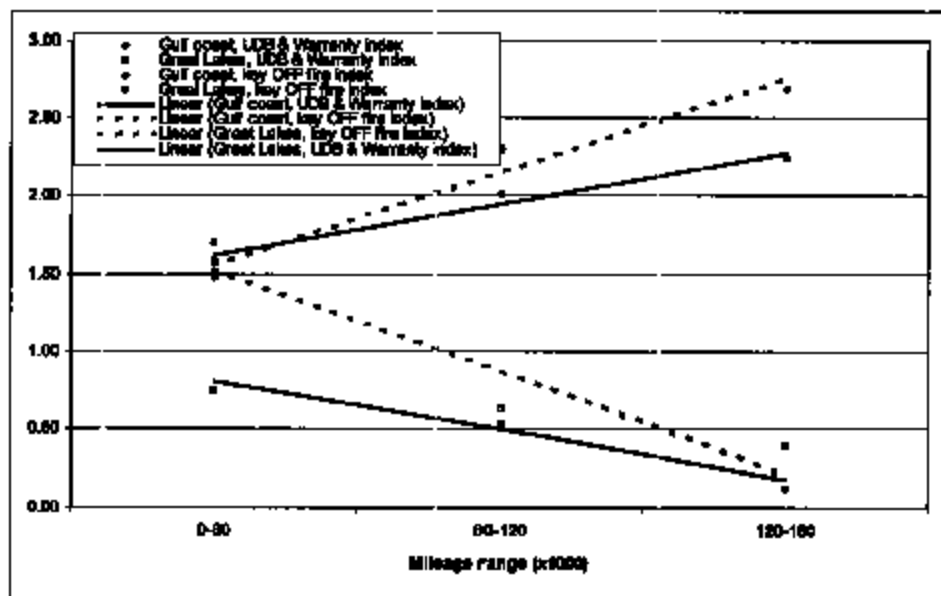
Warranty and UDB data. Both warranty and post-warranty part sales sampling data submitted by Ford provide information concerning the failure mode/symptoms associated with service repairs. These data are shown in Tables 8 and 9. Table 11 provides a comparison of SCDS fire, warranty and UDB data in two geographic regions with similar subject vehicle populations. The data in each of these categories are greater in the southern Gulf Coast states than in the northern Great Lakes states. These differences become more pronounced with increasing vehicle age and mileage, especially for the Town Car vehicles (Figure 8).⁶

Figure 8. Rate indices by region, category, and mileage range; MY 1993-95 Town Car (rate index = %category/%population, value of 1.0 indicates normal/average).

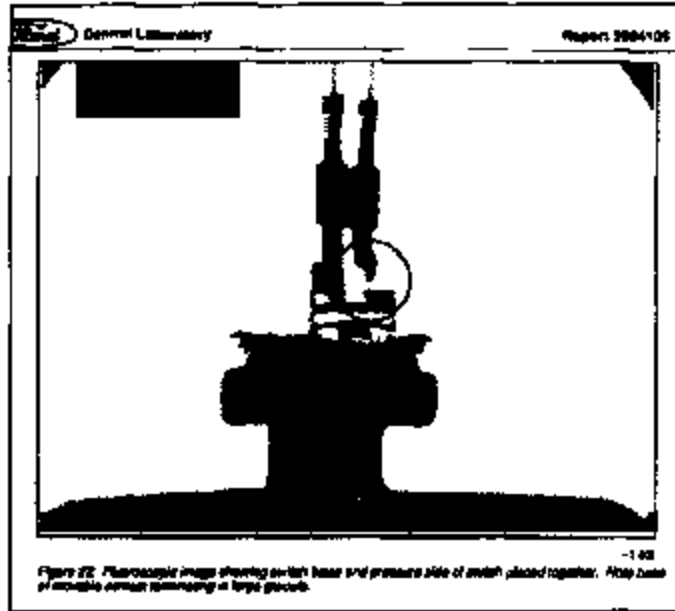
Water-contaminated brake fluid in the electrical cavity results in corrosion of the switch electrical contacts. Brake fluid and corrosion products (i.e., loose metal fragments) in the electrical cavity may then cause a resistive short to ground to develop from the stationary contact, carrying battery voltage, to the hexport body. From Ohm's Law, the leakage current (I) is determined by the relationship $I = V/R$, where V is system voltage (12 to 14.5 volts) and R is the resistance of the short to ground. The short to ground generates heat in the switch cavity proportional to the product of the square of the leakage current and the resistance ($P = I^2R$). Arcing may also occur between the contacts and from the powered contact to the hexport body (Figure 12). The heat may melt the plastic switch base (Figure 13) and the arcing may provide the source of ignition.

Figure 12. SCDS electrical cavity after contact corrosion and arcing (99V-124 Town Car).
