ODI RESUME

Investigation: EA 02-029

Subject: Hood Latch Failure

Products: 1993-1998 Jeep Grand Cherokee

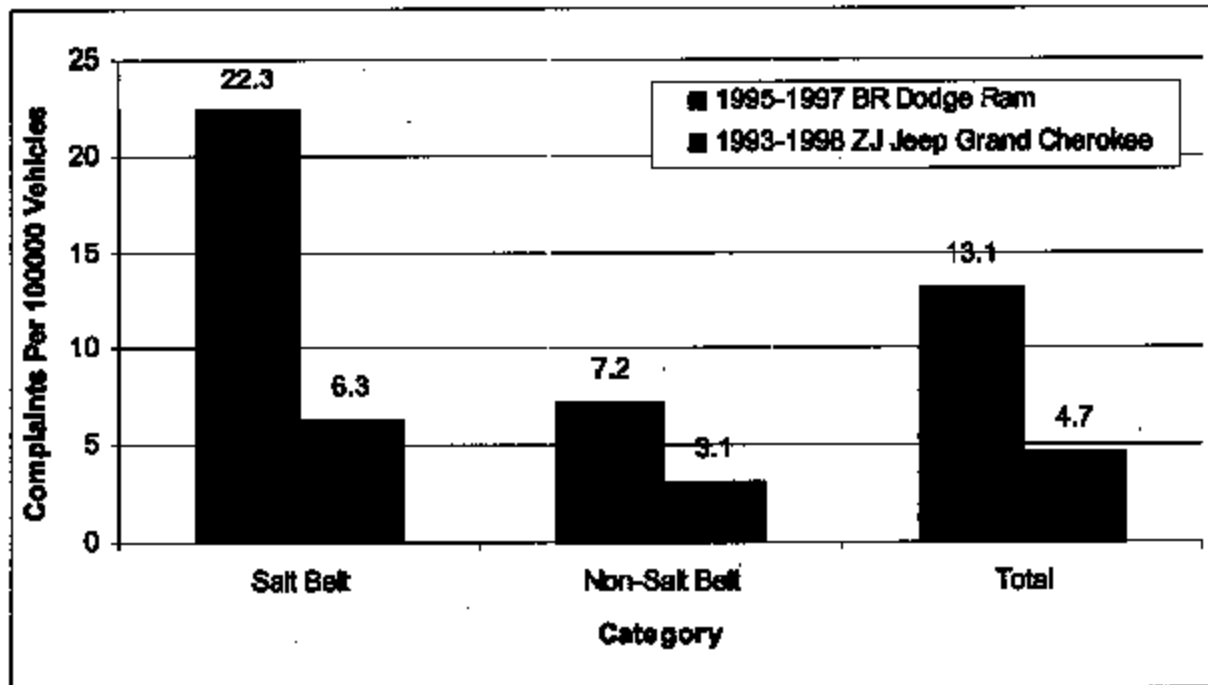
Figure 4: Dodge Ram vs. Jeep Grand Cherokee Secondary Hood Latch Complaint Rates

ODI's analysis of RQ00-012 and the MY 1994-1999 Dodge Ram hood latch regional (salt-belt states) recall (NHTSA recall number 01V-040) showed that although there was component material similarities between the MY 1994-1999 Dodge Ram hood latches and those of the subject vehicles, there were significant differences between the hood and the hood latch assembly designs in these vehicles (see Manufacturer's Analysis section). These differences could account for the significantly higher complaint rate and the safety-related defect trend that led to the MY 1994-1999 Dodge Ram recall. Although the subject vehicles are significantly older than the Ram trucks investigated in RQ00-012, their complaint rates in both salt-belt states and non-salt belt states are lower than the rate observed in the non-salt belt Ram trucks that were excluded from the 2001 recall (Figure 4).

The chart below shows a comparison of the MY 1995 – 1997 BR Dodge Ram² and MY 1993-1998 ZJ Jeep Grand Cherokee³ secondary hood latch complaint rates:
