EA02025

TEXAS INSTRUMENTS, INC.'S

09/10/03 LETTER TO ODI

From: Sharpe, Robert
Sent: Monday, January 18, 1999 9:09 AM
To: Douglas, Charles; Baumann, Russ
Cc: Rowland, Thomas; Balcer, Gary; Dague, Bryant; McGuirk, Andy; Dodd, Bob
Subject: Lincoln Town Car Brake Switch

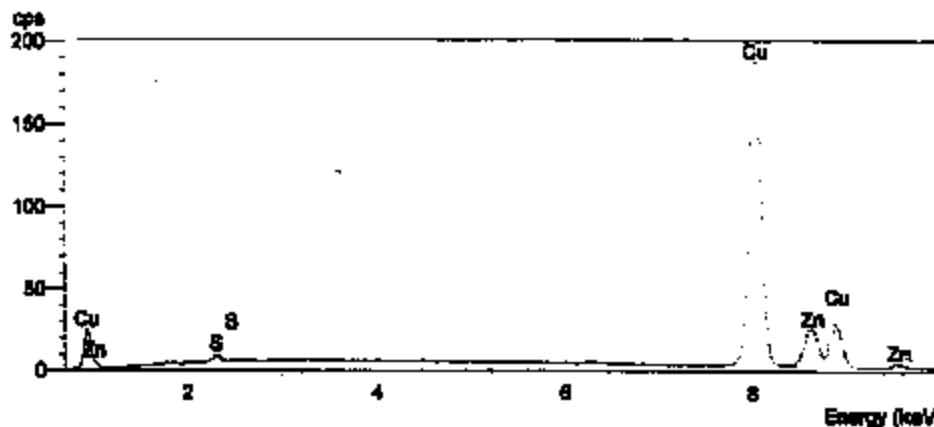
Figure 1: EDS X-ray spectrum of material scraped from the side of the stationary contact body.

The stationary contact exhibits intergranular cracks which indicate stress corrosion cracking (BCC). BCC is caused by combination of a specific corrosive environment and a sustained tensile stress (can be localized). Ammonia, ammonia compounds, sulfur compounds, and moisture are known to cause BCC in brass. The contact material has been reported to be 360 brass, which is highly susceptible to BCC.

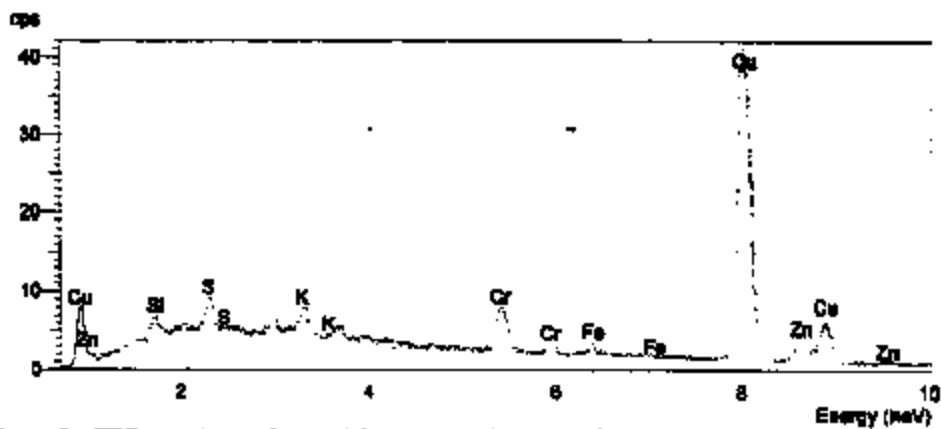
Figure 2: EDS spectrum of greenish compound scraped from the cup region.

The cup is partially covered with a greenish residue. Residue appears to be primarily an oxide of the brass contact material with possibly a sulfur compound. This suggests transfer of oxide or corrosion product from the brass contacts to the cup.

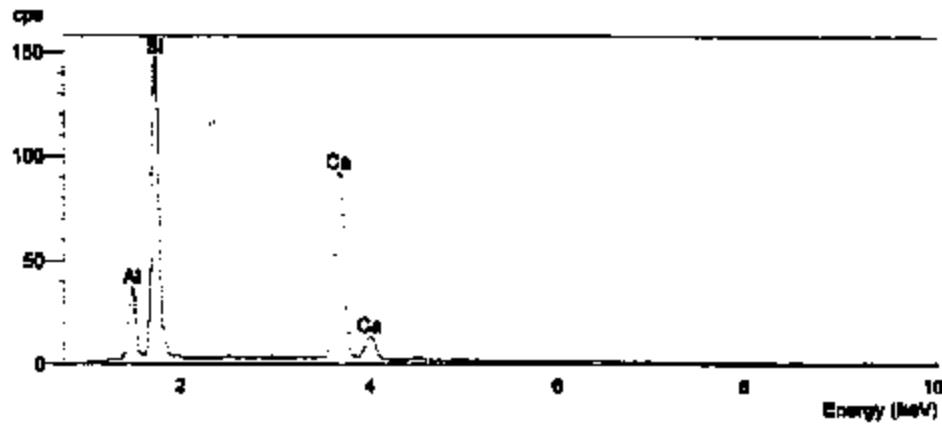
Conclusion: Surface analysis indicates that oxide or corrosion product from the brass contacts may have transferred to the cup component of the switch. Deposits on the cup also appear to contain fiber materials from the switch base.

Figure 3: EDS X-ray spectrum of fibrous material scraped from the cup region.

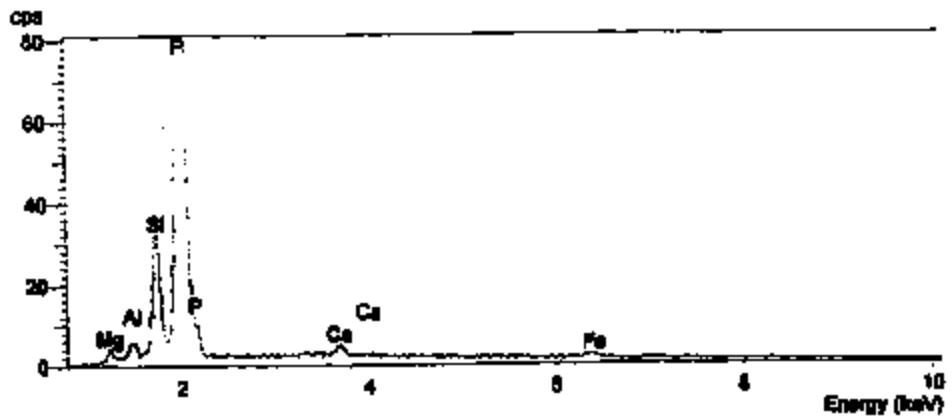
Spectra from the white deposit exhibit elements which would be found in dry chemical fire extinguishers, i.e., high phosphorous content material with plates of Si, Al, F - rich material (Muscovite).

Figure 6: EDS X-ray spectrum of one of three samples of the white powder taken from the connector cavity below the wire seal.

The white residue found in the connector cavity contains elements found in dry chemical fire extinguishers (Muscovite and phosphorus)

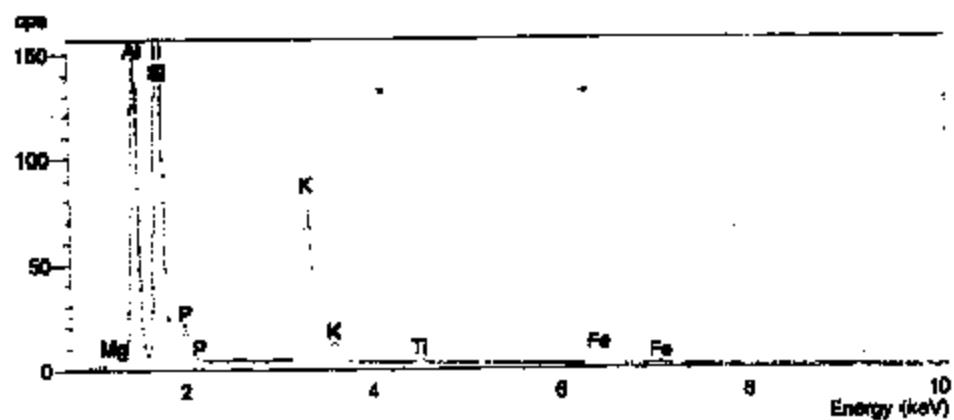
Figure 7: EDS X-ray spectrum of the second of three samples of the white powder.

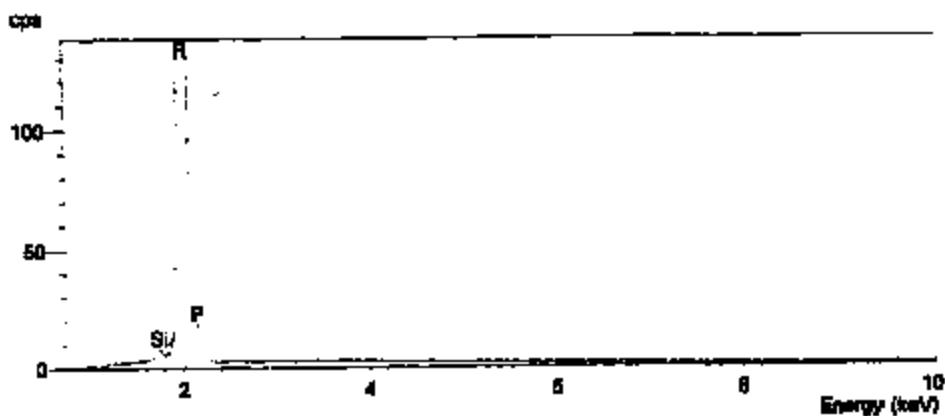
Figure 8: EDS X-ray spectrum of the third of three samples of the white powder.

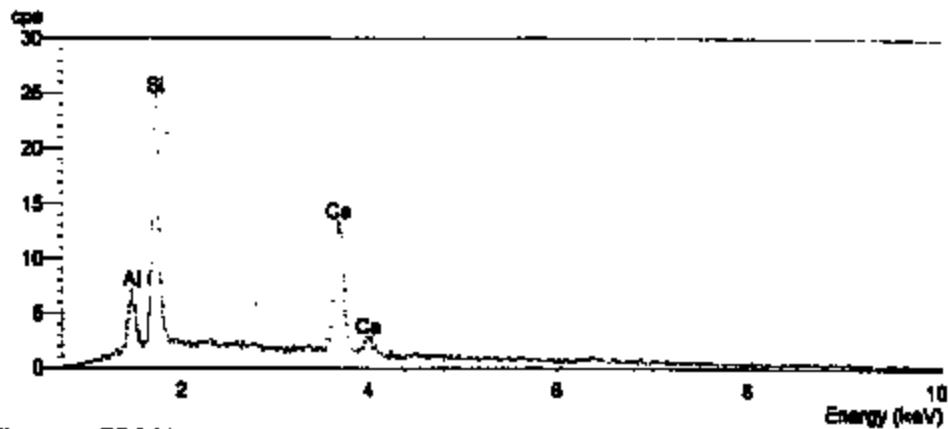
Figure 4: EDS X-ray spectrum of material shaved from a new base.

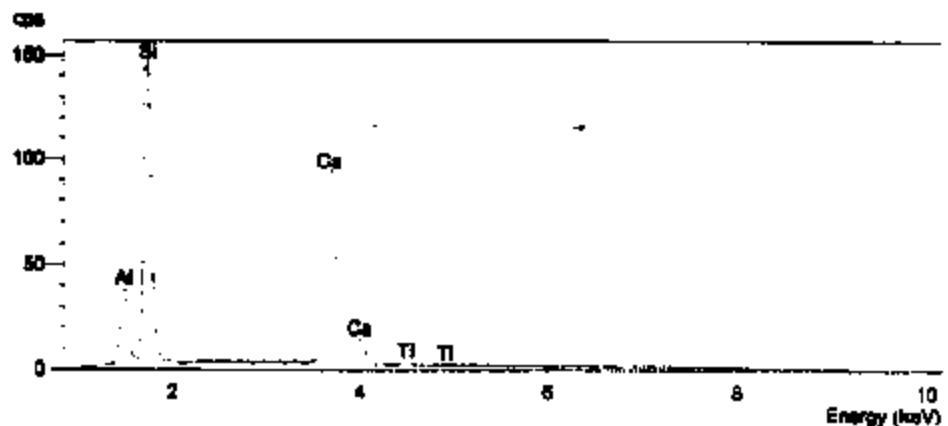
Figure 5: EDS X-ray spectrum of fibrous material scraped from the old base.
