EA02025

**TEXAS INSTRUMENTS, INC.'S
09/10/03 LETTER TO ODI**

From: LaRouche, Steve (S.) [slarouch@ford.com]
Sent: Tuesday, March 30, 1999 2:54 PM
To: Rahman, Aziz; LaPointe, Norman; LaRouche, Steve; Porter, Fred; Reimers, Steve; Stevens, Gregory
Subject: Latest Versions of Switch Log and Testing Checklist

Brake Switch Testing Checklist

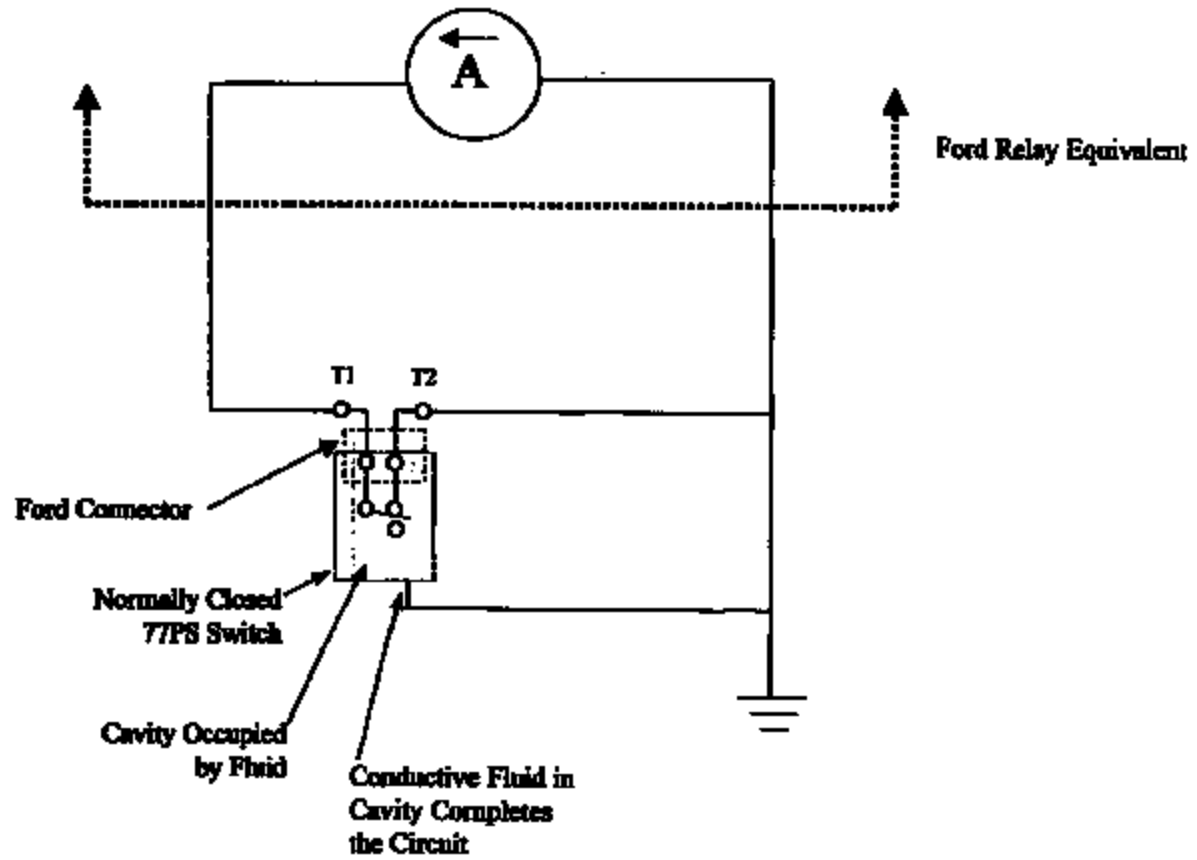
TI Test Circuit

Current limited to 0.2 Amps

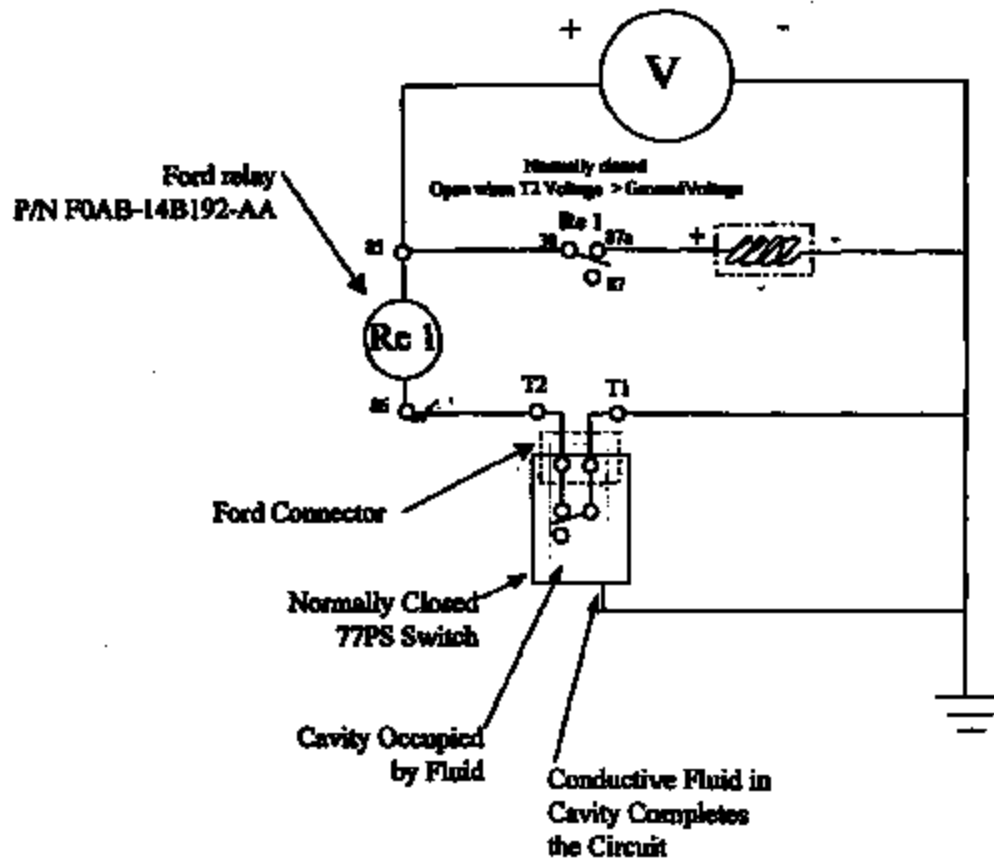
77PS Proposed Wiring Schematic

14 Volts DC
