**EA02-025**

**TEXAS INSTRUMENTS, INC.'S**

# 77PS Return Analysis

Ford 77Ps Recovered Parts Analysis

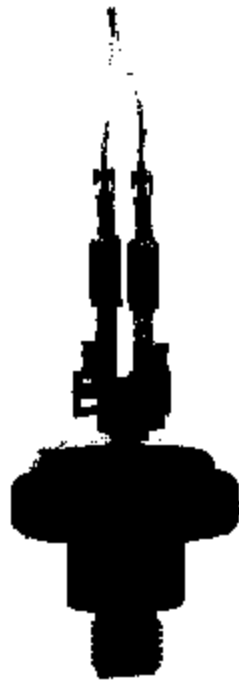
577-1

Hex port Internal Some Corrosion

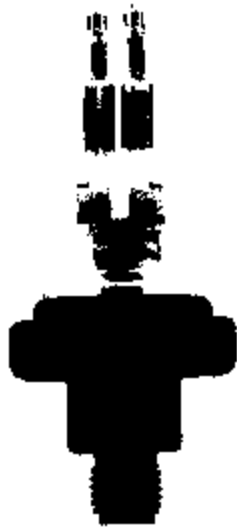
F77-3

Converter Good - Normal wear

Hex port Internal gasket good - some internal corrosion

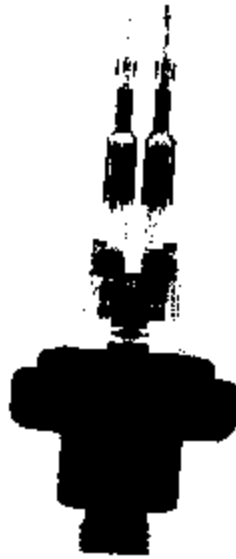
Converter good - Kapton SPACER good

Hex port Internal Light amounts of DEBRIS - gasket good

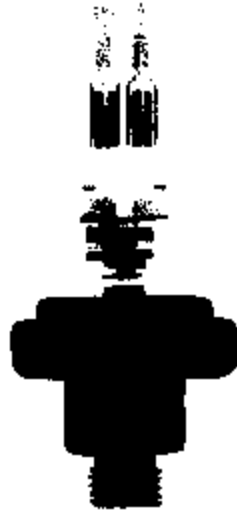
F77-4

Converter Normal wear

Hex port Internal Slight contamination + Debris

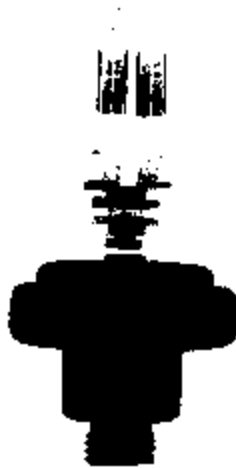
F77-5

Converter Good - Normal wear

Hex port Internal mild corrosion and Buildup of Gasket good

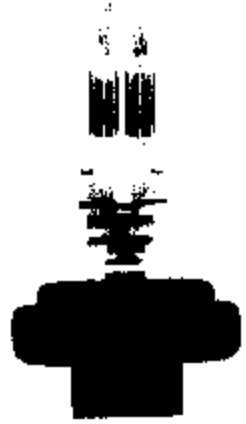
F77-6

Converter good - NORMAL WEAR

Hex port Internal SOME SLUDGE AND CORROSION
