**FORD 10/28/03
LETTER TO ODI**

VEHICLE AND GARAGE FIRE

CLAIM NO.: 565DP07941

P.A.C.E. PROJECT NO. I-2006A

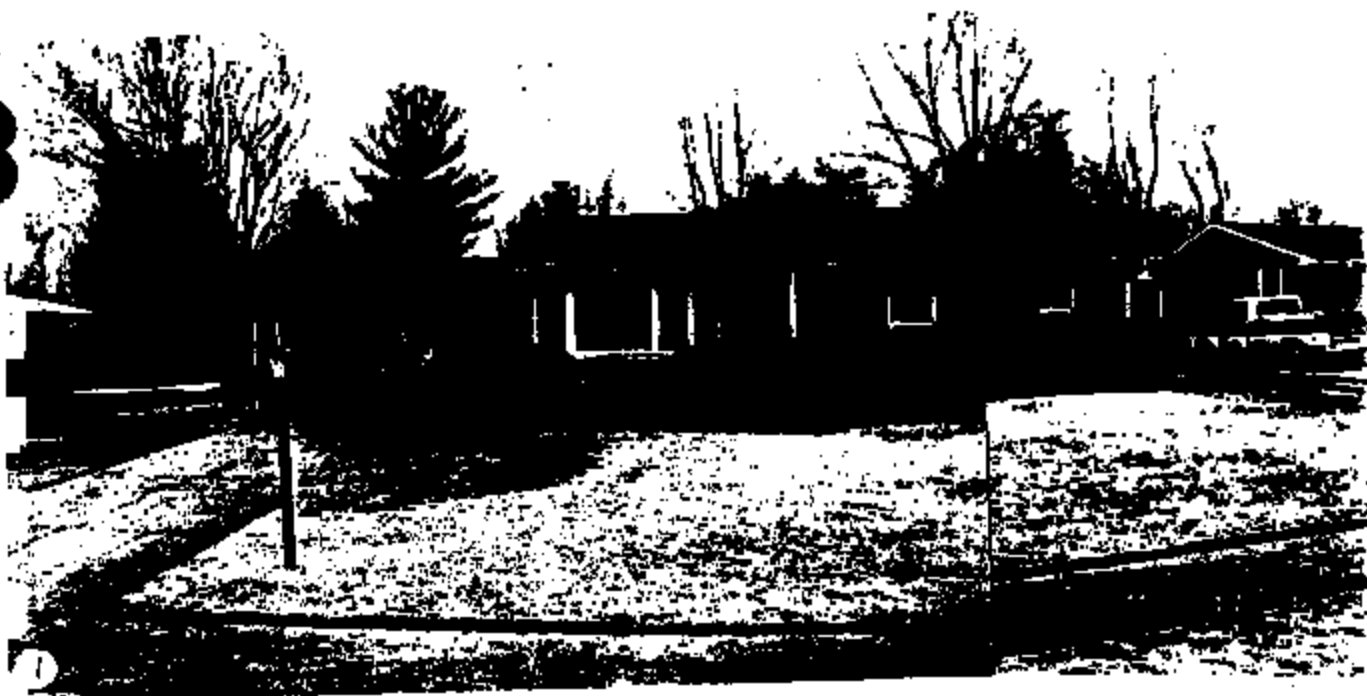
FIGURE 1

FRONT VIEW OF HOUSE AND GARAGE

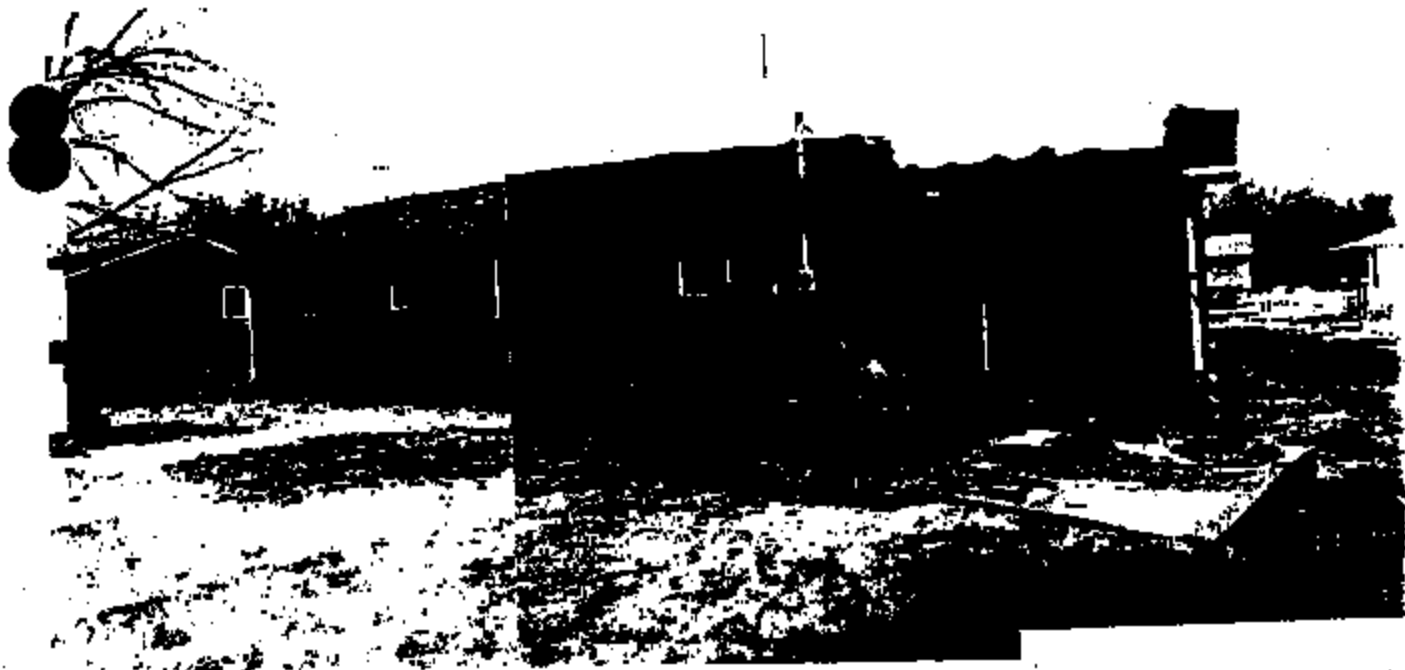
FIGURE 3

REAR VIEW OF HOUSE AND GARAGE

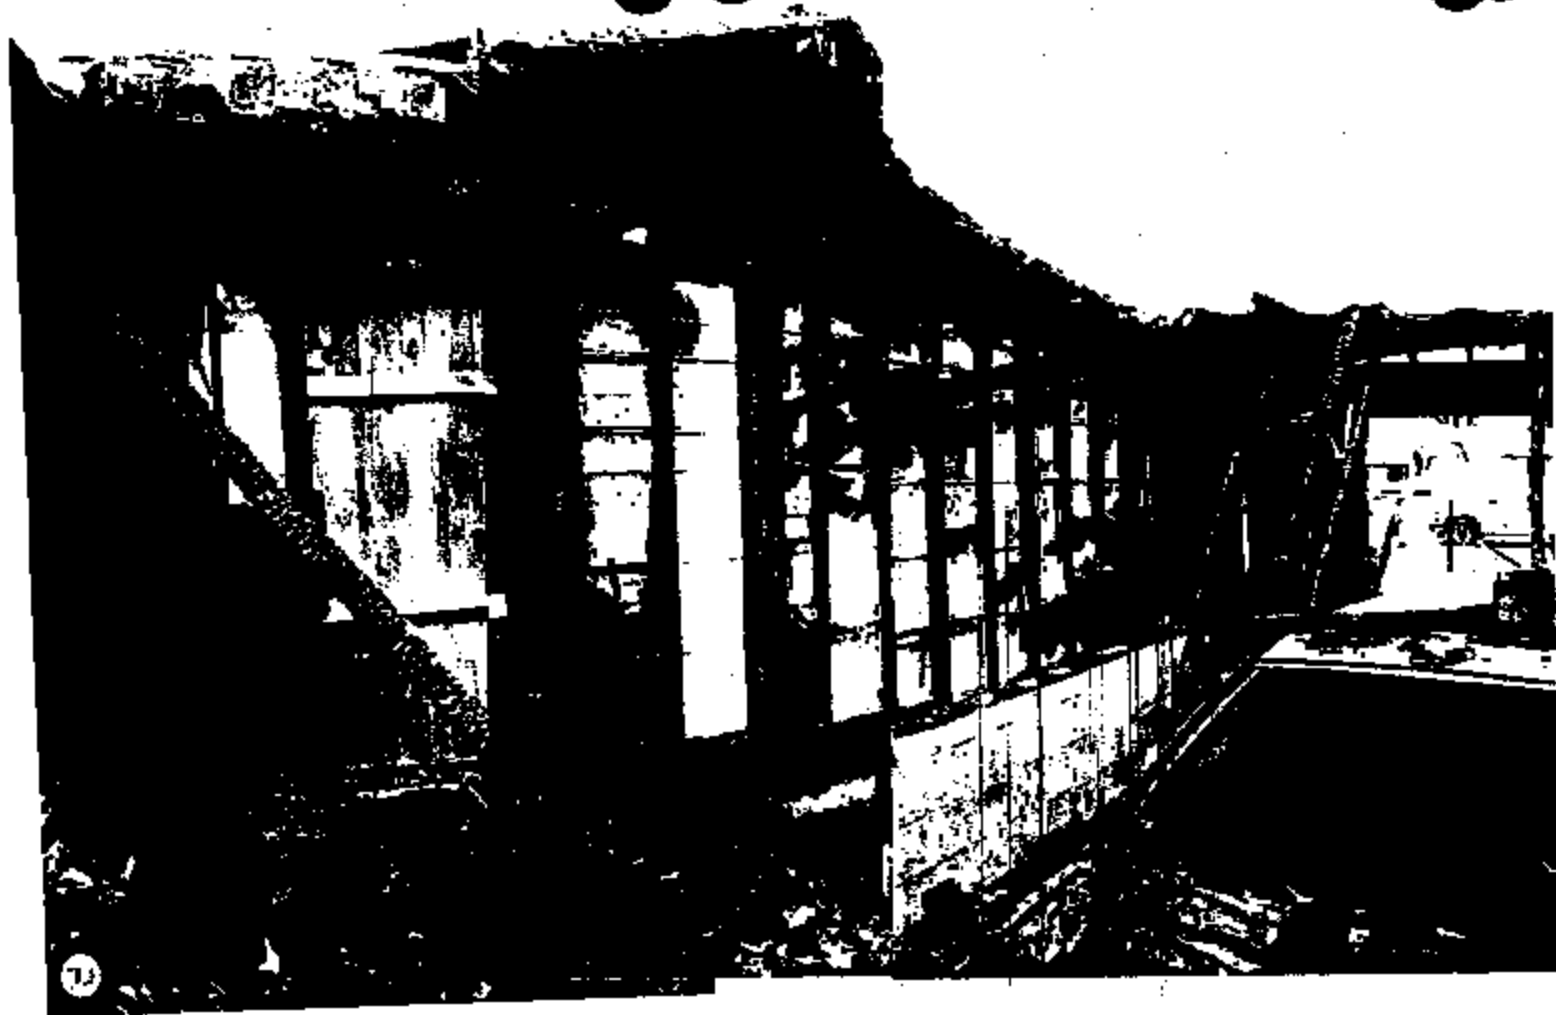
FIGURE 32

At the middle of Figure 2 a "clean area" may be observed on the block wall. This "clean area" is an area of very intense heating. This area was approximately in line with the right, front corner of the Mercury, which is where I believe the fire originated. Figure 33 is a view of this right, front

VIEW OF "CLEAN AREA" ON WEST GARAGE WALL
