EA02-025

**FORD 10/28/03
LETTER TO ODI**

ANALYSIS OF A 1992 FORD CROWN VICTORIA

S. D. LYONS, INC.

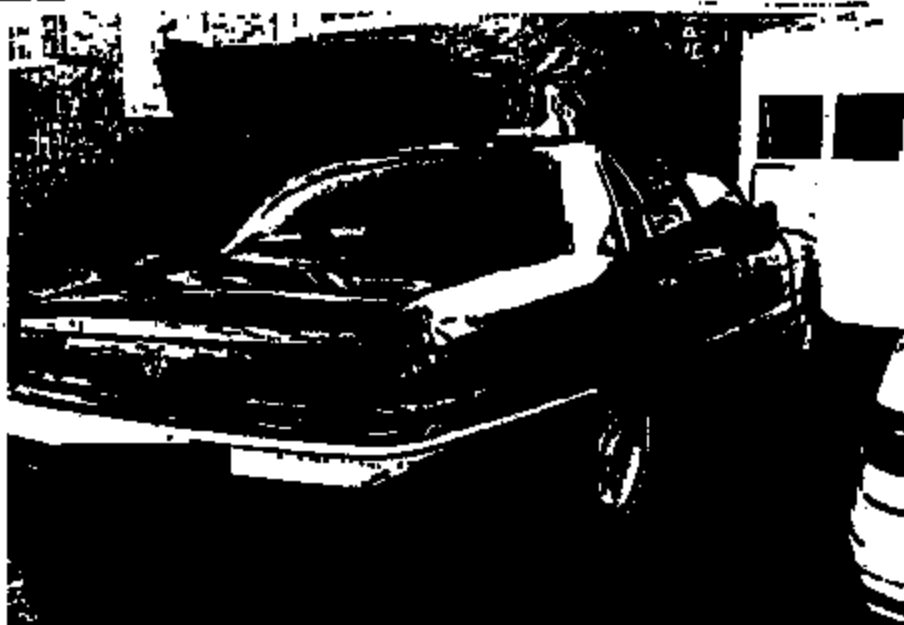
Photograph 1
Right rear view of the 1994 Mercury Grand Marquis. The vehicle was brand new, and it had not been previously damaged or repaired.

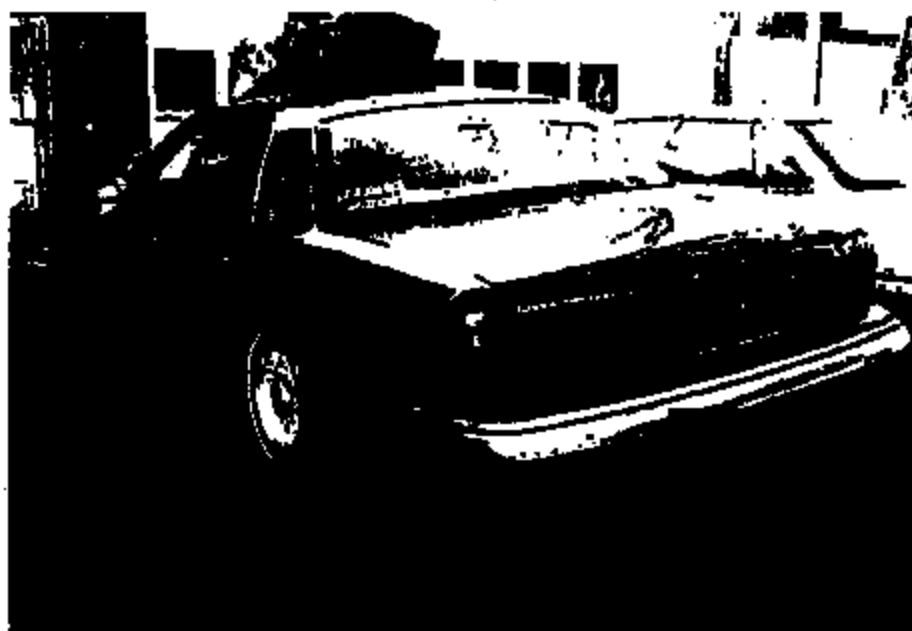
Photograph 2
Left rear view. There was no existing collision damage. Nothing was missing from the Marquis at the time of the loss.

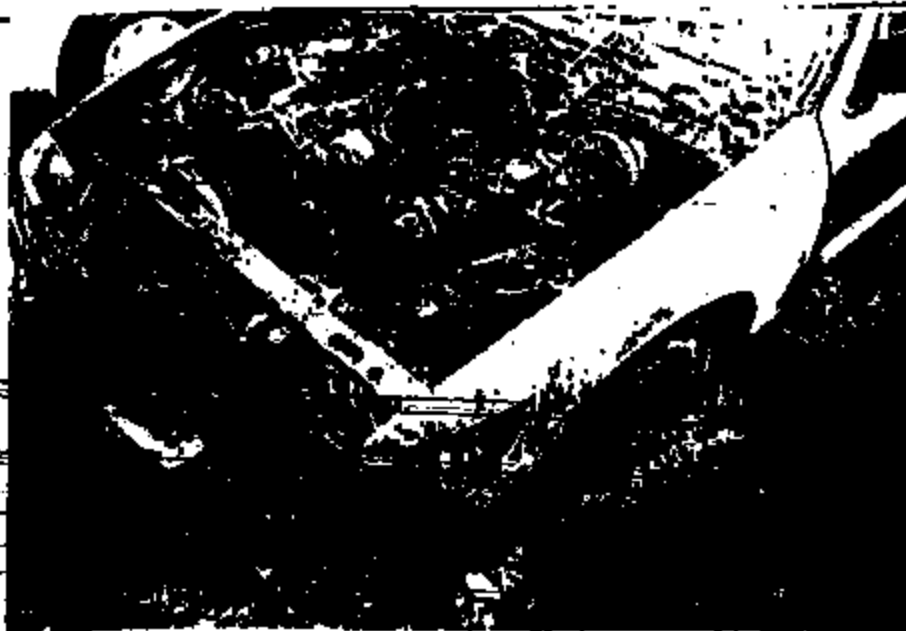
Photograph 9
View of burn patterns at the left front. The left side of the radiator support was extensively scorched, and the left side of the bumper support was melted.

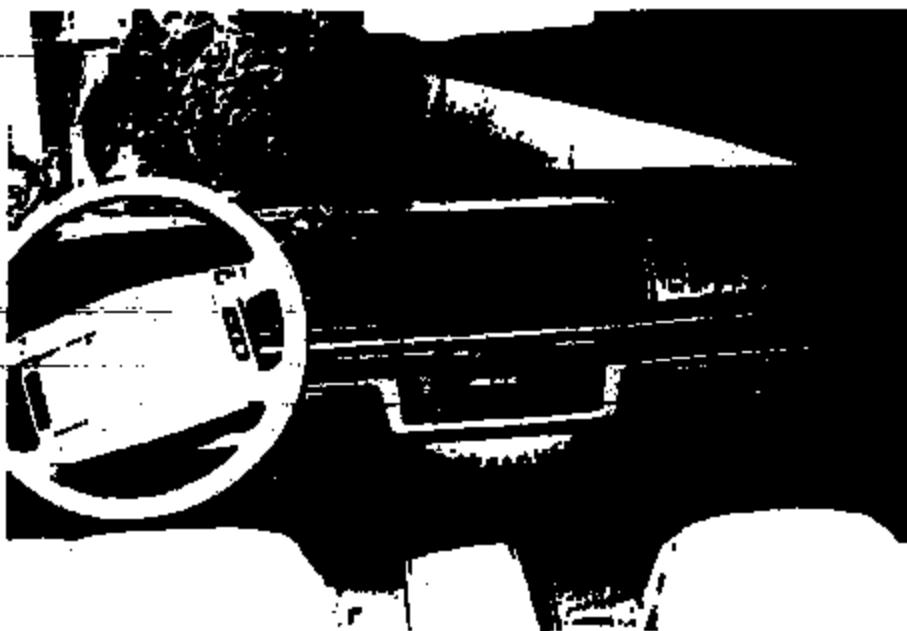
Photograph 12
View of the dash assembly. The fire did not originate in
the dash of the vehicle.
