**EA02-025**

**FORD 10/27/03**  
**LETTER TO ODI**

**PRIVILEGED AND CONFIDENTIAL**  
**REPORT NUMBER ONE - FINAL**  
September 28, 1993

The purpose of our investigation was to determine if there were any manufacturers defects with the 1992 Lincoln Towncar that led to or caused the fire at the [REDACTED] home on September 19, 1993. This report is in addition to the fire report by INS Investigations Bureau, Inc. dated September 28, 1993 (that report did not address the Lincoln Towncar possible electrical problems).

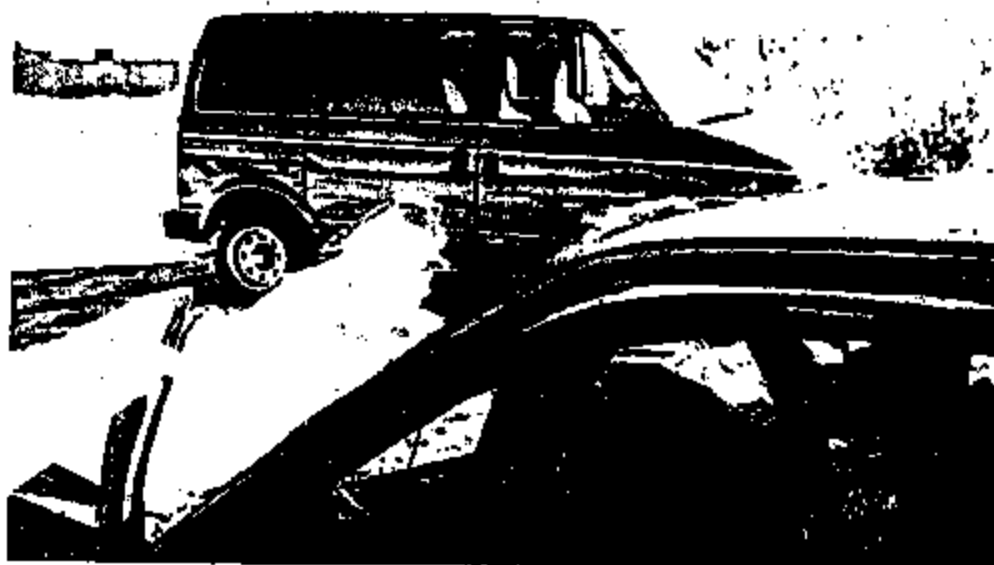
**INTERIOR/HOOD - 1992 LINCOLN TOWNCAR**

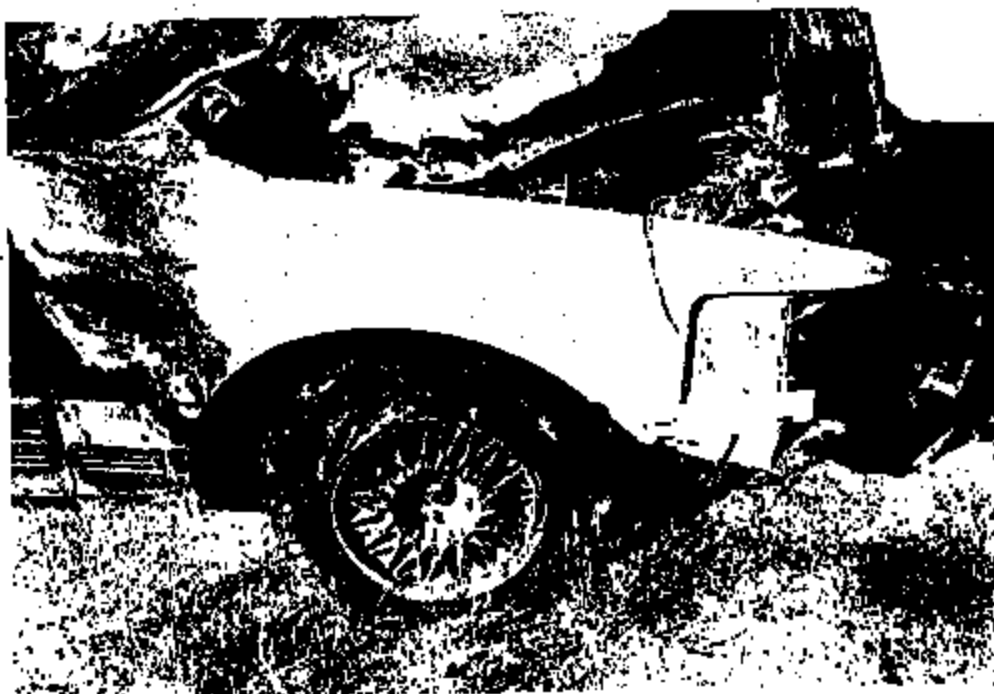
6. Right front fire damage was observed and documented as not extending below mid-height of the tire. (no damage was noted on the car below that mid-height point) Therefore, there is no way that the fire could have started at the floor level adjacent to the right front corner or that tire.

8. The surface above and around the engine compartment on the front right side is the only burned area. The tire was burned up from mid-height, therefore the fire was originating from the engine compartment and burning up through the hood.

**RIGHT FRONT FENDER/TIRE - 1992 LINCOLN TOWNCAR**

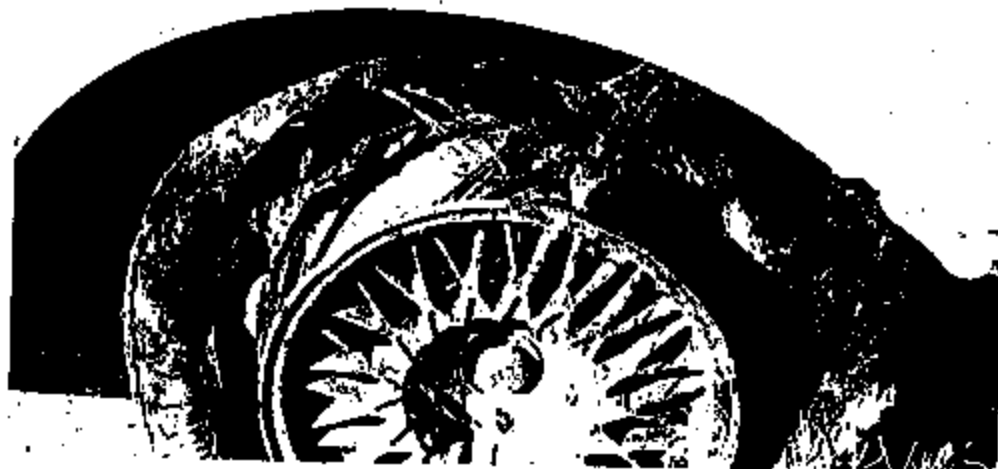
4. Note that the fire does not go below the centerline of the mid height of the right front tire and indicates that the fire came out through the engine compartment fueled by fuel in the engine compartment and then burned the top of the fire.

**RIGHT FRONT TIRE - 1992 LINCOLN TOWNCAR**
