EA02-025

**FORD 10/27/03
LETTER TO ODI**

BOOK 6 OF 22

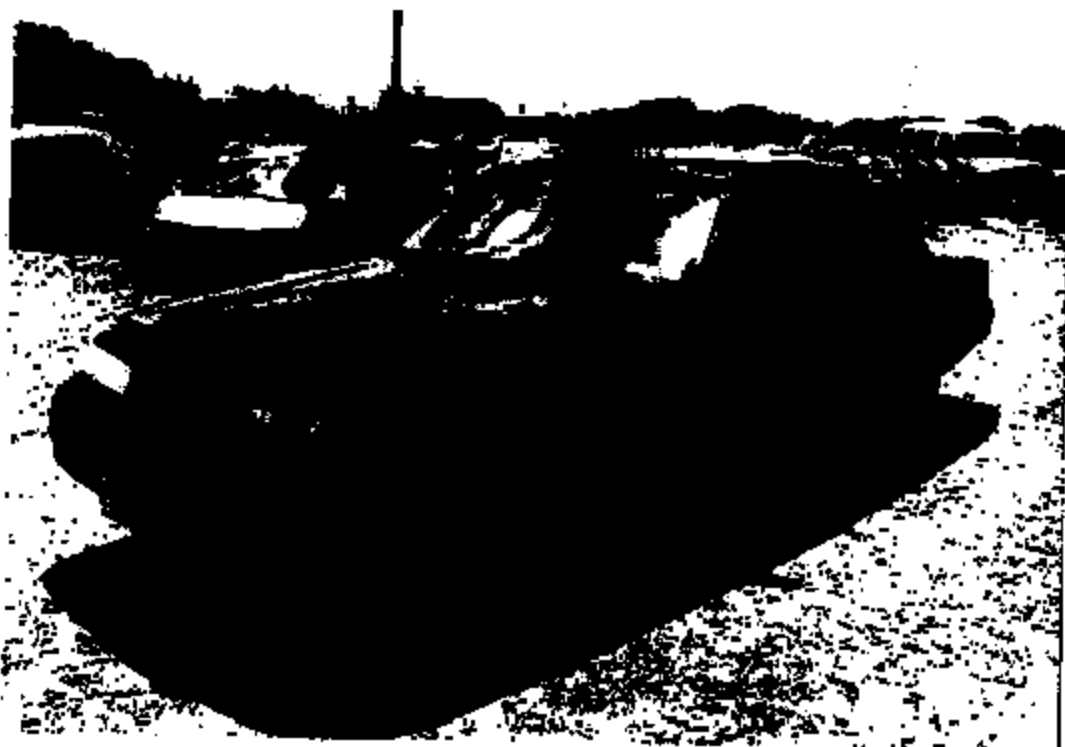
No. 5

5. Left front corner of involved vehicle.
6. Undamaged paint on exterior surface of the hood.
7. Minor damage and heat stress on right front corner of hood.

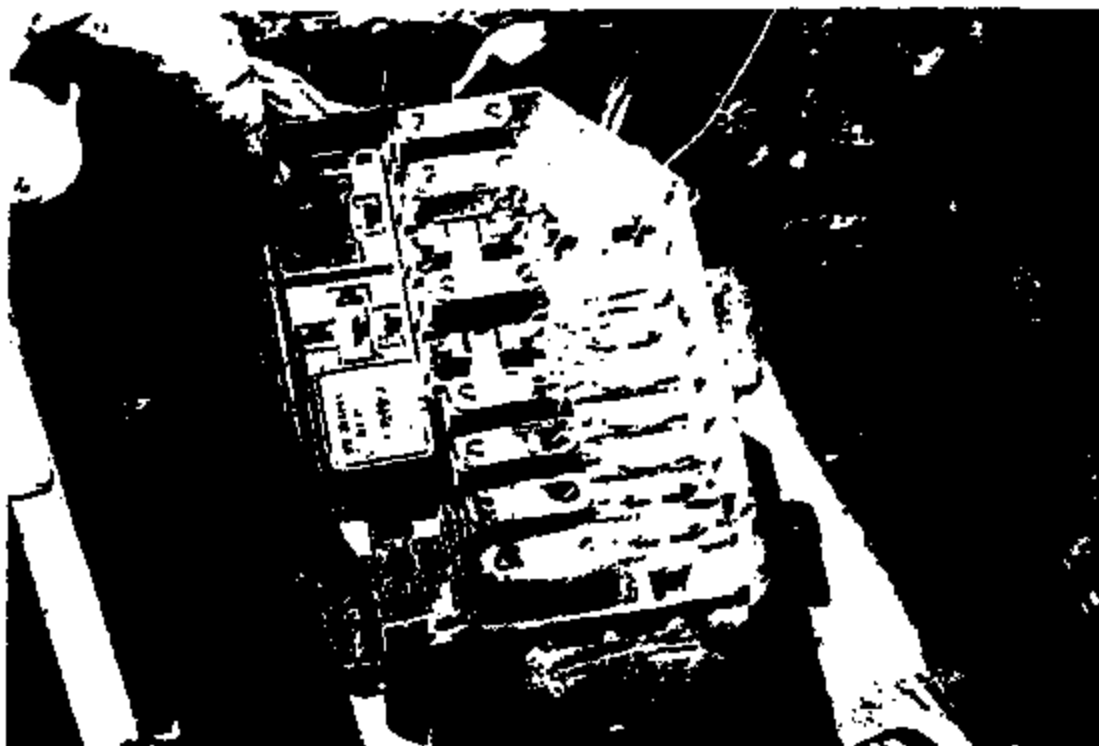
No. 19

Once the fuse box cover was removed, it was evident the only fire damage was to two of the large fuses on the rear of the panel (photo #19). The bottom cover was removed from the electrical distribution box at which time I noted an interior cover was burned approximately half way off (photo #20). The burning to the underside of the component was clearly localized with fire damage to three of the wires (photo #21).

19. Fire damage to fuses in electrical distribution box.
20. Burning to lower cover on electrical distribution box.
21. Burning to under side of electrical distribution box.
22. Burning to under side of electrical distribution box. NOTE loose wire was replaced in approximate area prior to fire.
23. Blown and damaged fuse.
24. Blown and damaged fuse.
25. Close up of damage to fuses in electrical distribution box.
26. Localized burning to end of electrical distribution box.
27. Localized burning to end of electrical distribution box.
28. Internal burning in electrical distribution box.
29. Internal burning to electrical distribution box.
