TEXAS INSTRUMENTS, INC.'S

Ford 77Ps Recovered Parts Analysis

Ford 77PS Issue Recovered Parts Analysis

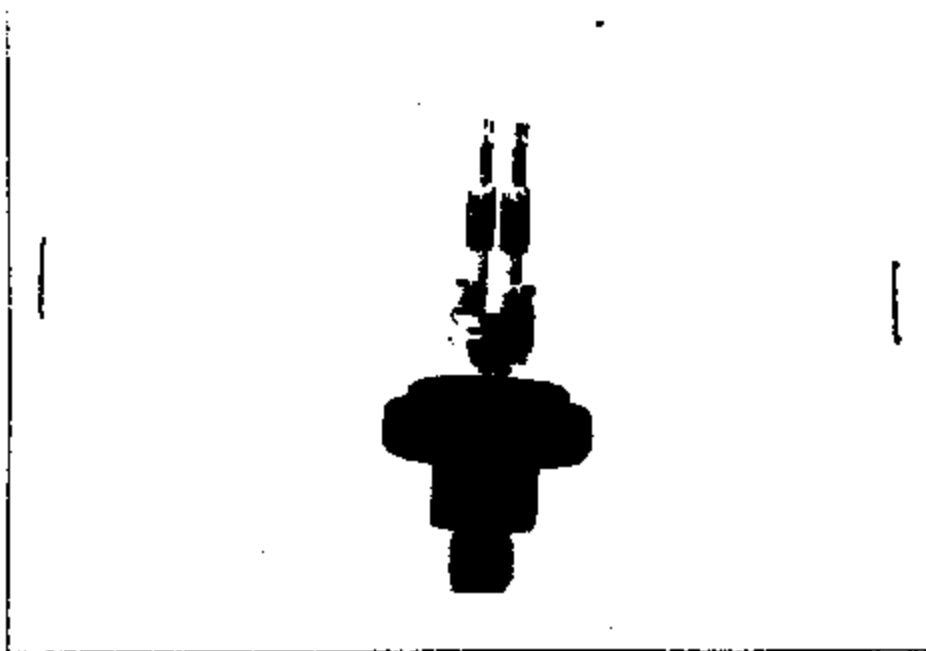
F77-1

External switch condition Fair - Corrosion on Hex AND
Partially Deformed Terminals - Soldered Circuit -
Slight Displacement of O-Rings on Plug Inlet

Terminal Condition Good - Clean with no Corrosion

Contact Assembly Clean - No Contamination
No Marking of Contacts - No Heat Discoloration or
Cracked Area

Sensor Assembly Some Corrosion Approaching
Base/Sensor Socket and Completely Absent Bottom
of Sensor Near Hex

Kapton Condition Good - Some dust from cycling DELAYER
Bottom - Cracking seen with Fluid Seepage to DELAYER
Contacts - Minor Spitting from Bottom in High Pressure

Hex port Internal Some Corrosion

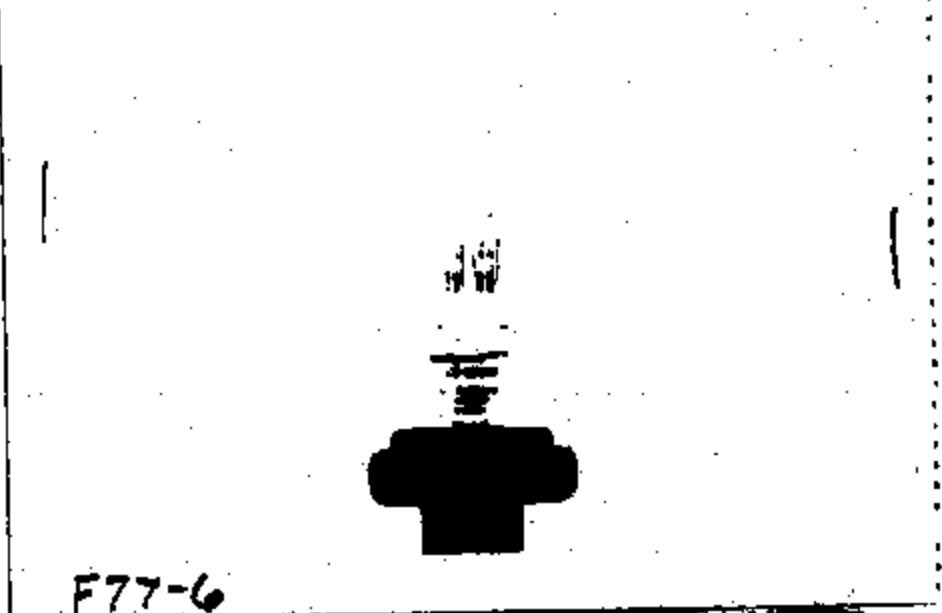
F77-6

External switch condition good - RED Rust on hex and PARTIALLY DOWN THREADS - Connector clean - mating surface good

Terminal Condition CLEAN - NO CORROSION - Slight mis-alignment of terminals

Sensor Assembly CORROSION UP SIDE UNDER CRIMP RING

Kapton Condition CRACKS AND/OR DELAMINATION ON 1ST LAYER
2 - Normal wear
3 - Normal wear

Hex port Internal Some Sludge and Corrosion

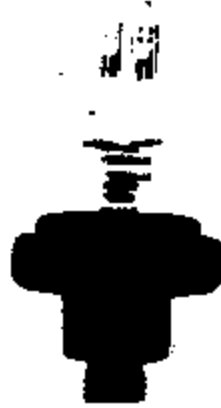
F77-5

External switch condition Fair - Red Rust on hex Port
NO CORROSION ON CRIMP RING - Partial corrosion
DOWN THREADS

Sensor Assembly Slight corrosion UP SIDE - overall
good condition

Kapton Condition 1 - De-laminated with Fluid - not all the way through
2 - normal
3 - normal

Washer Deformation in Button area - CAUSING MISHAPE IN Kapton

Hex port Internal mild corrosion AND Buildup of Gasket good

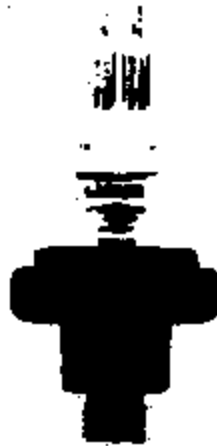
F77-4

External switch condition Red Rust on hex part - Slight Amount
on Crimp Ring - Seal Area good Same Debris as what
Partial Corrosion Down Threads

Sensor Assembly CORROSION UP SIDE AND ONTO TOP WEAR
AN AREA

Environmental Seal Slight Lift FROM SENSOR TO GASKET FROM RUST
DISTORTED SHAPE

Kapton Condition Print FROM GASKET MARK on Kapton
1- Delamination Seen 2- Normal wear DRY
3- Normal wear - DRY

Hex port Internal Slight Contamination + Debris

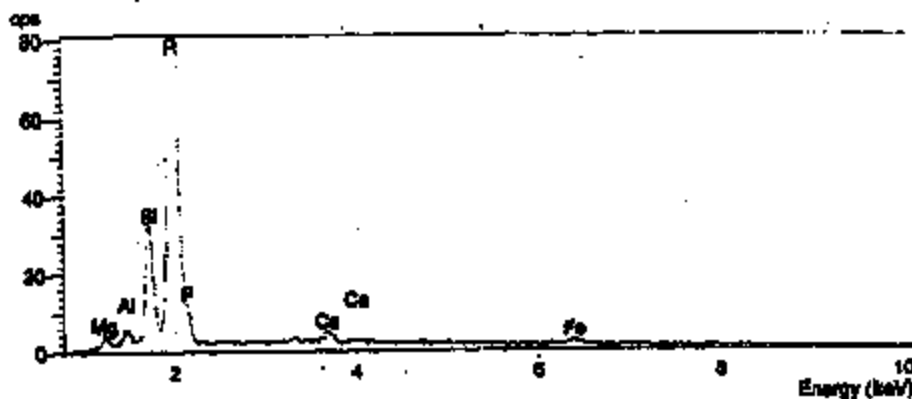
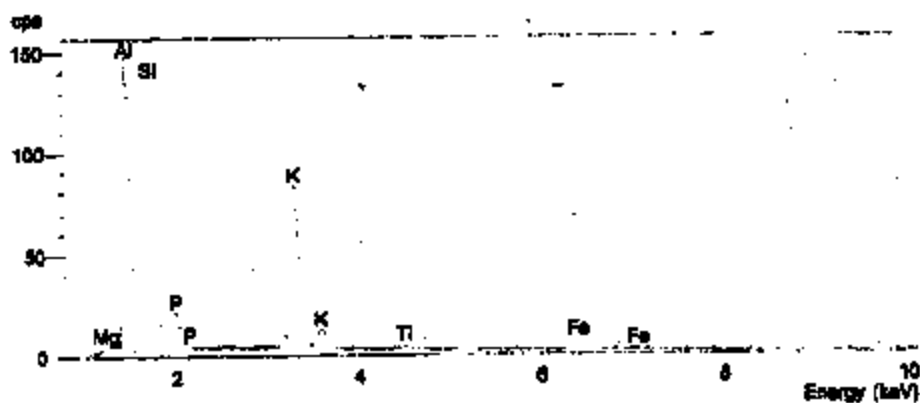
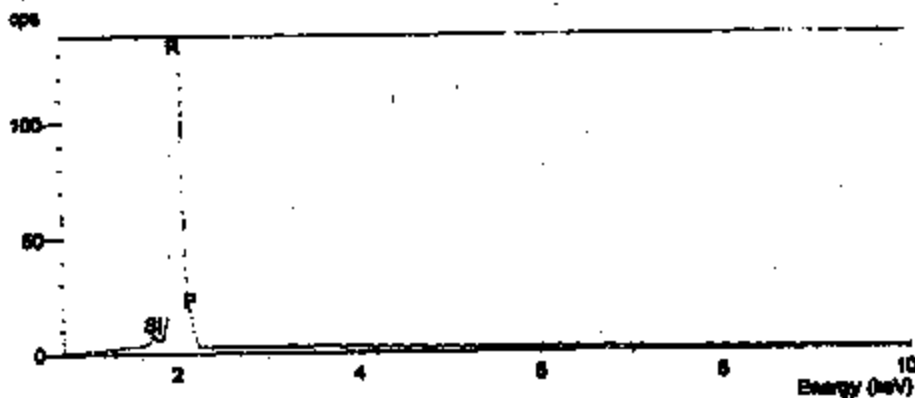
Figure 6: EDS X-ray spectrum of one of three samples of the white powder taken from the connector cavity below the wire seal.

Figure 7: EDS X-ray spectrum of the second of three samples of the white powder.

Figure 8: EDS X-ray spectrum of the third of three samples of the white powder.

The white residue found in the connector cavity contains elements found in dry chemical fire extinguishers (Muscovite and phosphorus)

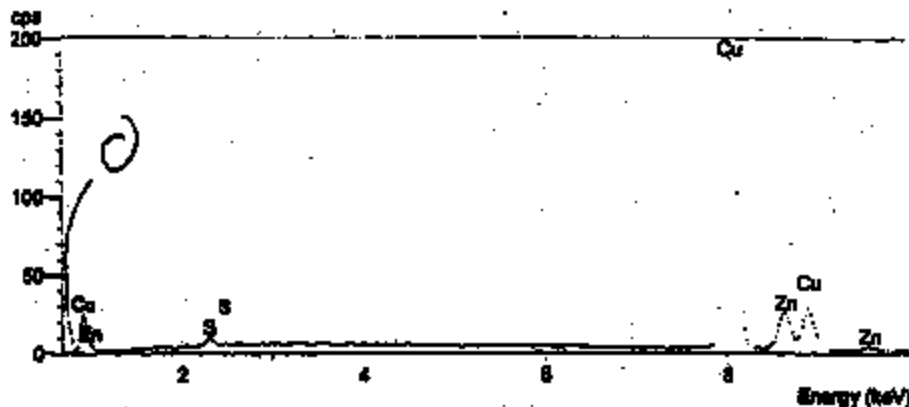
Figure 1: EDS X-ray spectrum of material scraped from the side of the stationary contact body.

The stationary contact exhibits intergranular cracks which indicate stress corrosion cracking (SCC). SCC is caused by combination of a specific corrosive environment and a sustained tensile stress (can be localized). Ammonia, ammonia compounds, sulfur compounds, and moisture are known to cause SCC in brass. The contact material has been reported to be 300 brass, which is highly susceptible to SCC.

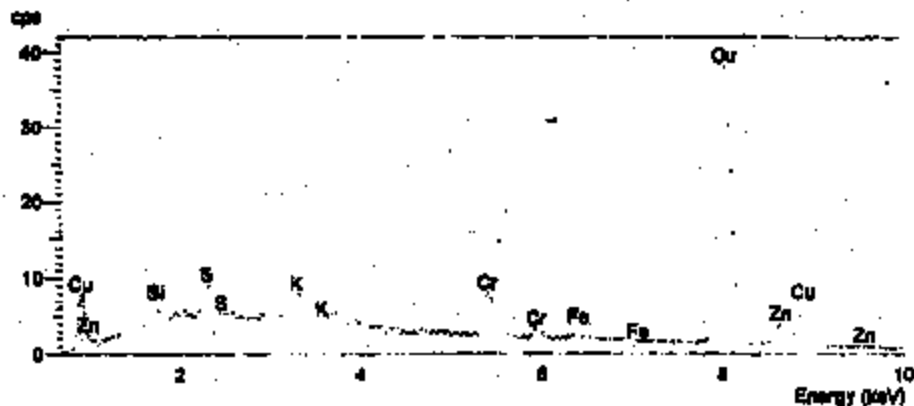
Figure 2: EDS spectrum of greenish compound scraped from the cup region.

The cup is partially covered with a greenish residue. Residue appears to be primarily an oxide of the brass contact material with possibly a sulfur compound. This suggests transfer of oxide or corrosion product from the brass contacts to the cup.
