To: Rock Carter (Ford) Fax: 313-621-0646
From: Al Hopkins (Texas Instruments) Date: 04/13/99
Re: SEM-EDS Data Collected at TI Pages: This Cover Sheet & 41 Pages of Data
SAC-41
CC: [Click here and type name]

<u>Sample</u>	<u>Pages</u>	<u>Photos</u>	<u>Spectra</u>
Top Surf of Cap after Degreasing	1-14	01-08	001-009
Terminal Cavity after Disassembly	15-28	06-15	010-013
"A" -Black Flake from Trough	29-31	20	024-021
"B" - Material Scrapped from Cap Assembly	32-37	21	022-026
"C" - Green Material on Cap	38-41	22	027-029

SUBJECT: 99-181: TSL # 131700: PRELIMINARY FINDINGS ON LINCOLN SIMULATION SAMPLES

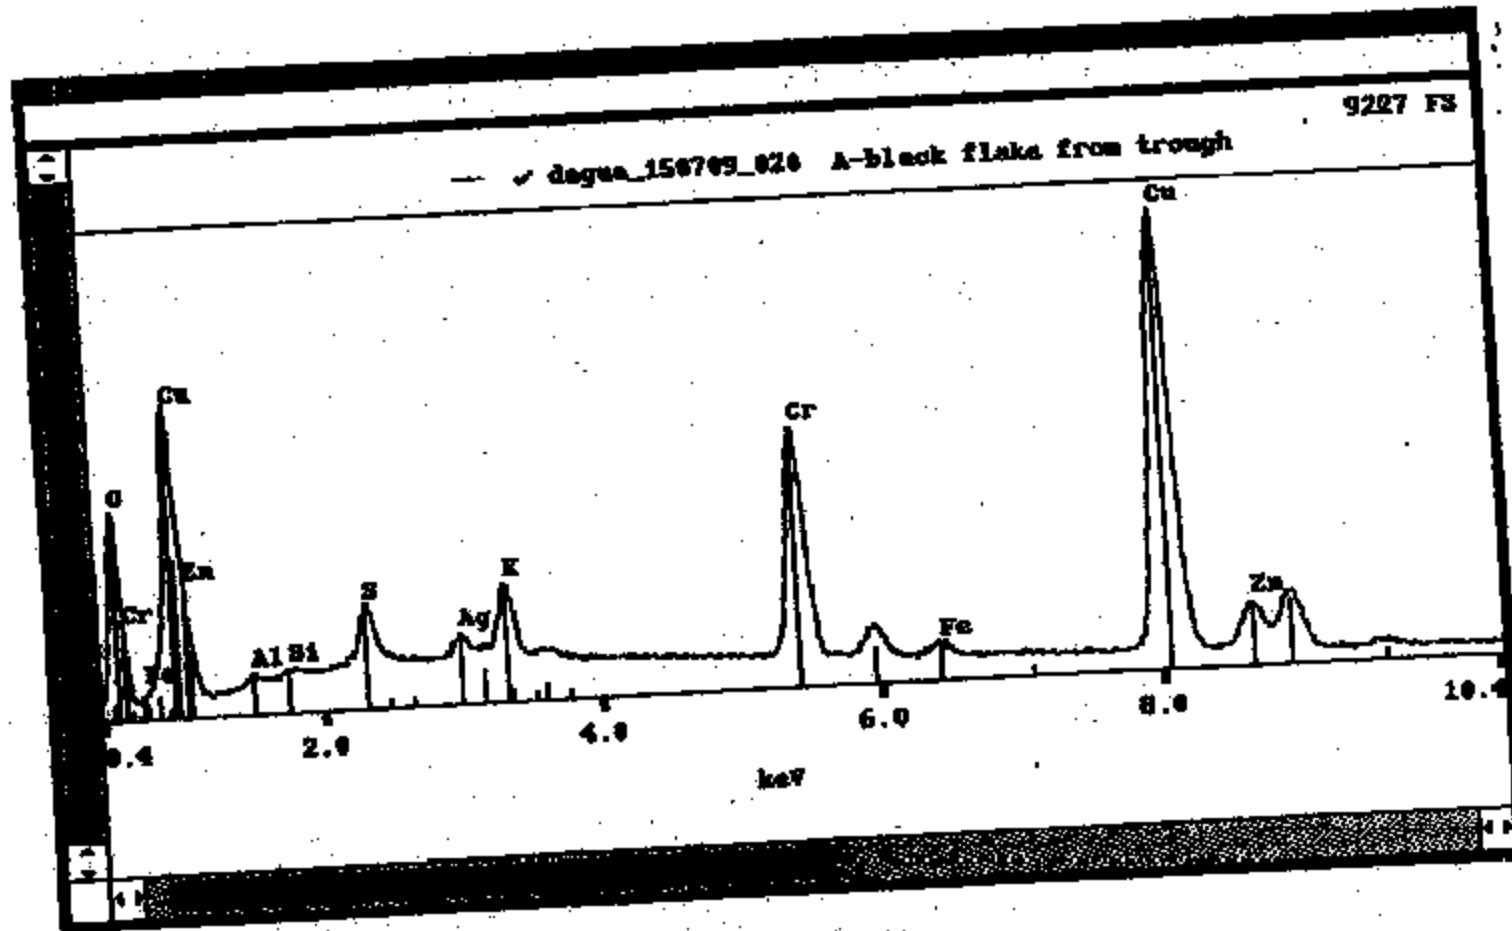
150709 A-black flake from trough, 50x bee 20
