**TEXAS INSTRUMENTS, INC.'S**

## TI 77PS Test Synopsis

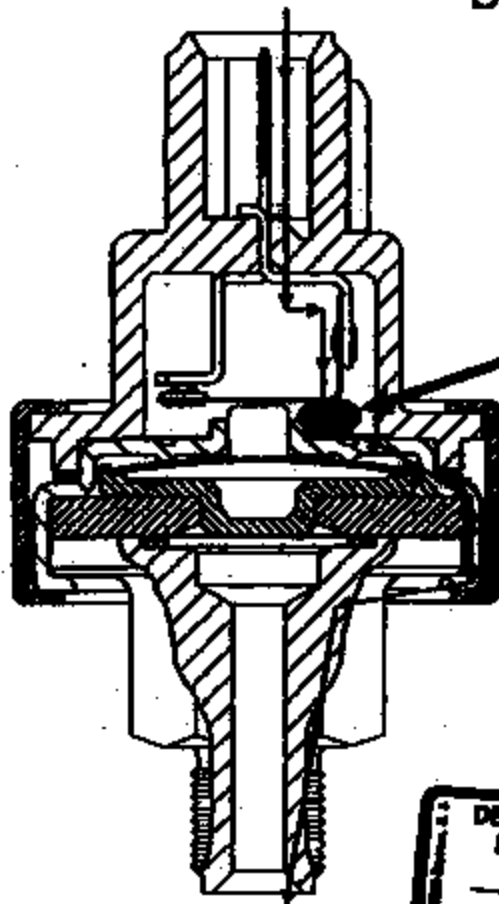
## Scenario

1. Contamination enters switch cavity through perforated kapton seal or connector seal.
2. Switch components and cap corrode with aid of electric field and contamination.
3. Current path forms between battery and ground.
4. Current increases as material builds until heat is generated to melt plastic.
5. When plastic melts enough to open the switch cavity to external air, the plastic ignites consuming the switch housing and connector.
