**EA02-025**

**TEXAS INSTRUMENTS,  
INC.'S 9/10/03  
ATTACHMENT**

NON-CONFORMING MATERIALS ADVISORY NOTICE

| PROJECT TITLE: <b>Release Test Failure</b> | | | |

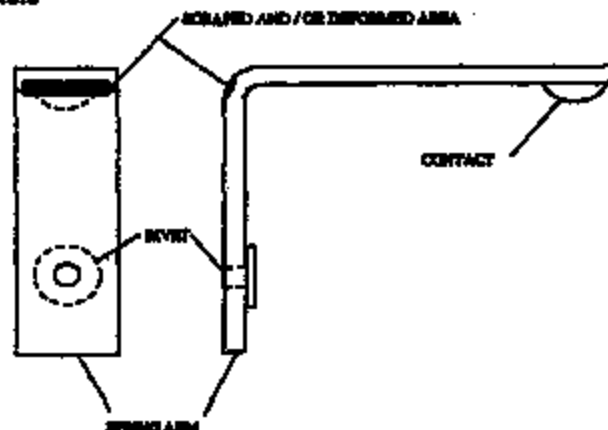
The spring anomaly is best described as a scoring or scraping, and/or material necking of the spring at the bend location.

The spring arm anomaly was created during the bending operation. It was caused by a loose tooling fixture. The problem was sporadic in nature. At times the tooling fixture was correctly aligned producing "good springs". At other times the tool was mis-aligned creating various levels of spring arm scoring, scraping, and necking.

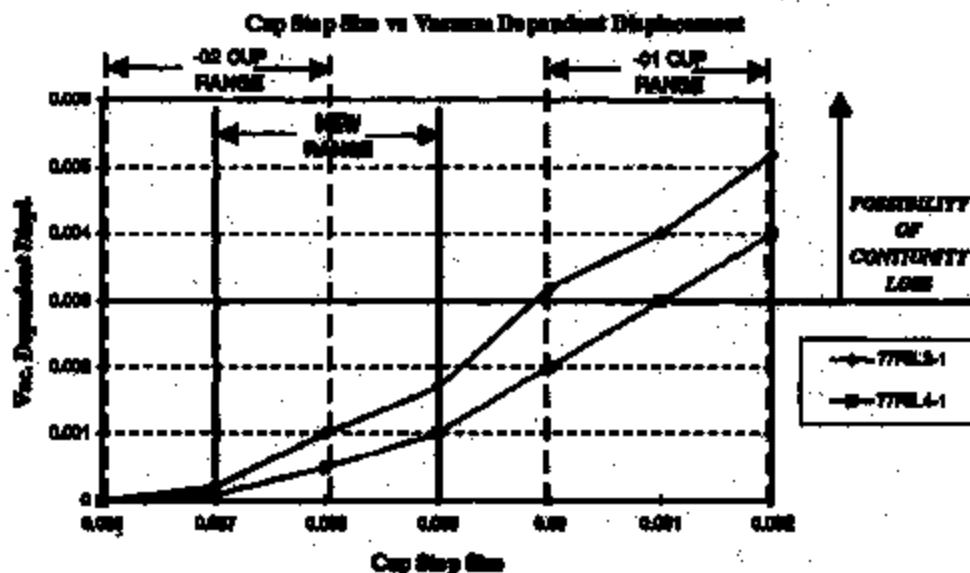
- Preloading refers to the disc being initially deformed by forces created during the assembly process.

The results of this study show that a cup step height of 0.087 to 0.089 will eliminate vacuum dependent continuity loss without causing disc preload.
