**EA02-025**

**LETTER TO ODI**

**APPENDIX M**

FIRE STUDY

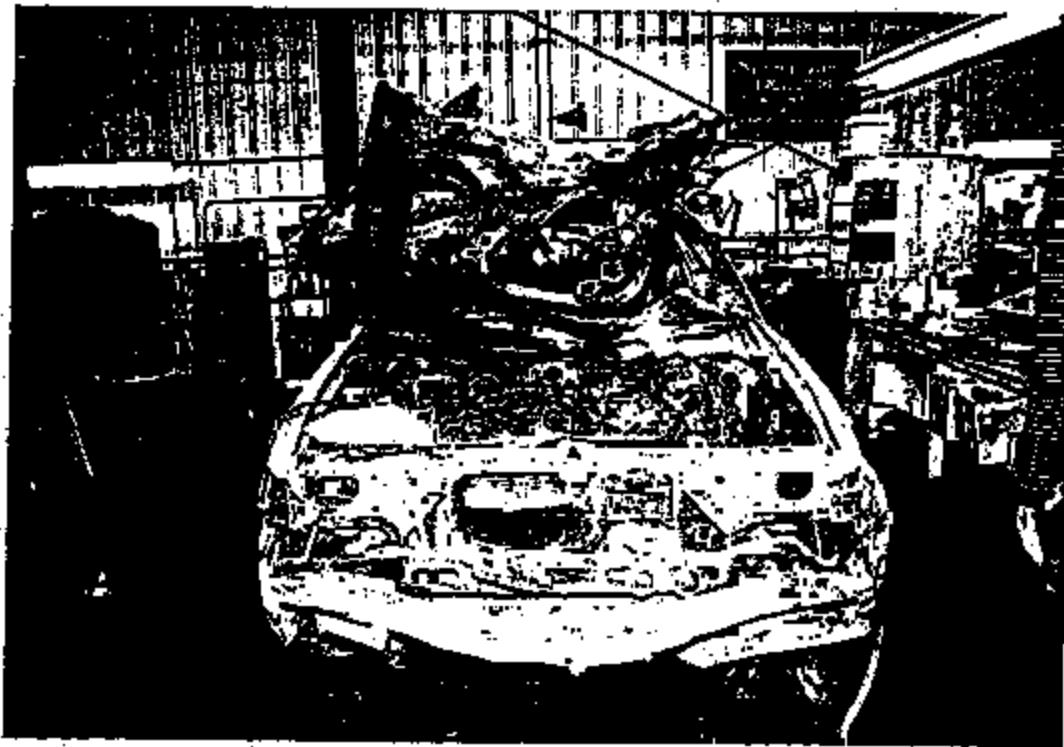
Figure 1 Front view of vehicle
