**EA02-025**

**LETTER TO ODI**

**AMERICAN STATES INSURANCE COMPANY**

[REDACTED]  
1992 Ford Crown Victoria  
VIN #2FACP74W6NX127687  
Oregon License [REDACTED] Expiration Date: June 1993

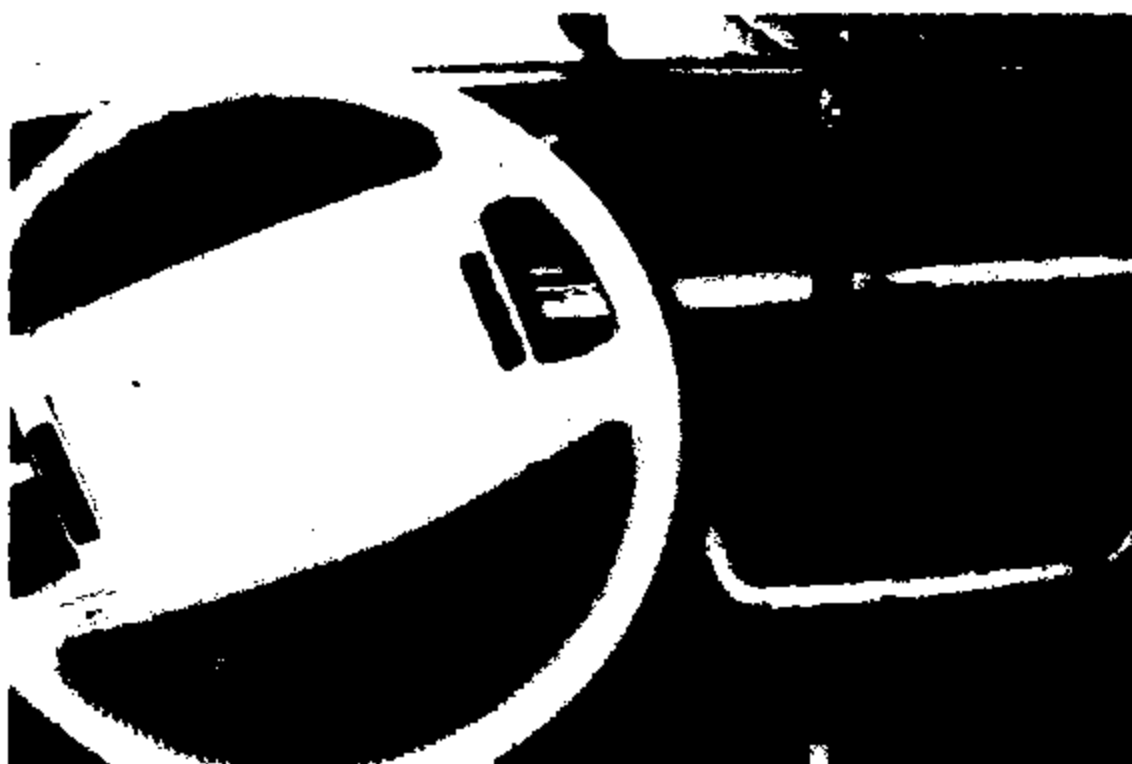
PHOTO #X-5

This photo has a view of the interior of the passenger compartment looking at the dashboard, showing the steering wheel and dashboard components.

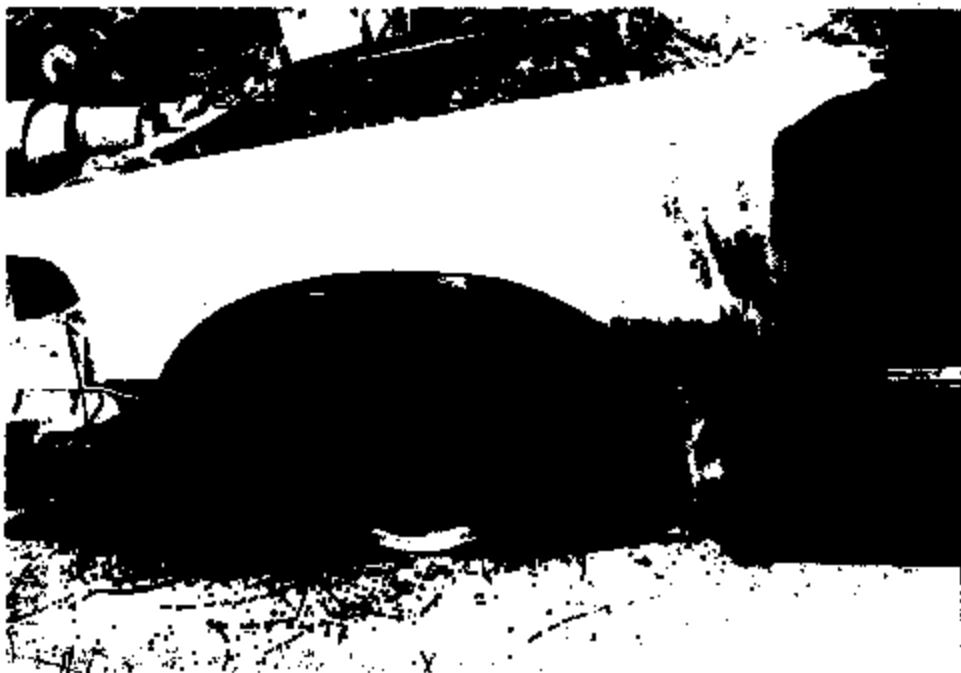
Photo B-35 is a view of the left front, or driver's, side front fender and wheel, showing the demarcation lines at approximately the location of the fire wall.
