EA02-025

This letter is to advise you that the Office of Defects Investigation (ODI) of the National Highway Traffic Safety Administration (NHTSA) is conducting a Preliminary Evaluation concerning engine compartment fires in certain Lincoln Town Car vehicles manufactured by the Ford Motor Company.

(STEP 4) ROOT CAUSE

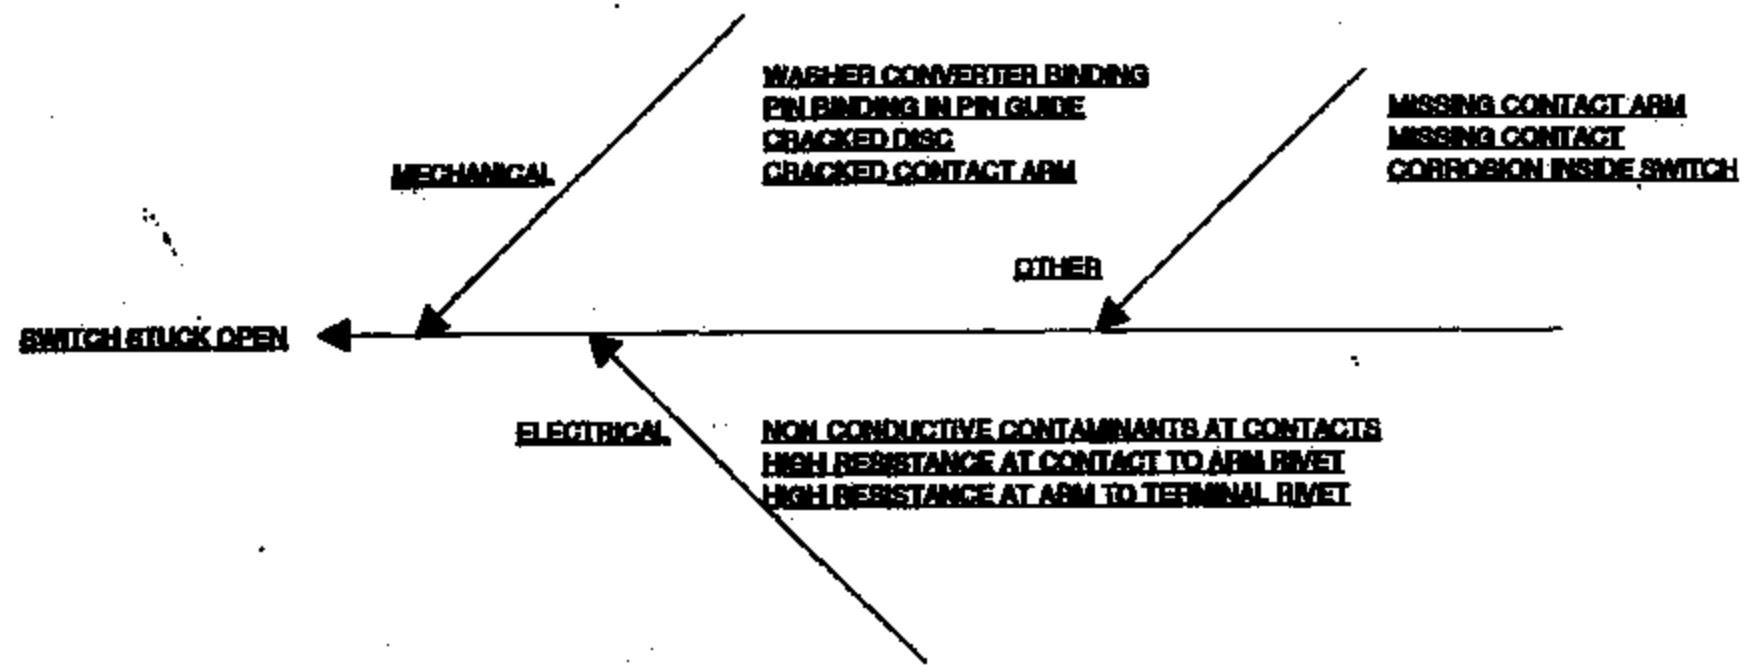
ATTACHMENT "B"

The switches analyzed were inoperative since there was no electrical continuity between the terminals. Attachment "B" shows the fishbone diagram for a stuck open switch. The lack of continuity was due to presence of large amounts of corrosion products inside the switch cavity and, in some cases, failure of contact elements due to corrosion. The large quantity of corrosion products is due to fluid that entered the switch cavity. Because of the severe amount of corrosion observed, it is believed that the corrosion is accelerated by the potential difference between the grounded body of the switch and current carrying members.
