**EA02-025**

**APPENDIX N**

PE Opening Reports (PE98-055)  
 1992 Lincoln Town Car Engine Fires

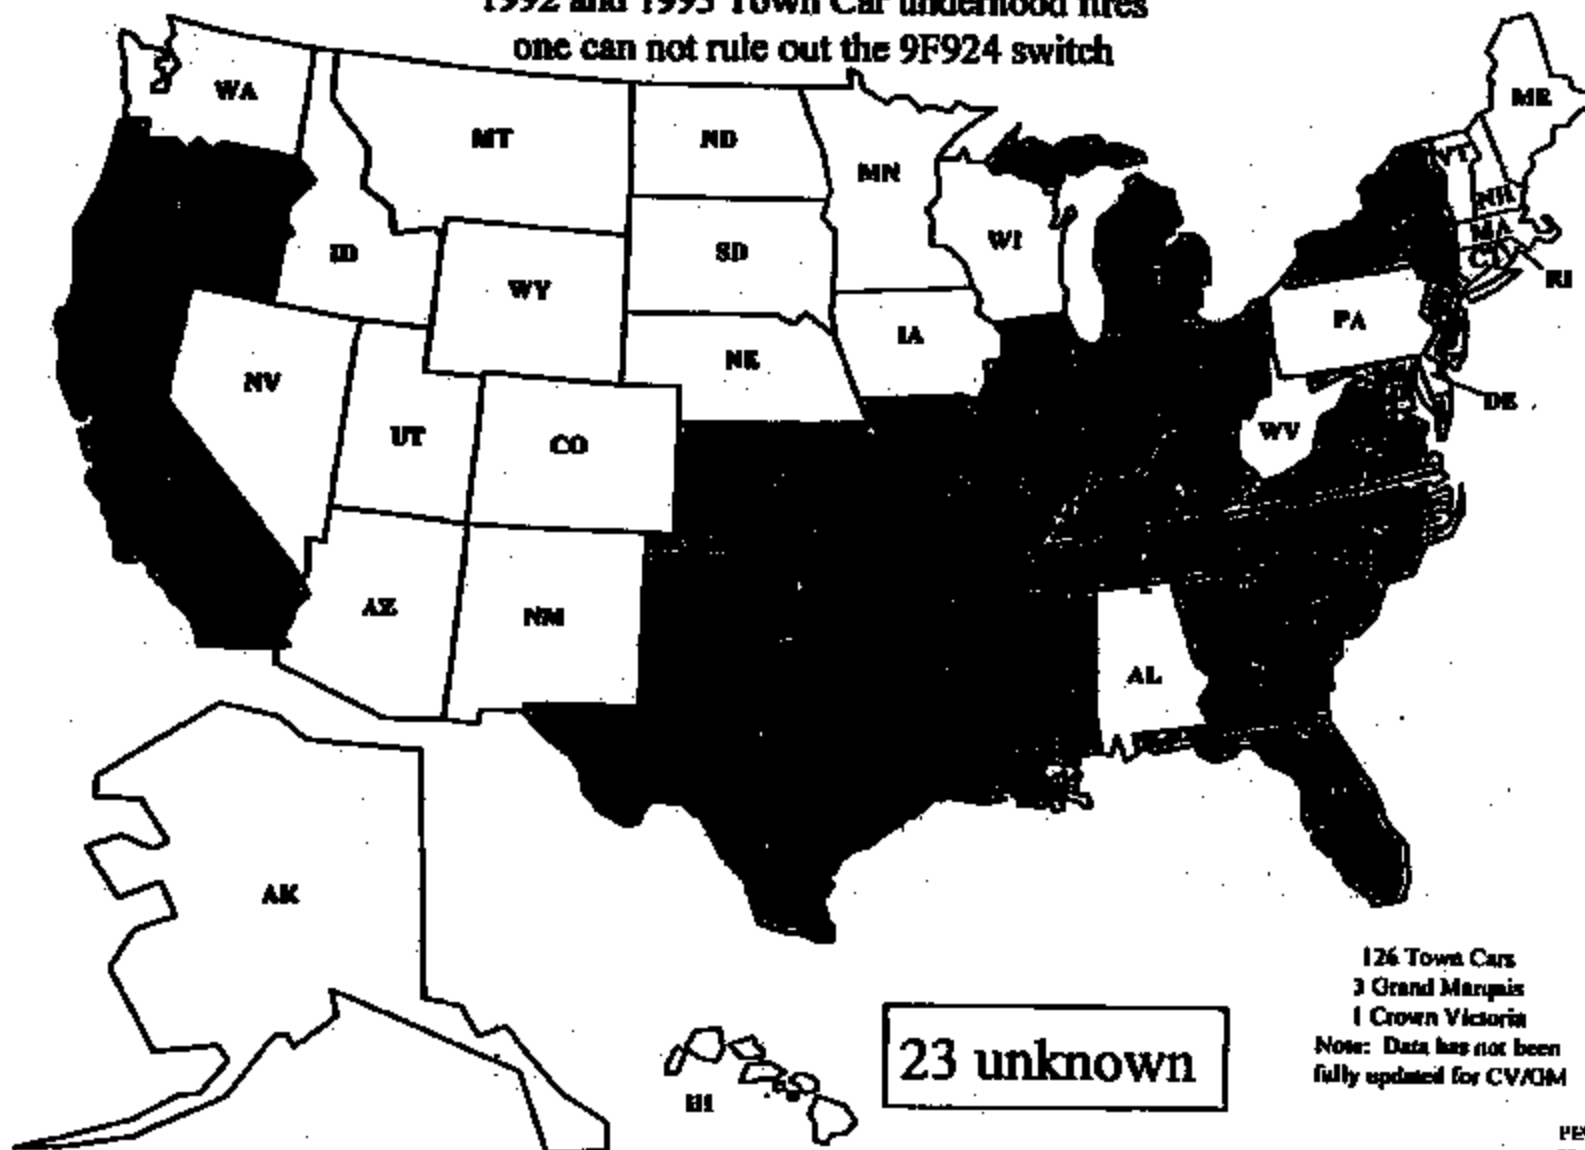
1992 and 1993 Town Car underhood fires  
one can not rule out the 9F924 switch

126 Town Cars  
3 Grand Marquis  
1 Crown Victoria  
Note: Data has not been  
fully updated for CVADM

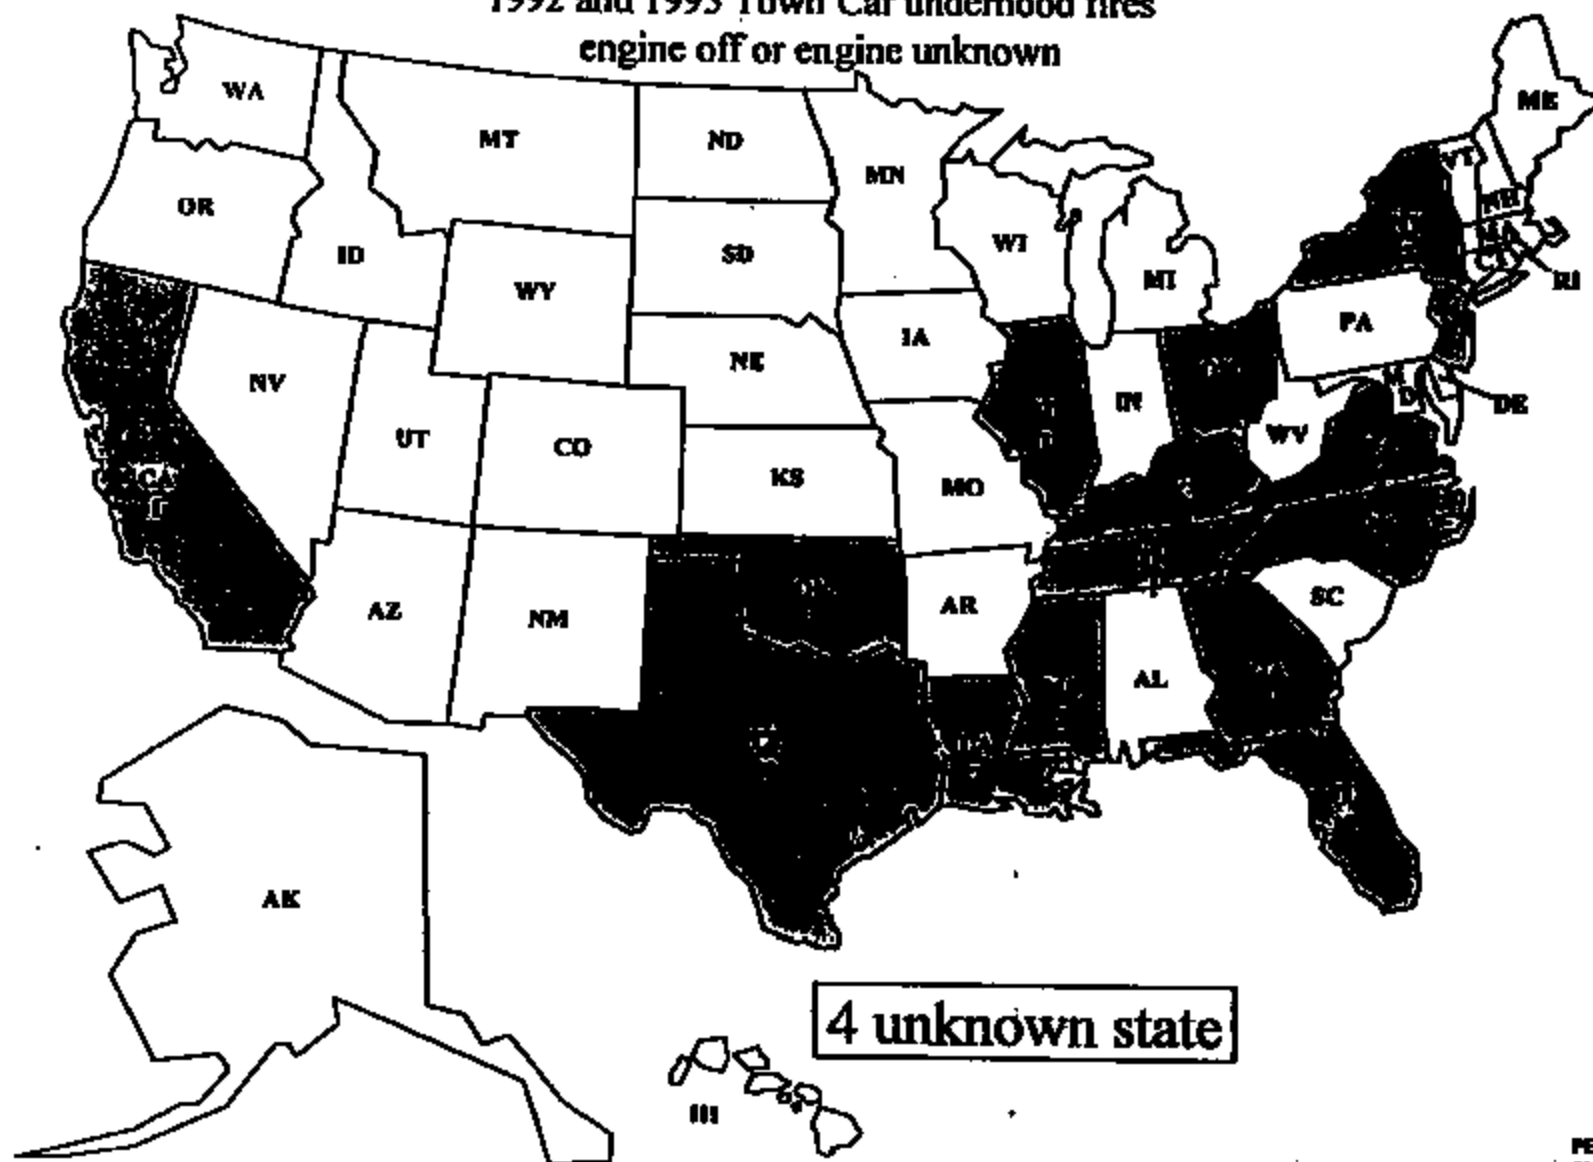
1992 and 1993 Town Car underhood fires  
engine off or engine unknown
