**EA02-025**

**APPENDIX N**

# PE98-055 1992-1993 Lincoln Town Car

14D Number:	14D Title:	92-93 Town Car F2VC-9FB24-A Brake Pressure Switch		
Plant/Activity:	Open Date:	12/15/1998	Close Date:	Status: Open
<b>D1. PROBLEM DESCRIPTION:</b>				
NHTSA letter PELB-055 identifies "...21 reports of engine compartment fires in 1992 and 1993 Lincoln Town Cars." One of the insurance reports included with the letter states "...that the fire originated in the area of the brake system pressure switch located below the master cylinder..."				
<b>D2. DEFINE ROOT CAUSE:</b>				
<b>D3. PROBLEM INVESTIGATION/VERIFICATION DATA:</b>				
One sensor which exhibited a melted cavity was analyzed by Texas Instruments (the supplier) showing corrosion in the switch cavity. All three layers of the 'topper' membrane were blistered and perforated.				
Two sensors from suspected incidents were analyzed by Ford's Central Laboratory. The plastic housing and switch mechanism were gone and the other components damaged too greatly to identify a leak path.

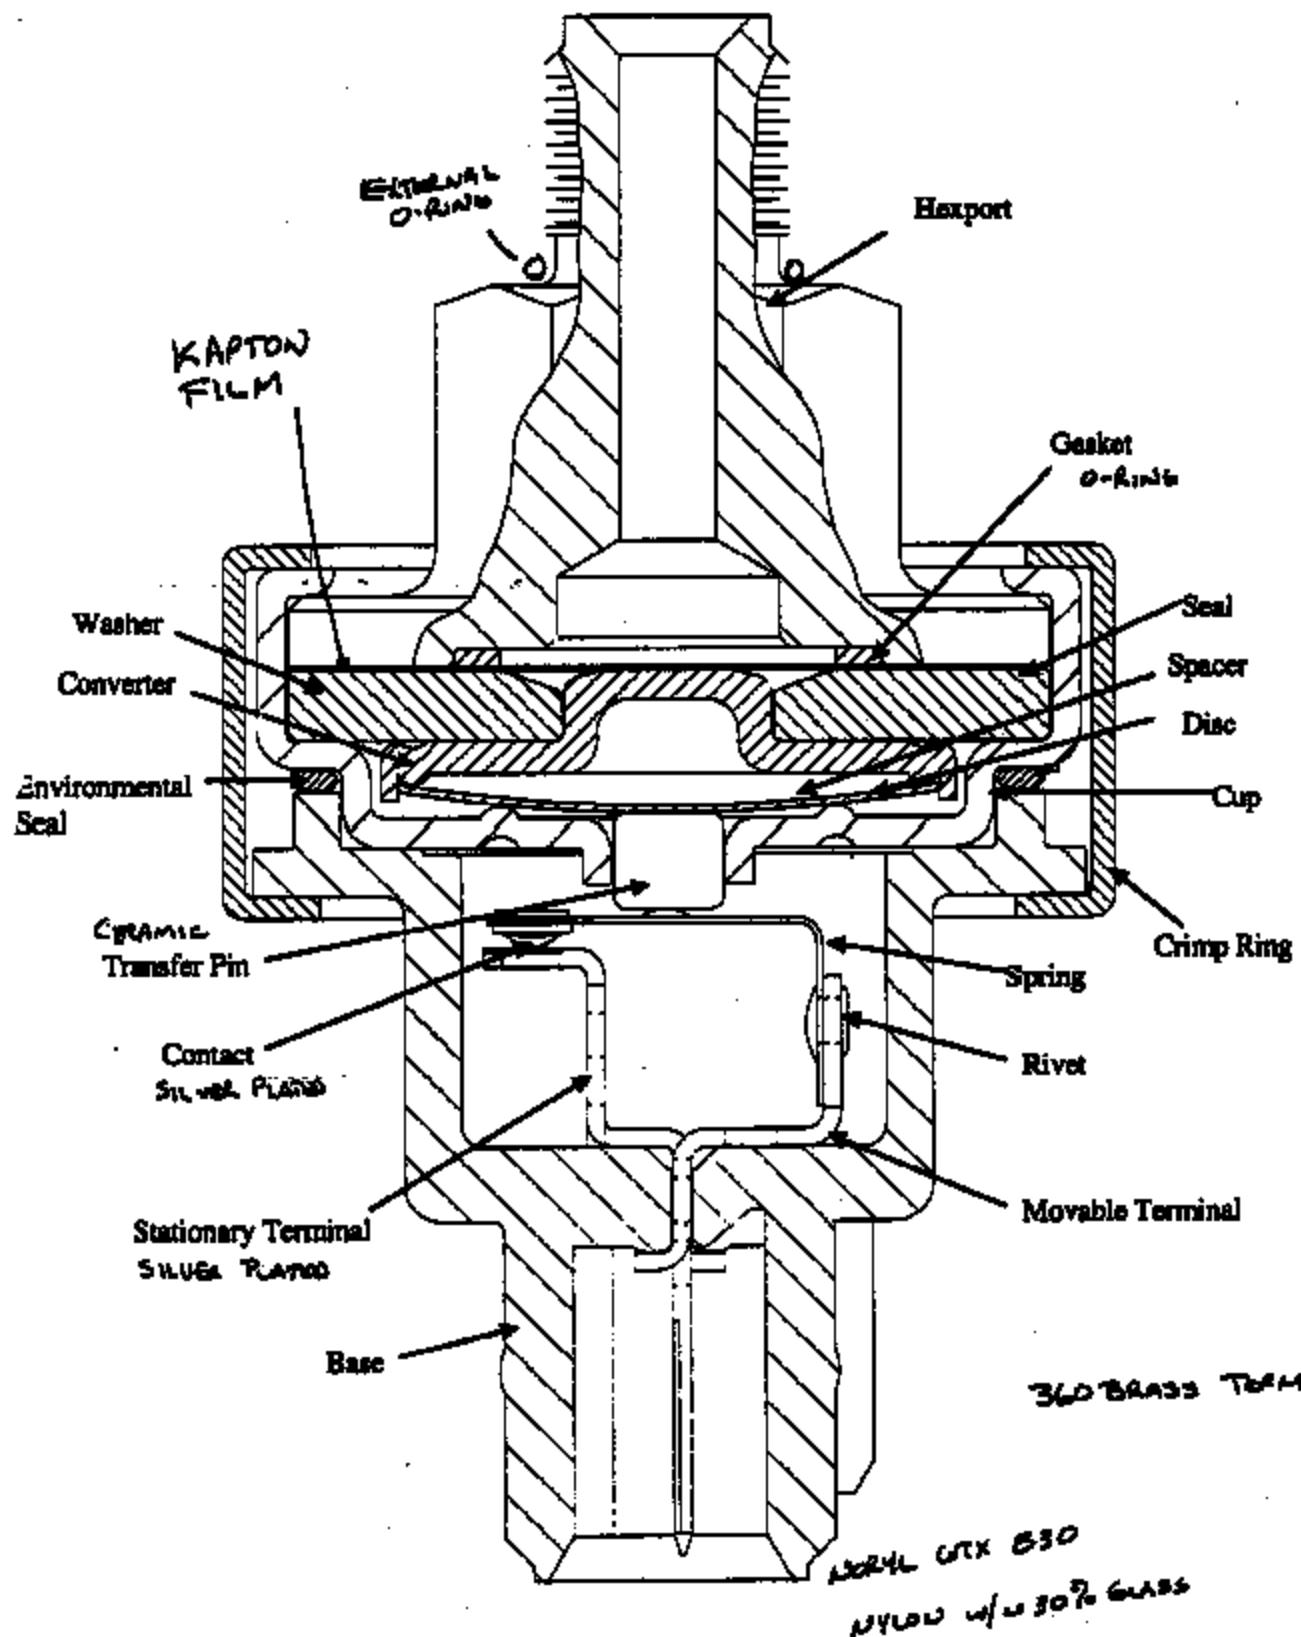
### Hydraulic Pressure Switch Cross Section

The cup is partially covered with a greenish residue. Residue appears to be primarily an oxide of the brass contact material with possibly a sulfur compound. This suggests transfer of oxide or corrosion product from the brass contacts to the cup.

The stationary contact exhibits intergranular cracks which indicate stress corrosion cracking (SCC). SCC is caused by combination of a specific corrosive environment and a sustained tensile stress (can be localized). Ammonia, ammonia compounds, sulfur compounds, and moisture are known to cause SCC in brass. The contact material has been reported to be 360 brass, which is highly susceptible to SCC.

All three diaphragms exhibit what appears to be mechanical damage. The damage does not match up with any mating parts of the switch. This suggests that damage may have occurred prior to assembly. The diaphragm has become brittle and cracked in the vicinity of the damage. Brake fluid has become entrained between the layers (Teflon and captor) of the diaphragms.

The post of the movable contact melted back into the bulkhead between the switch and terminal cavities of the base. There is also arc damage (localized melting) to one corner of the bridge of the stationary contact. This damage appears fresh (surfaces bright and shiny) which suggests that it may have occurred in the later stages of the thermal event.

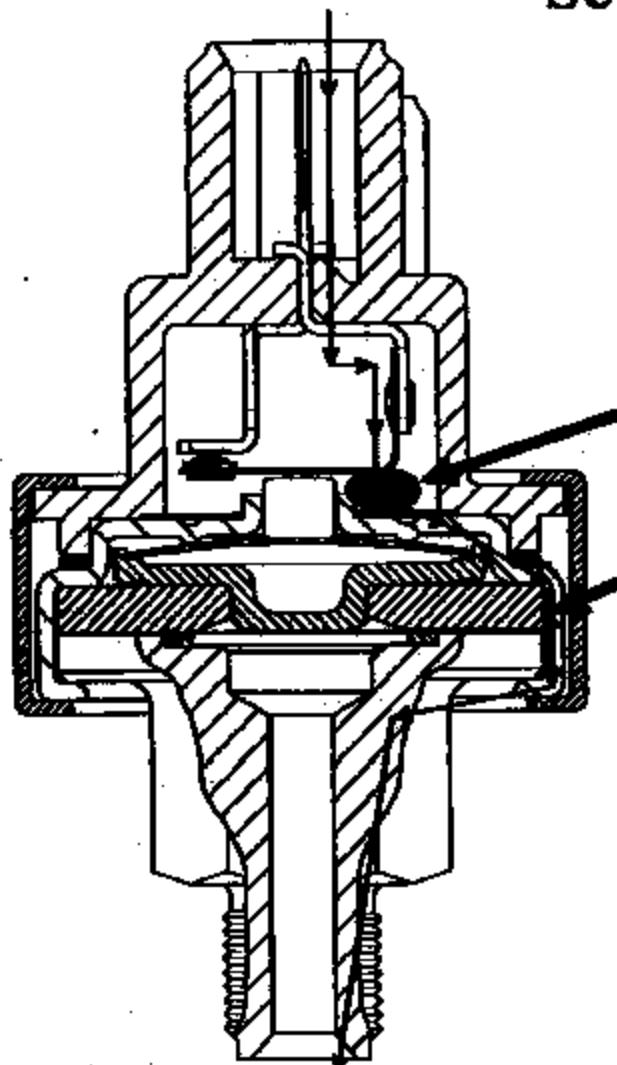
## Scenario

1. Contamination enters switch cavity through perforated kapton seal or connector seal.
2. Switch components and cup corrode with aid of electric field and contamination.
3. Current path forms between battery and ground.
4. Current increases as material builds until heat is generated to melt plastic.
5. When plastic melts enough to open the switch cavity to external air, the plastic ignites consuming the switch housing and connector.

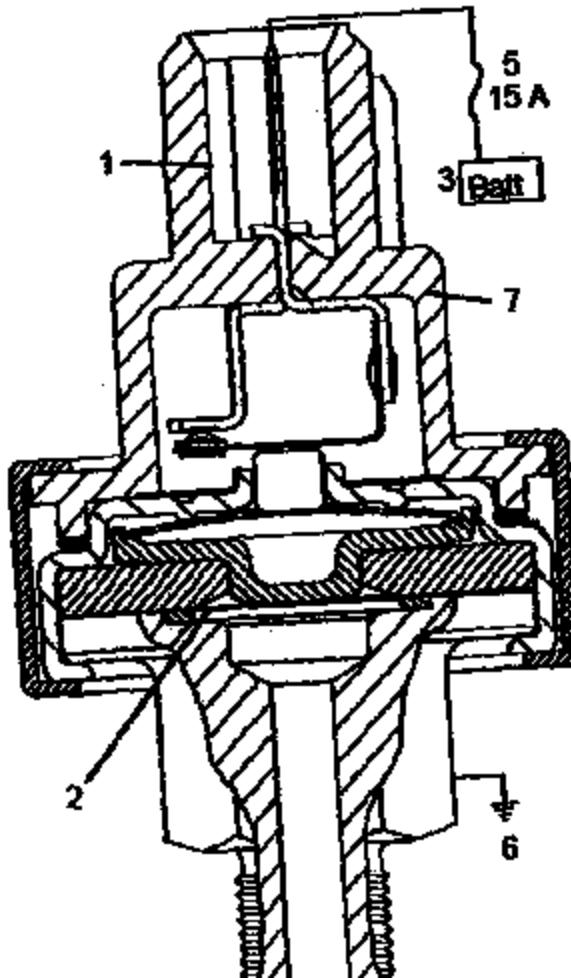
# Contributing Factors

1. Connector Seal
2. Kapton Life
3. Continuous Power
4. Switch Orientation
5. Current Capability
6. Grounded Hex-Port
7. Plastic Parameters
