EA02-025

FORD 10/27/03

APPENDIX N

CAN A REPLACEMENT CONNECTOR
BE CAUSING EXCESS LEAKAGE?

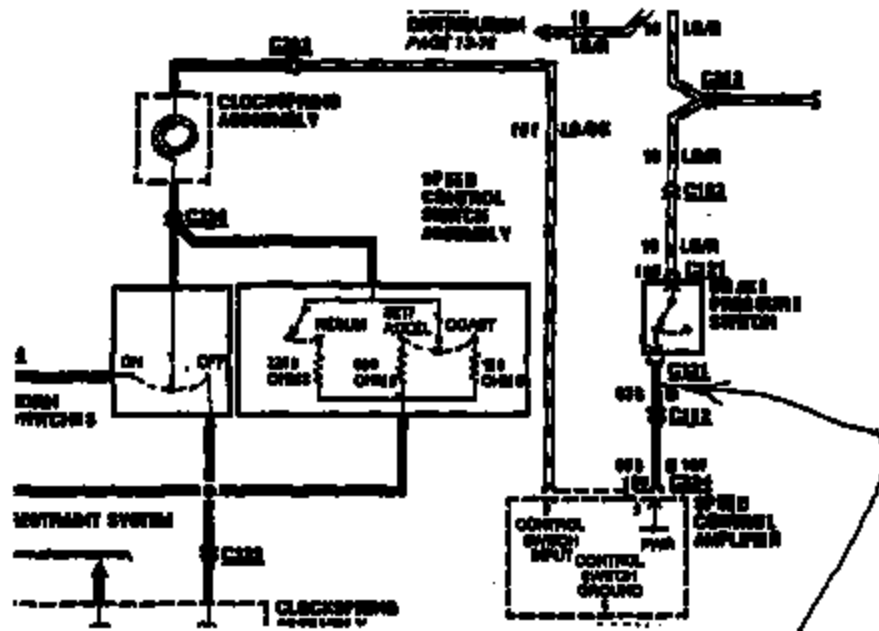
31-1 Speed Control

Shows when Brake pressure
switch opens & closes.

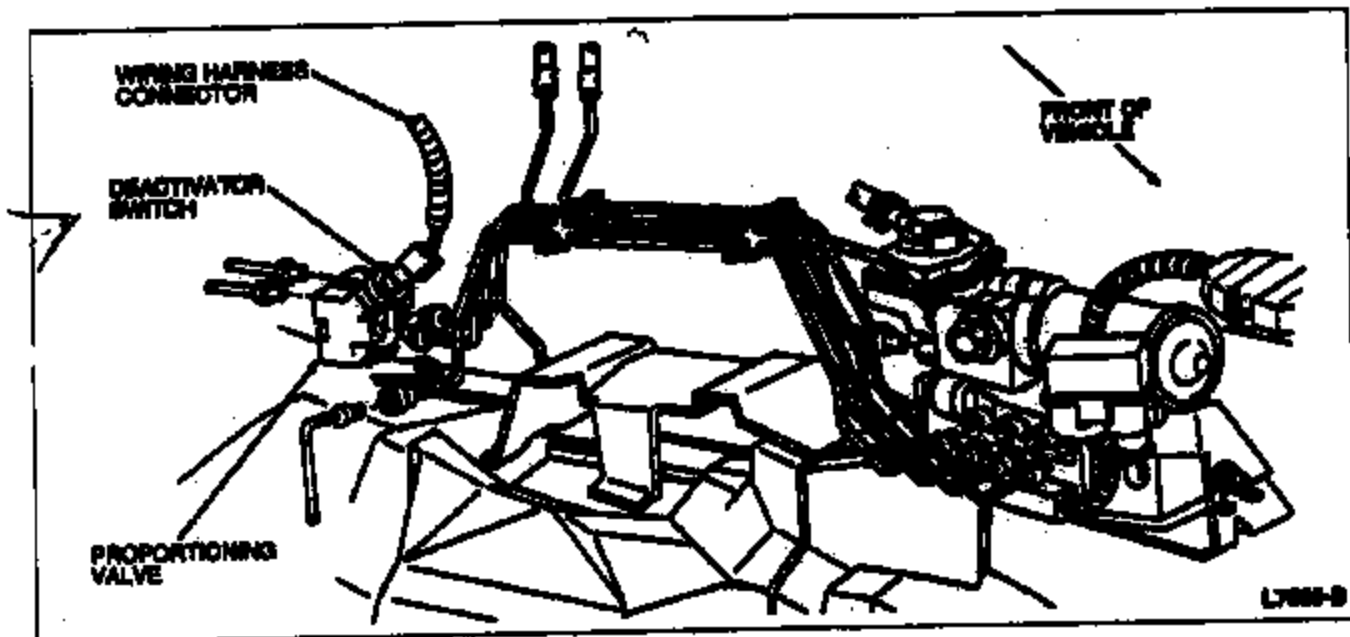
Brake Pressure Switch

Deactivator Switch (Brake Pressure Switch)

The deactivator switch is a normally closed switch and replaces the vacuum dump valve as a redundant safety feature in the system. Normally when the brake pedal is depressed, an electrical signal from the brakelamp circuit to the speed control servo will disengage the system. Under increased brake pedal efforts (5-10 lbs, engine running), the deactivator switch mounted in the brake line will open and remove power to the speed control servo clutch, releasing the throttle independent of the speed control servo control. The deactivator switch is located at the rear brake proportioning valve (ABS brakes) or junction block (Non-ABS brakes) below the brake booster.

1. Screw switch into proportioning valve or junction block. Tighten to 15-20 N-m (12-14 lb-ft).
2. Attach electrical connector.
3. Bleed brake lines as outlined in Section 06-09, ABS brakes, or Section 06-08, non-ABS brakes.

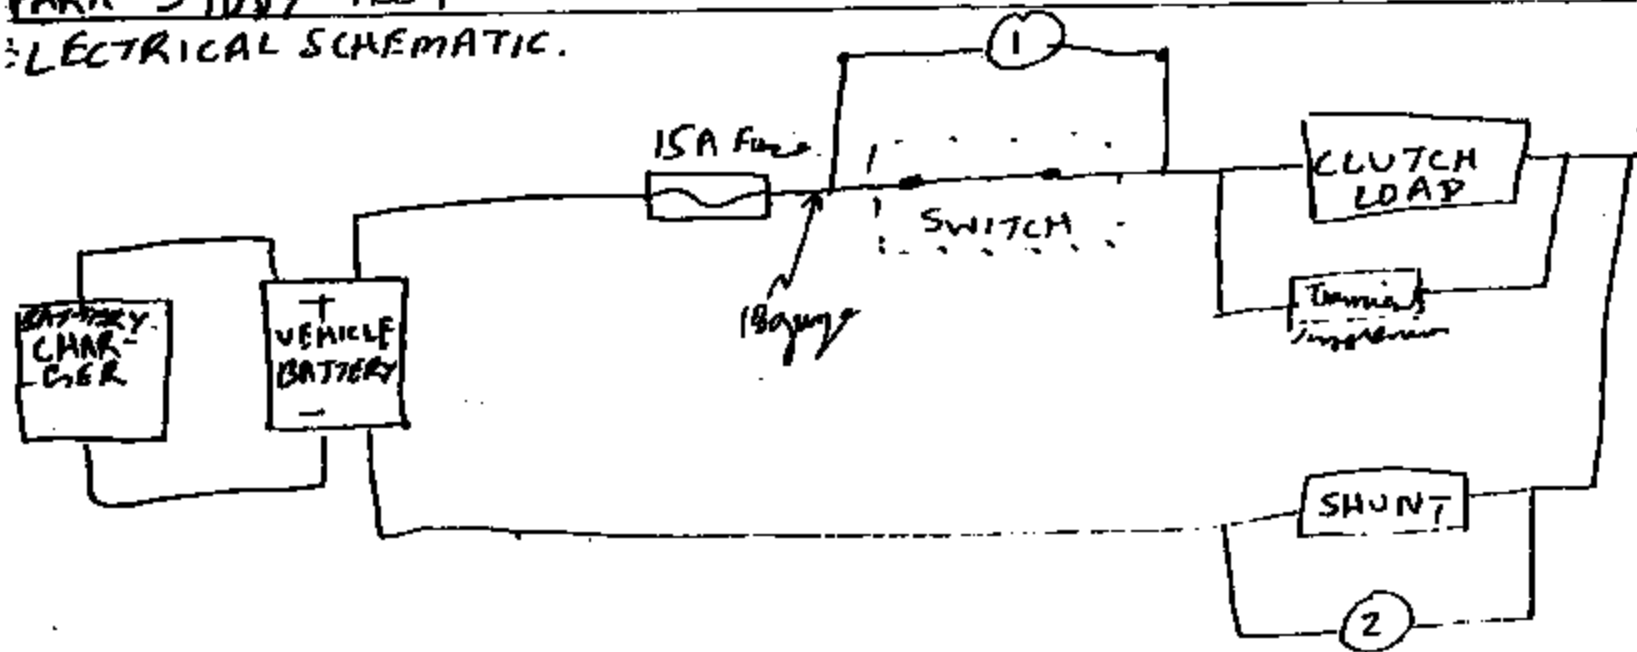
PARK STUDY TEST
ELECTRICAL SCHEMATIC.

- Channel ① = Voltage drop across switch
- ② = Current through switch
- ③ = Pressure transducer on manifold
