EA02-025

FORD 10/27/03

APPENDIX N

BOOK 17 OF 61

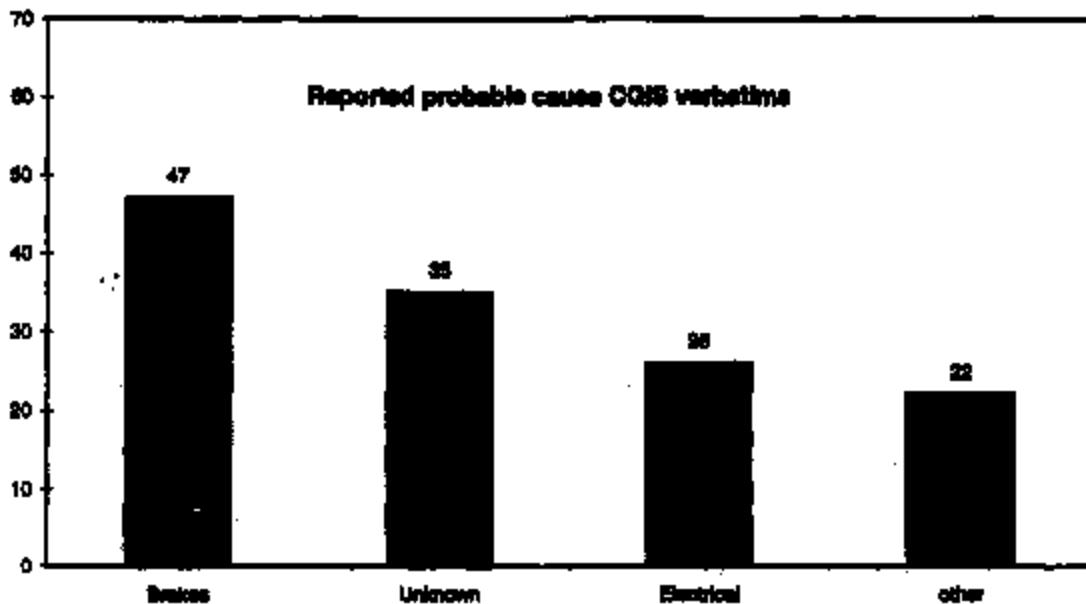
92MY Town Car CQIS Pareto Analysis

(1) Brakes account for 47 out of 130 92MY Town Car CQIS verbatim.

* No probable root cause identified.

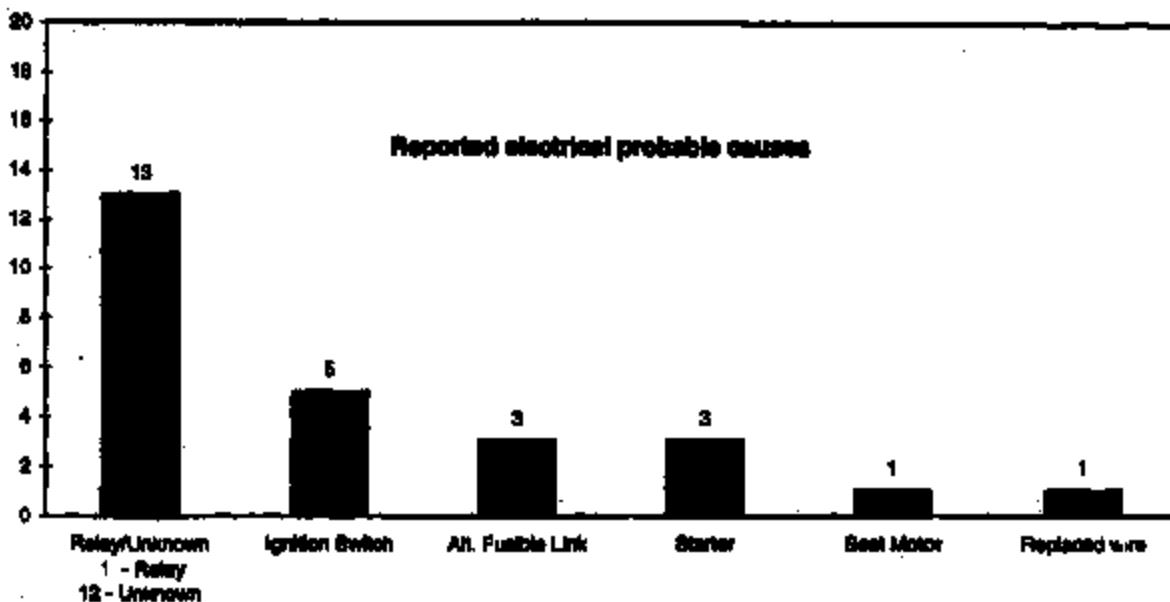
92MY Town Car CQIS Pareto Analysis

- (1) Of the 13 probable electrical issues on the first bar, 12 are stated as an electrical issue without any other conclusion.

- * 2 of the 5 ignition switches were previous recall issues that customers did not bring in for service.
- * 3 are identified as possible ignition switch.

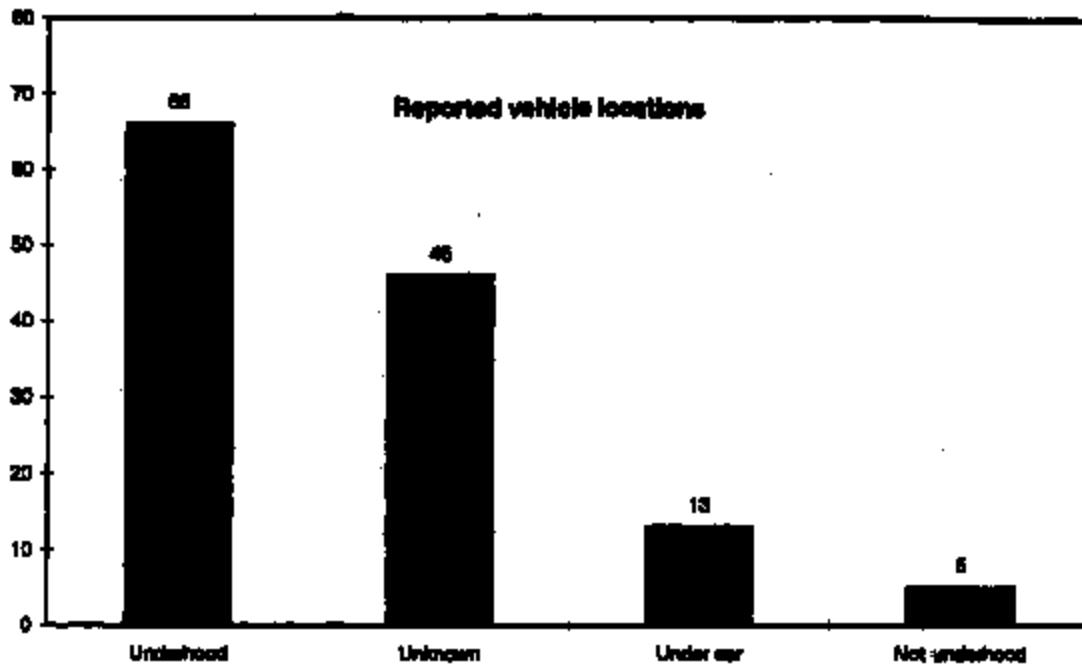
92MY Town Car CQIS Pareto Analysis

* Underhood location is broken down into the following categories as probable causes:

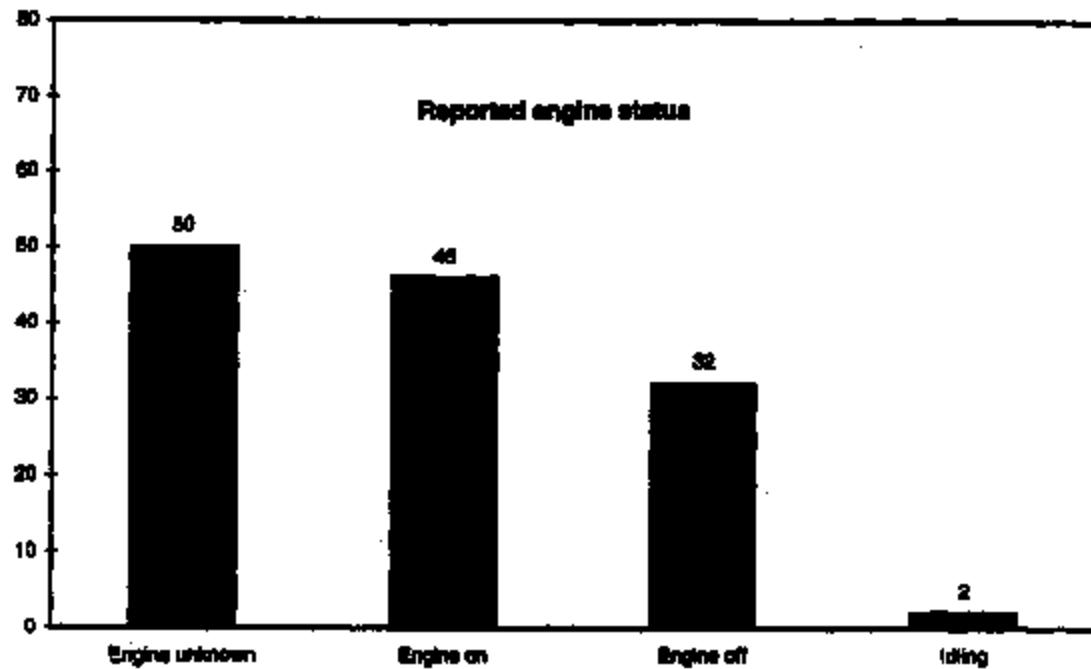
92MY Town Car CQIS Pareto Analysis

* Of the reported probable causes with the engine off:
