**EA02-025**

**FORD 10/27/03**

**APPENDIX N**

# Parade of 92/93 Town Car Underhood Fire Allegations With Engine On/Off/Unknown

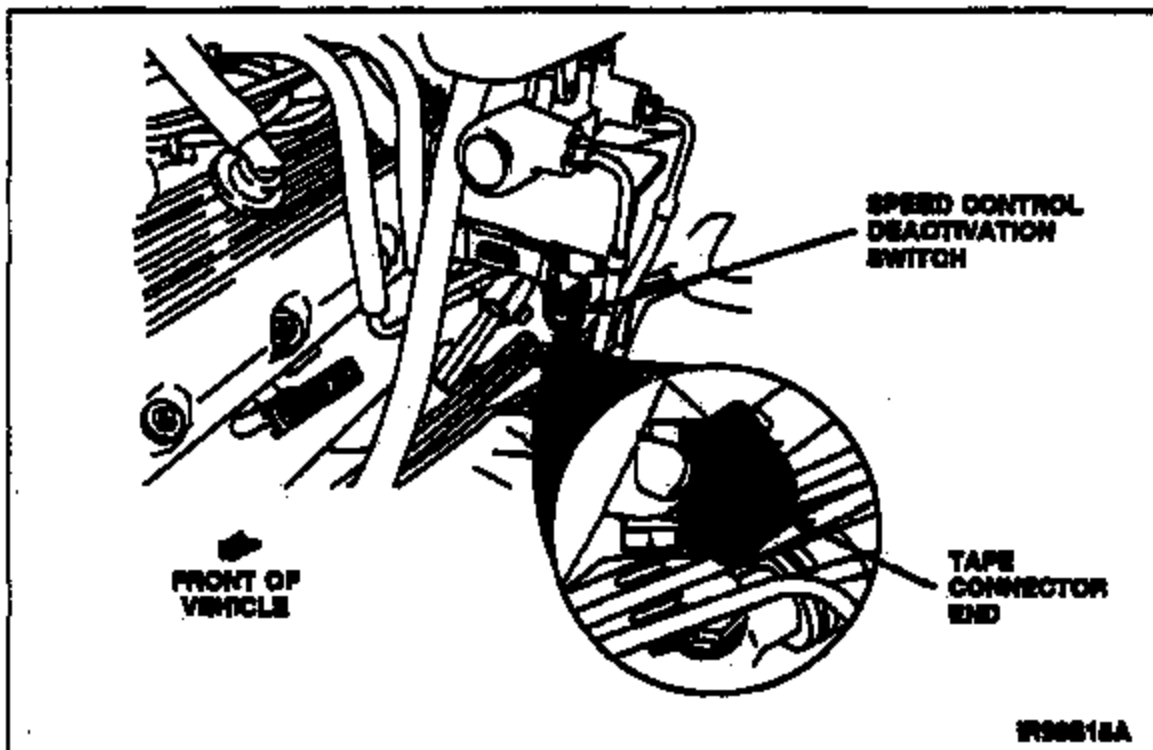
**FIGURE 1**

1. Disconnect the electrical connector from the speed control deactivation switch. See Figure 1.

2. Tape the end of the connector to prevent contamination from entering the end of the connector.
3. Tie strap the connector to the wiring harness located on the left splash shield.

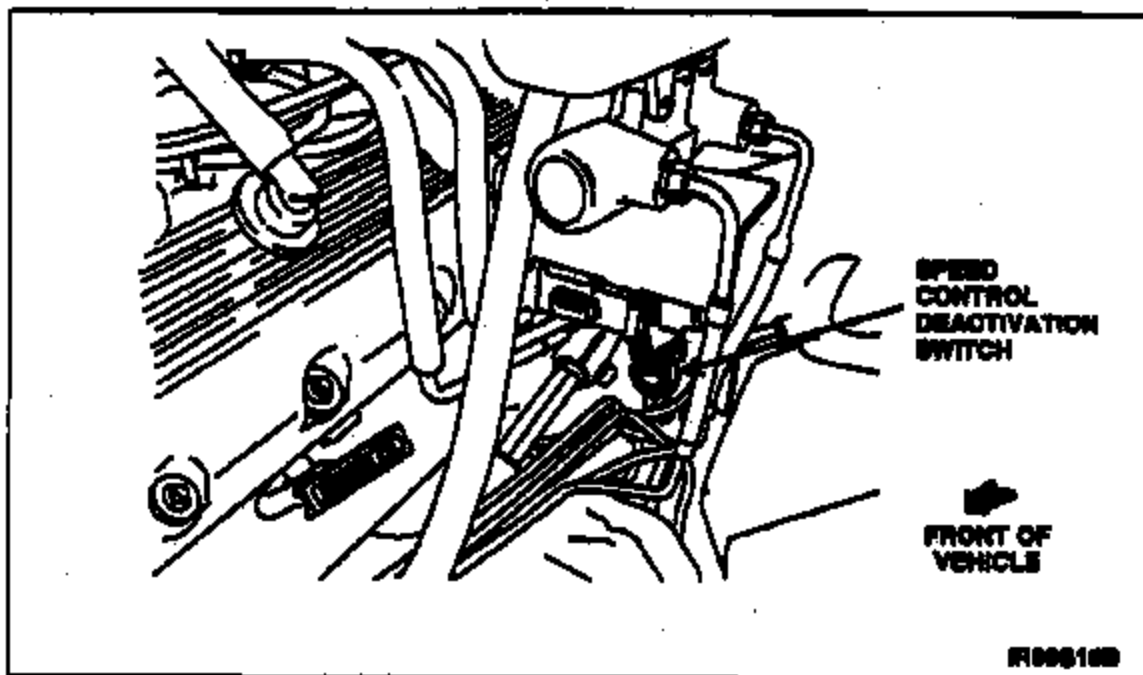
FIGURE 2

1. Install a memory saver and disconnect the negative battery terminal.
2. Disconnect the electrical connector from the speed control deactivation switch. See Figure 2.

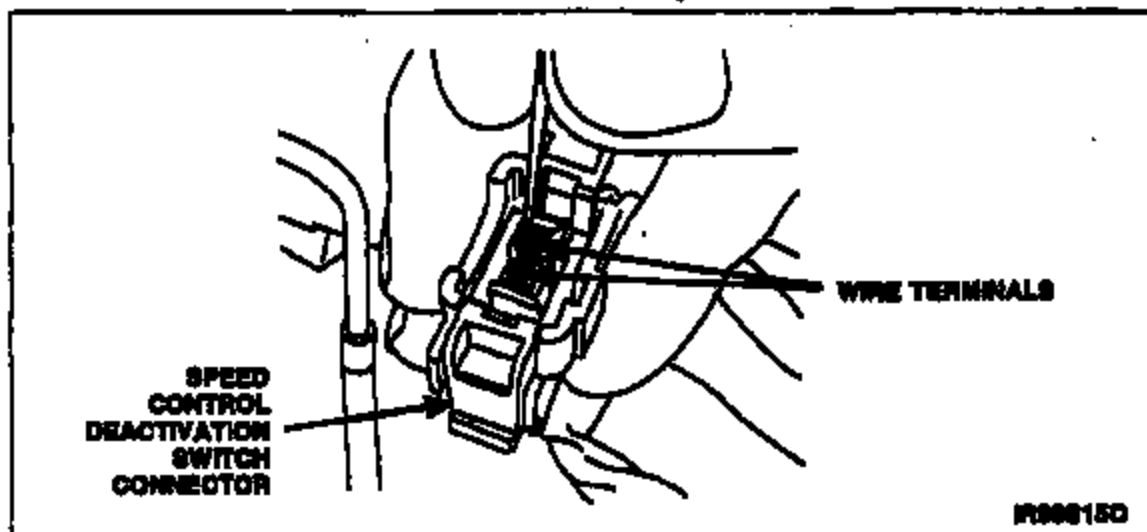
3. Remove the locking wedge from the end of the connector. Then, disengage the locking tabs and remove the wire terminals from the connector. See Figure 3.

4. Obtain the new connector from the kit. Insert both wire terminal ends through the connector seal and into the connector hard shell. (The wire terminal ends may be installed into either of the connector cavities).

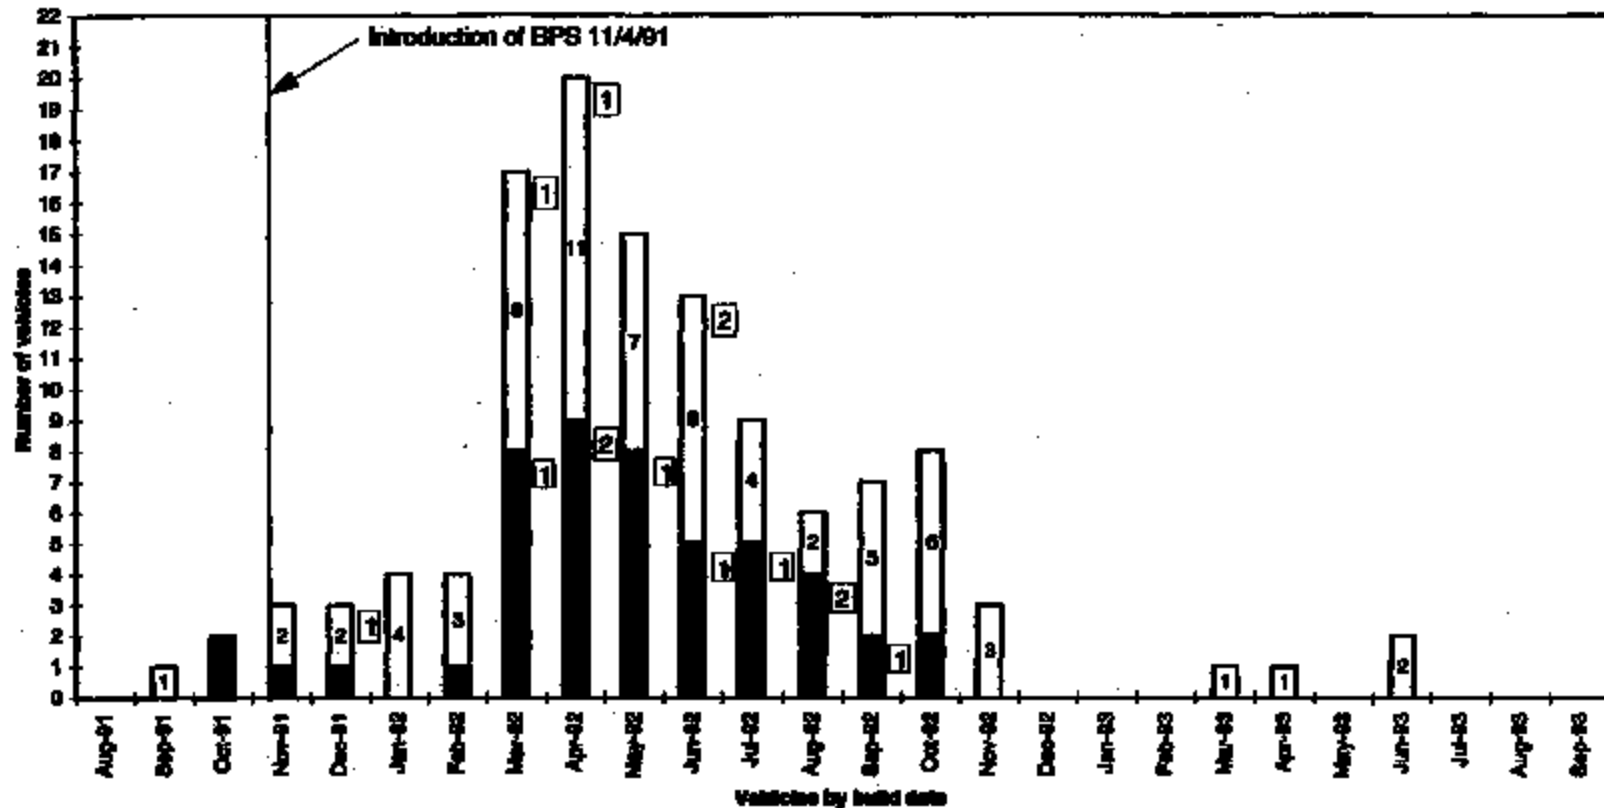
- The shaded region represents vehicles with engine off/unknown.
- The unshaded region represents vehicles with engine on.
- 1 Represents BPS symptoms

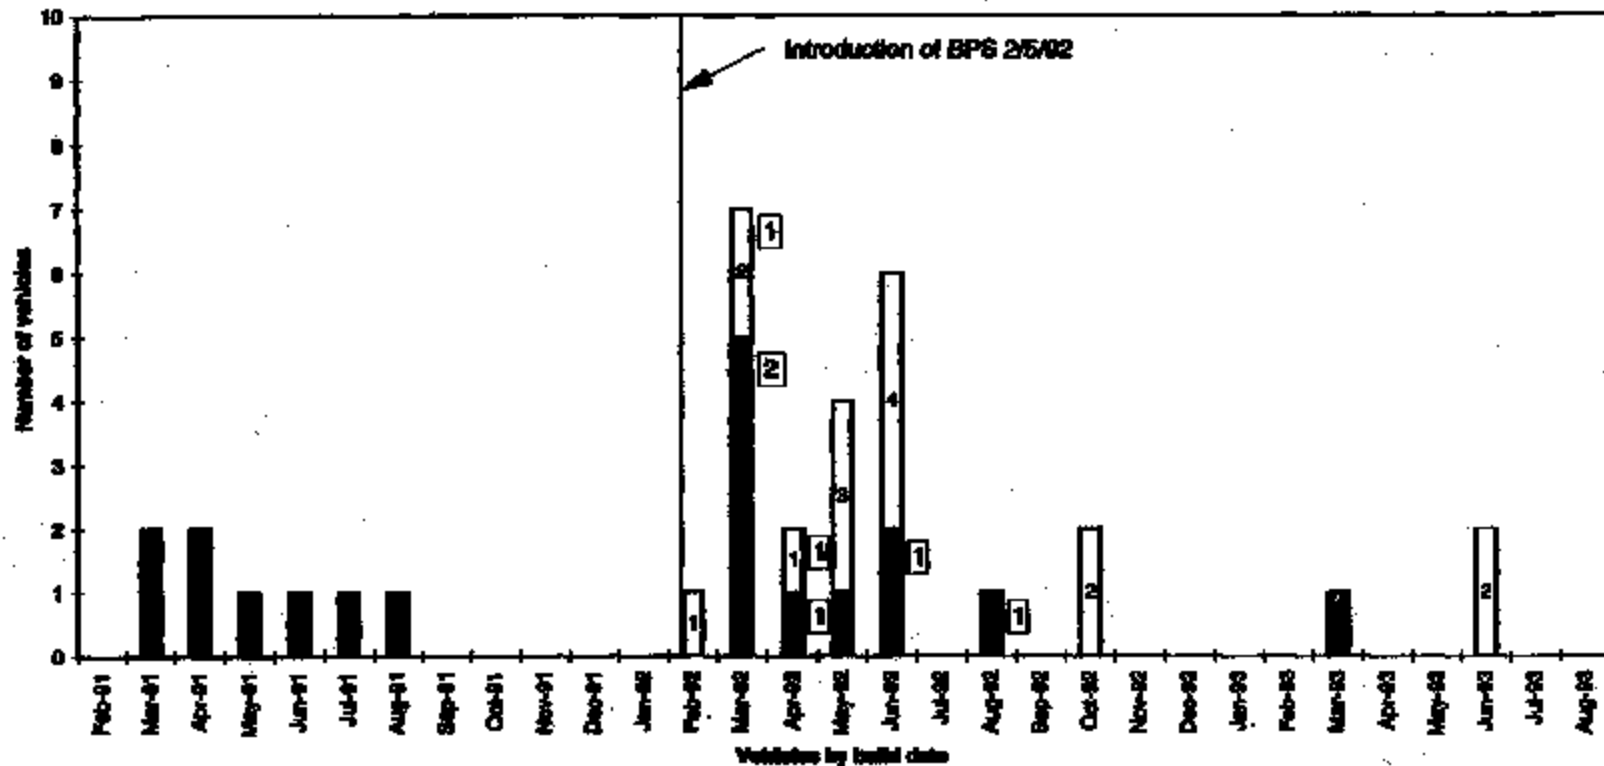
# Parade of 92/93 CV/GM Underhood Fire Allegations With Engine On/Off/Unknown

- The shaded region represents vehicles with engine off/unknown.
- The unshaded region represents vehicles with engine on.
- 1 Represents BPS symptoms

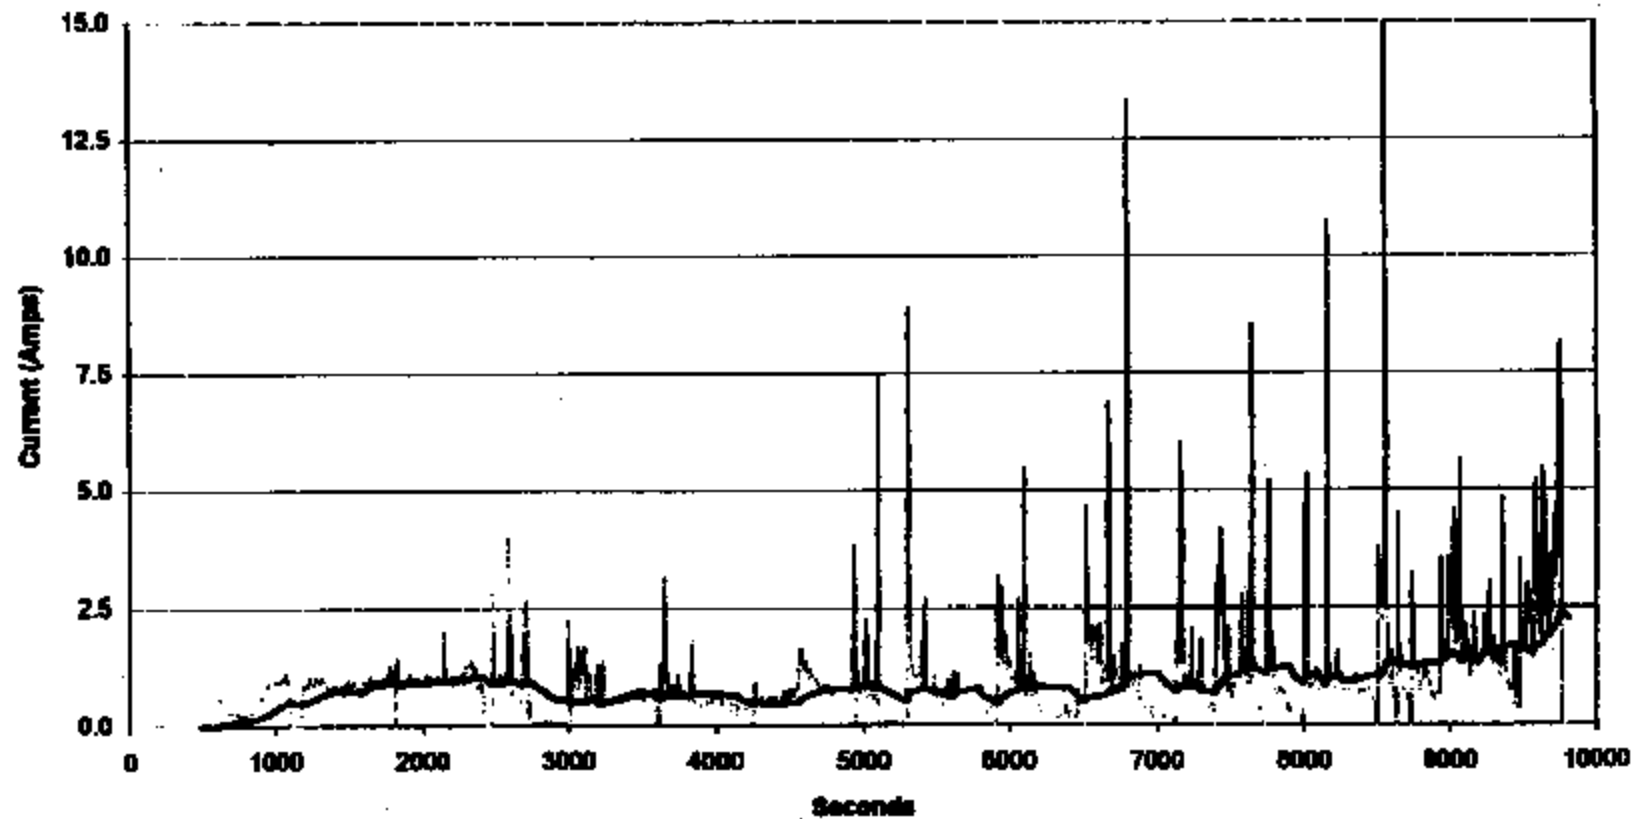
# Hexport Current vs. Time Fluid Ingress Experiment

**Conclusion:** 0.75 Watts, the maximum power in the proposed circuit design, is not enough power to cause switch terminal heating sufficient for ignition. In previous tests, using a resistor as the heating element, approximately 5 Watts of power was necessary to create an ignition. There is not enough power in the proposed circuit to create ignition.

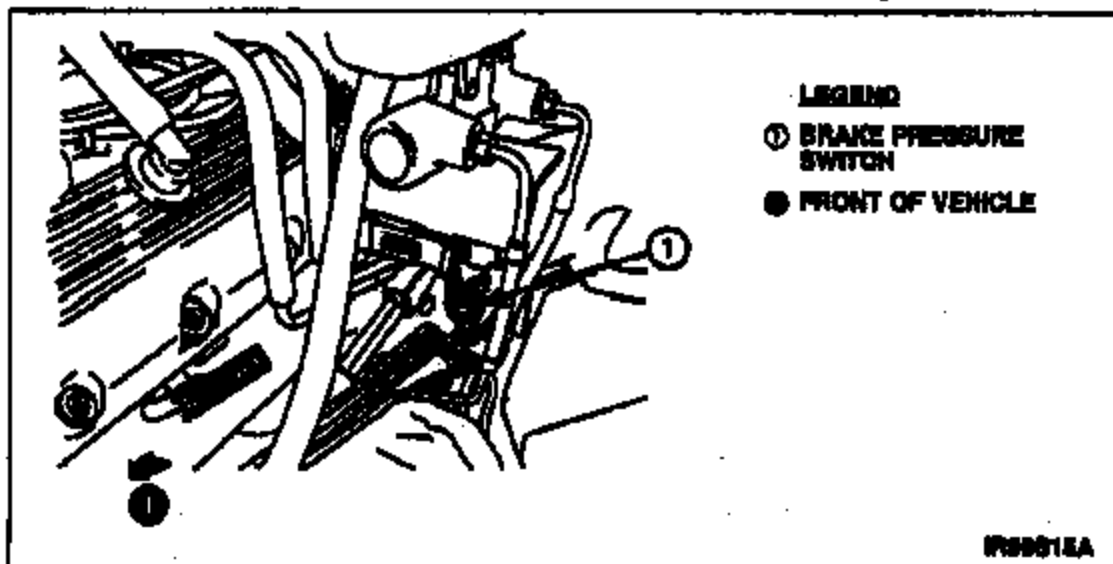
FIGURE 1

1. Install a memory saver and disconnect the negative battery terminal.
2. Disconnect the electrical connector from the brake pressure switch. See Figure 1

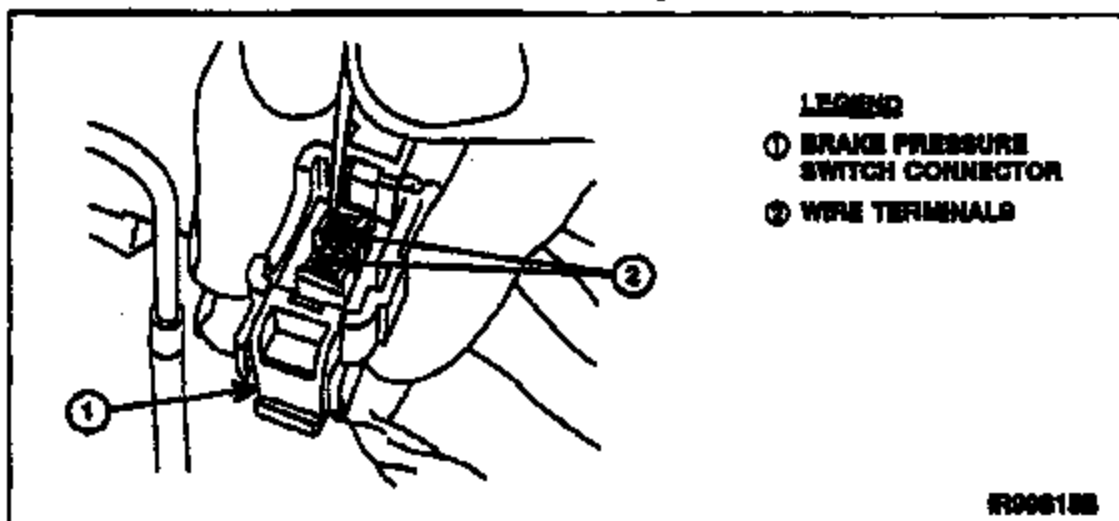
FIGURE 2

3. Remove the locking wedge from the end of the connector. Then, disengage the locking tabs and remove the wire terminals from the connector. See Figure 2.

4. Obtain the new connector from the kit. Insert both wire terminal ends through the connector seal and into the connector hard shell. (The wire terminal ends may be installed into either of the connector cavities).
