**EA02-025**

**APPENDIX N**

NHTSA

**1992-93 Town Car/Crown Vic/Grand Marquis Under hood Fire Oesthousky**

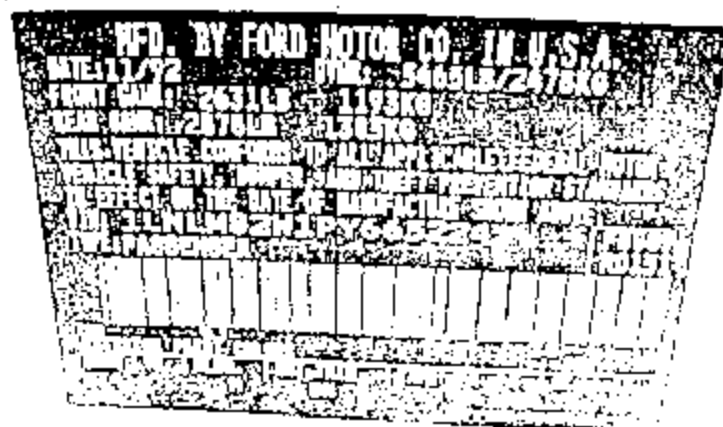
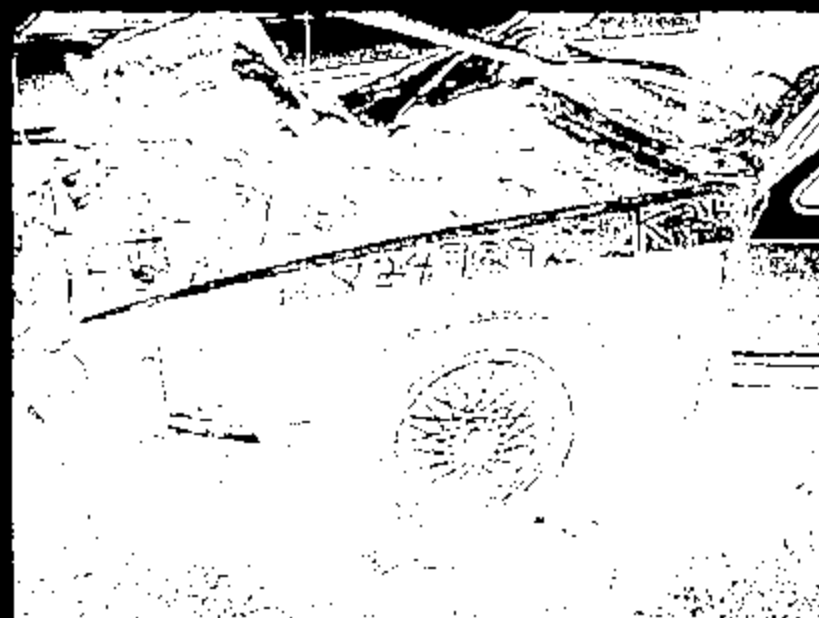
Switch A

1LNLM92WIPY665224 1993 Lincoln Town Car - Houston, Tx 99-Jan-14 PE98-055

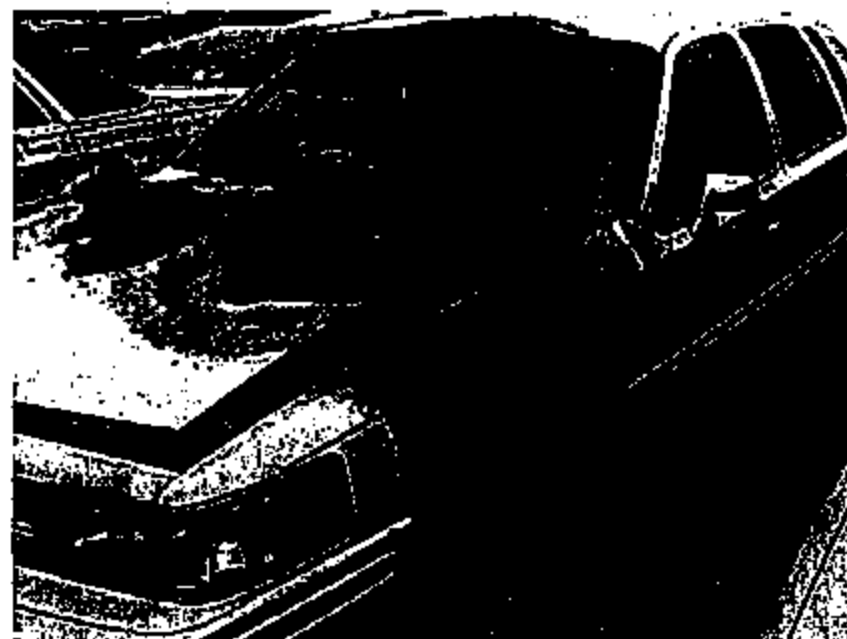
Switch C

1LNLM81W2NY703705 1992 Lincoln Town Car - Houston, TX 99-Jan-14 PE98-055

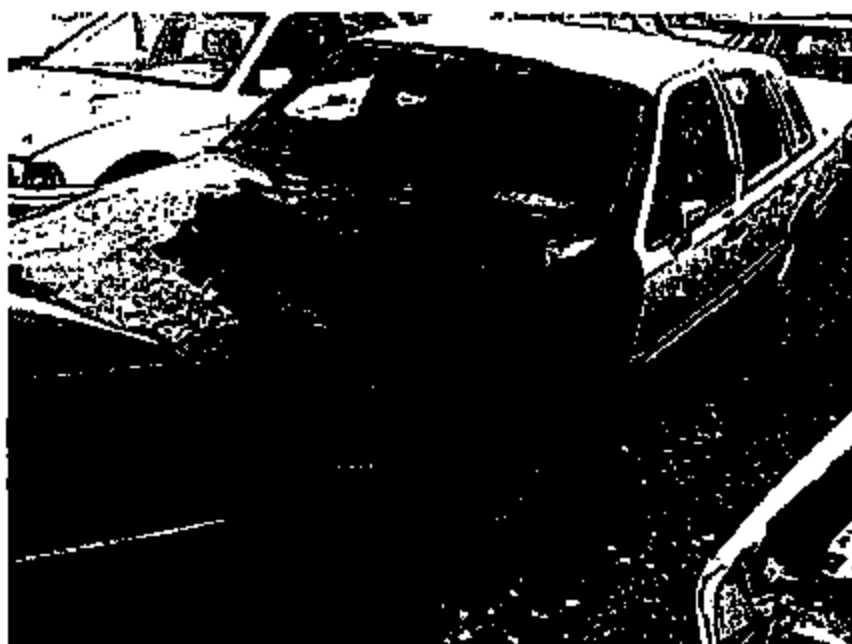
3713 2481

1LNLM82W7NY740537 1992 Lincoln Town Car - Houston, TX 99-Jan-14
