**EA02-025**

**FORD 10/27/03**

**APPENDIX N**

# 1992-93 LINCOLN TOWN CAR UNDERHOOD FIRES

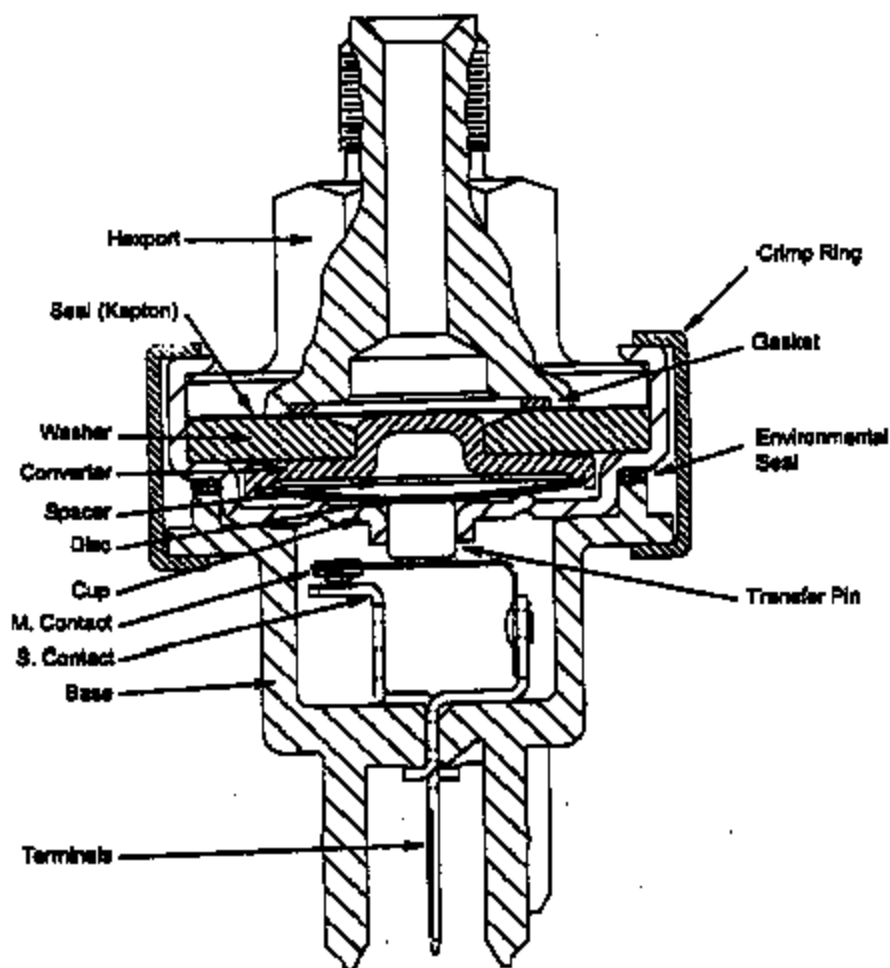
Diagram showing components of switch.

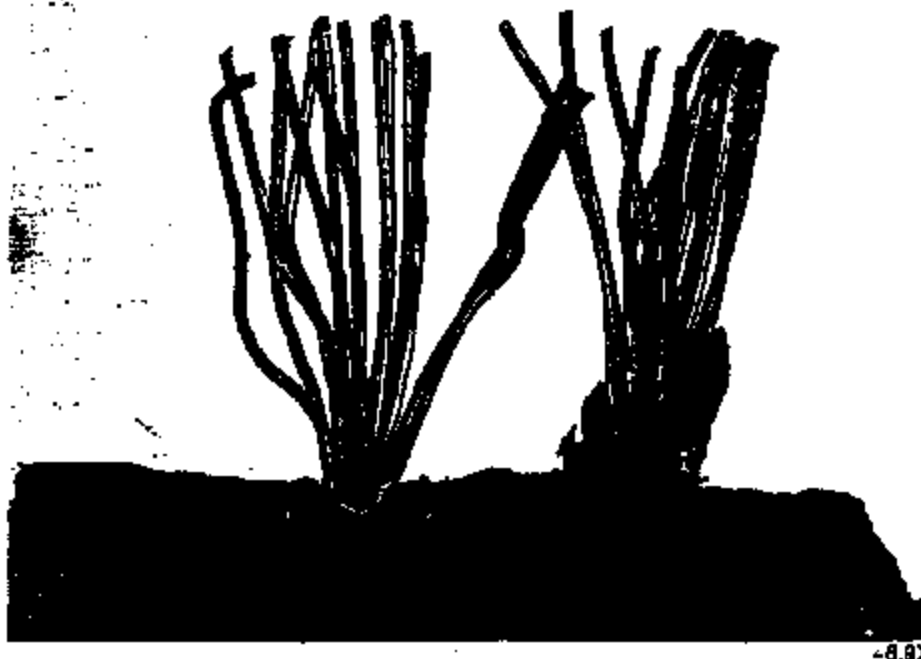
Figure 19: Image showing tarnished condition of wires below insulation.

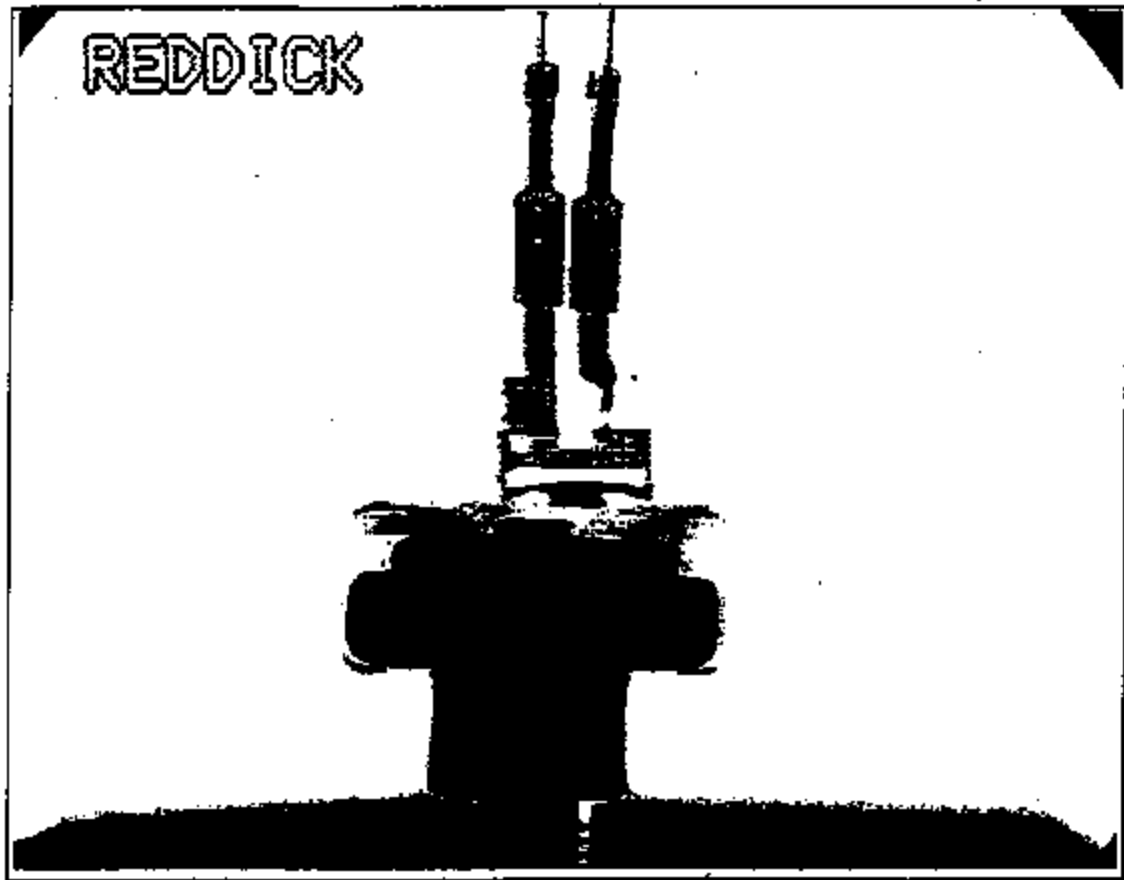
Figure 23: Fluorescopic image showing switch base and pressure side of switch placed together. Note base of movable contact terminating in large globule.

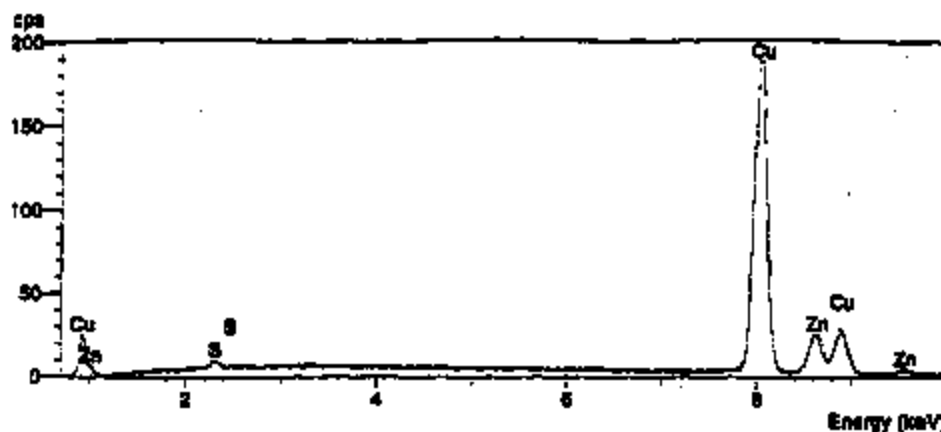
Figure 36: EDS X-ray spectrum of material scraped from the side of the stationary contact body.

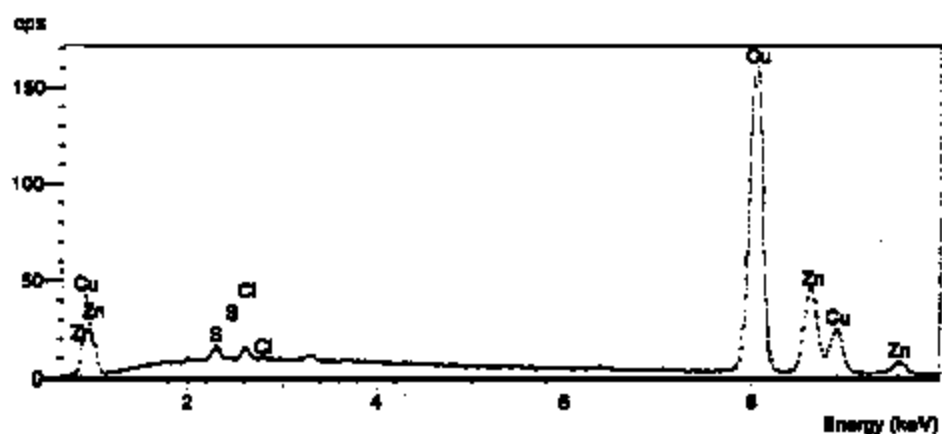
Figure 45: EDS X-ray spectrum of the crack surface.

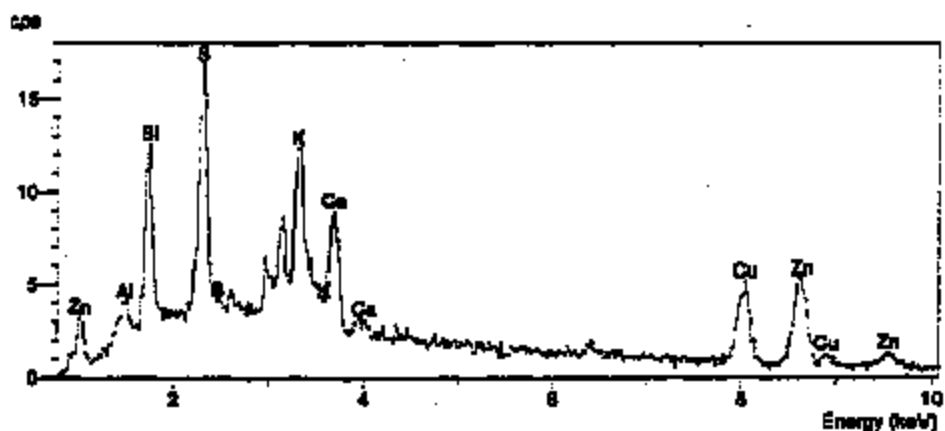
Figure 46: EDS X-ray spectrum of the green deposit from terminal of stationary contact.

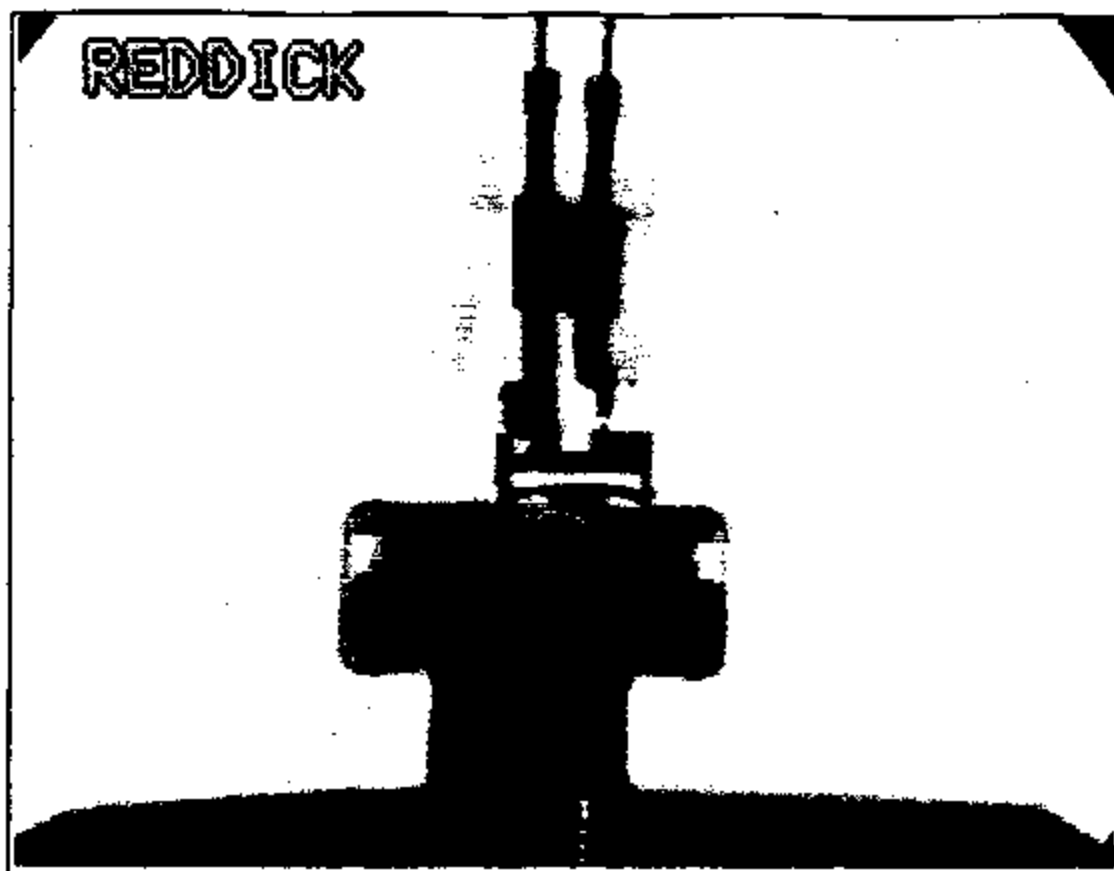
Figure 23: Fluoroscopic image showing switch base and pressure side of switch placed together. Note base of movable contact terminating in large globule.
