**EA02-025**

**FORD 10/27/03**

PE Opening Reports (PE98-055)  
1992 Lincoln Town Car Engine Fires

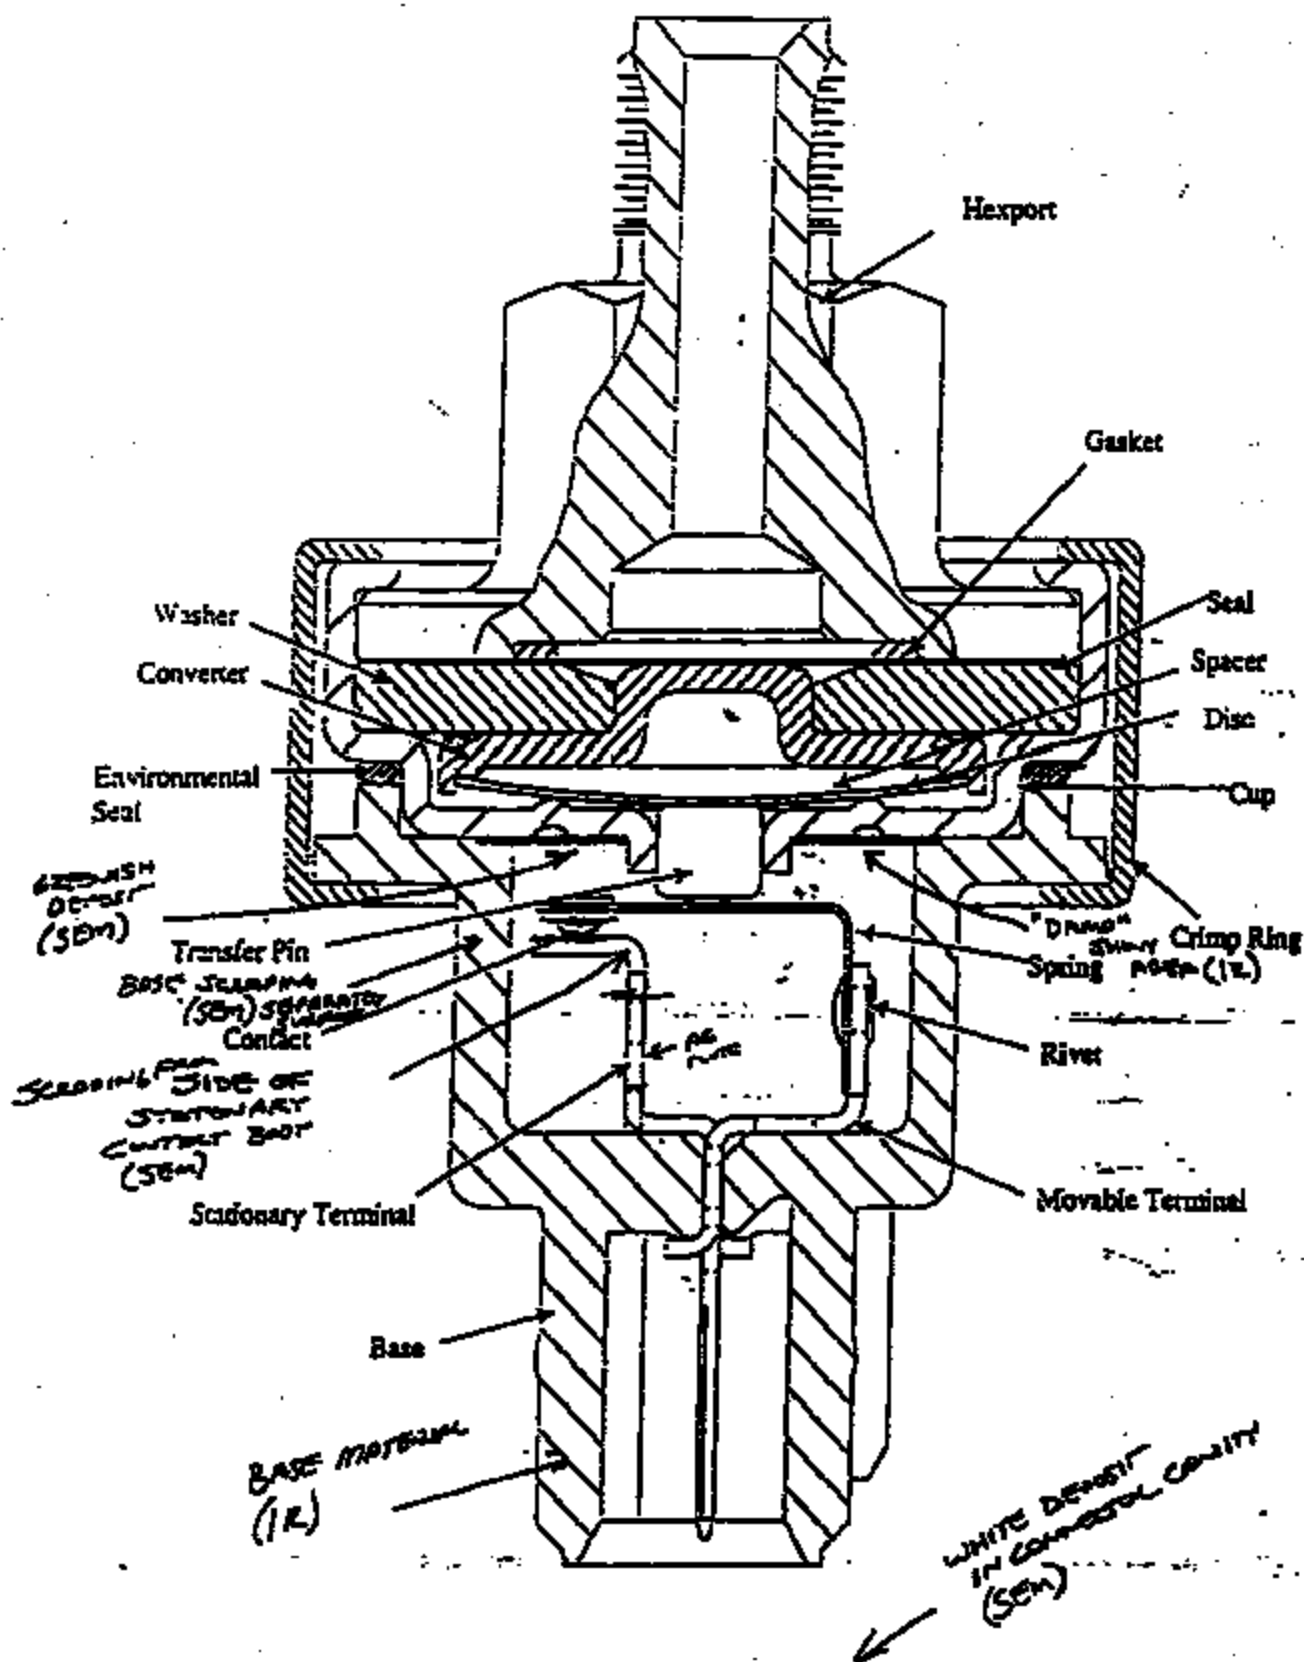
### Hydraulic Pressure Switch Cross Section

The cup is partially covered with a greenish residue. Residue appears to be primarily an oxide of the brass contact material with possibly a sulfur compound. This suggests transfer of oxide or corrosion product from the brass contacts to the cup.

The stationary contact exhibits intergranular cracks which indicate stress corrosion cracking (SCC). SCC is caused by combination of a specific corrosive environment and a sustained tensile stress (can be localized). Ammonia, ammonia compounds, sulfur compounds, and moisture are known to cause SCC in brass. The contact material has been reported to be 360 brass, which is highly susceptible to SCC.

All three diaphragms exhibit what appears to be mechanical damage. The damage does not match up with any mating parts of the switch. This suggests that damage may have occurred prior to assembly. The diaphragm has become brittle and cracked in the vicinity of the damage. Brake fluid has become entrained between the layers (Teflon and capton) of the diaphragms.

The post of the movable contact melted back into the bulkhead between the switch and terminal cavities of the base. There is also arc damage (localized melting) to one corner of the bridge of the stationary contact. This damage appears fresh (surfaces bright and shiny) which suggests that it may have occurred in the later stages of the thermal event.

The terminals exhibit deposits which appear to be primarily sulfur compounds of the terminal material (tin plated brass). Although these deposits appear visually similar to the deposit found on the cup, they appear to be of different composition.

The white residue found in the connector cavity contains elements found in dry chemical fire extinguishers (Muscovite and phosphorus).
