**EA02-025**

**APPENDIX N**

**BOOK 24 OF 61**

**PART 1 OF 5**

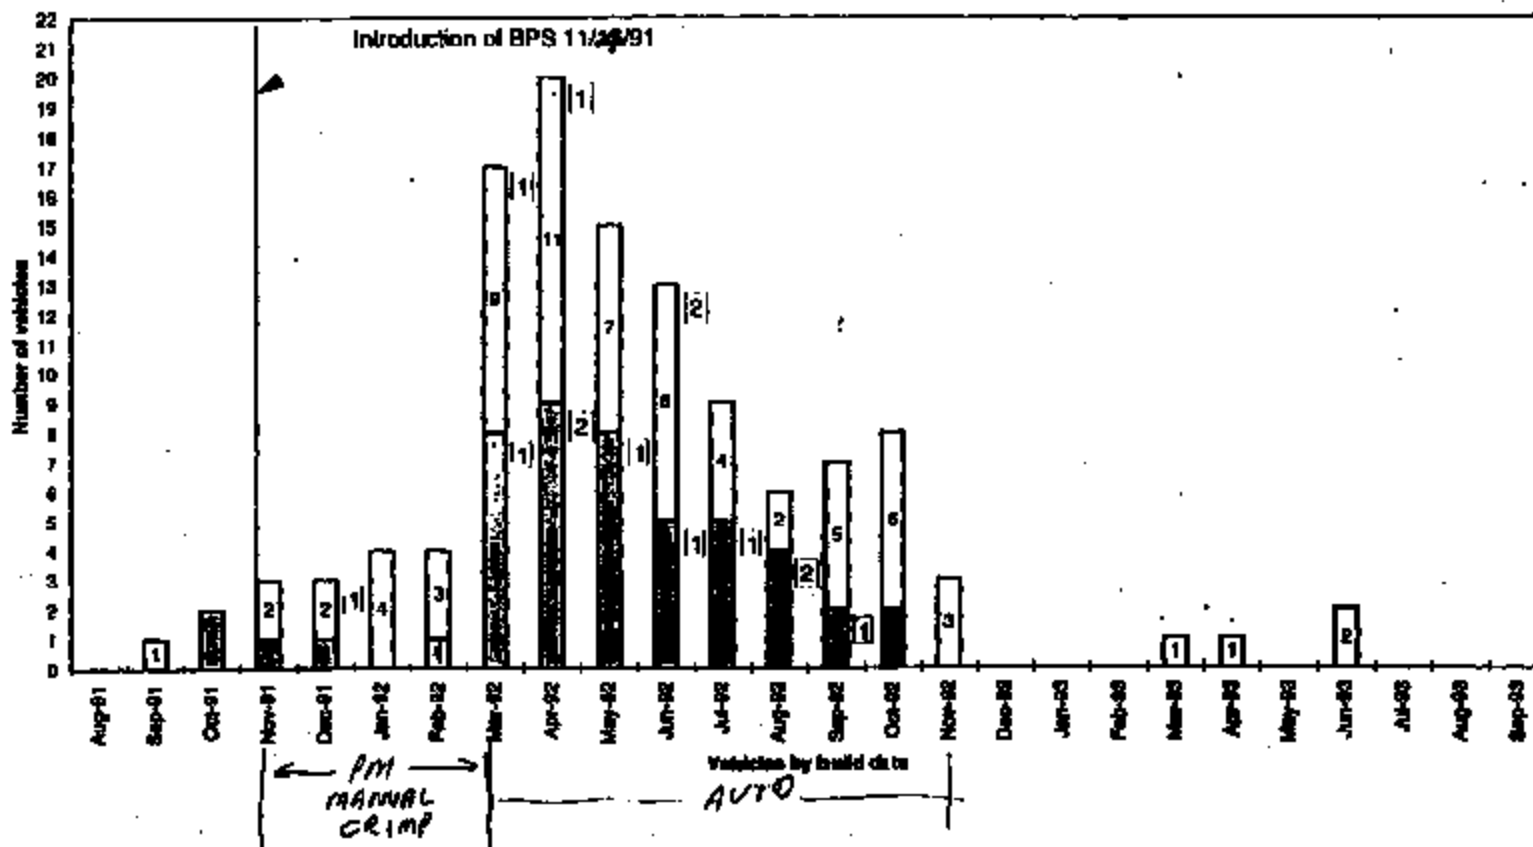
### Parato of 92/93 Town Car Underhood Fire Allegations With Engine On/Off/Unknown

- The shaded region represents vehicles with engine off/unknown.
- The unshaded region represents vehicles with engines on.
- Represents BPS symptoms

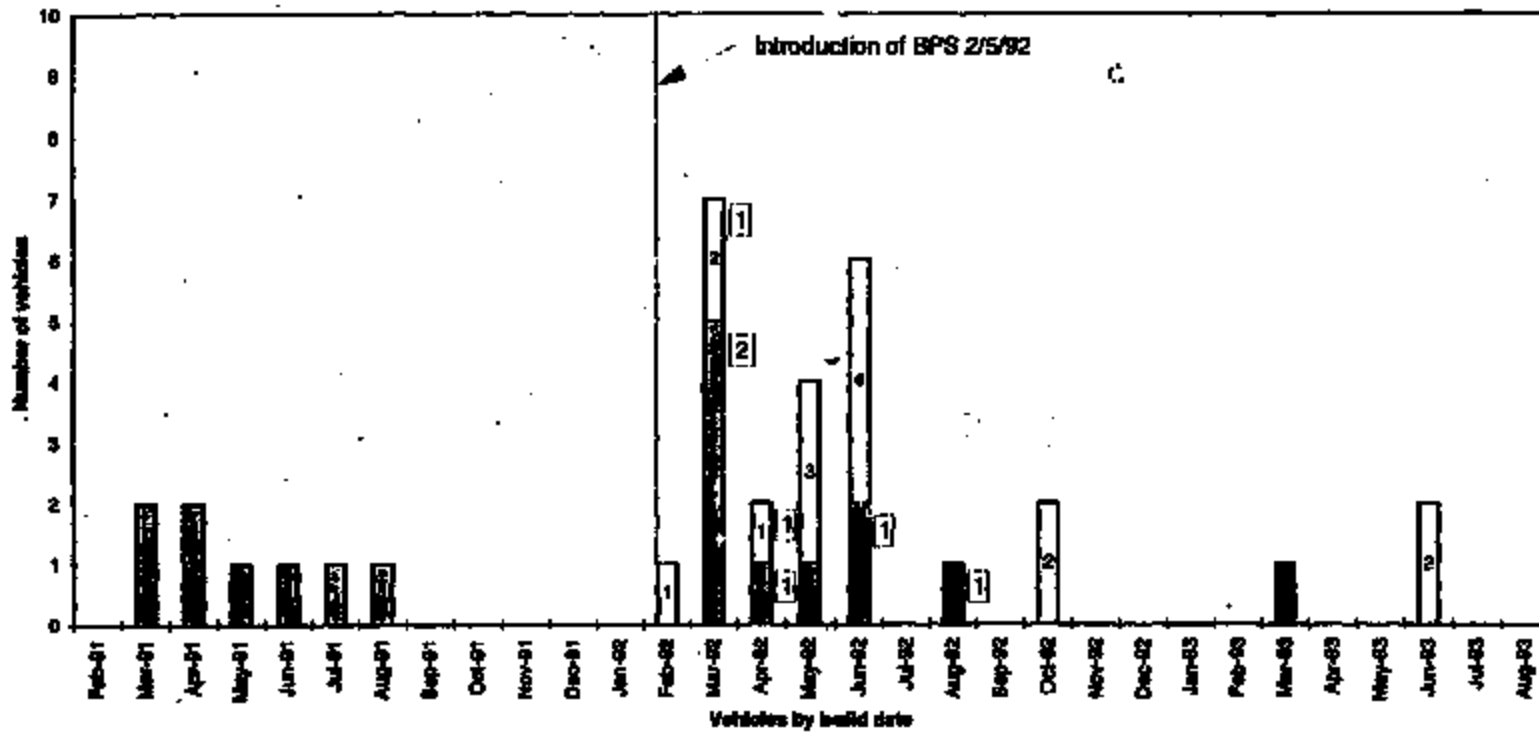
Parato of 92/93 CV/GM Underhood Fire Allegations With Engine On/Off/Unknown

- The shaded region represents vehicles with engine off/unknown.
- The unshaded region represents vehicles with engine on.
- 1 Represents BPS symptoms

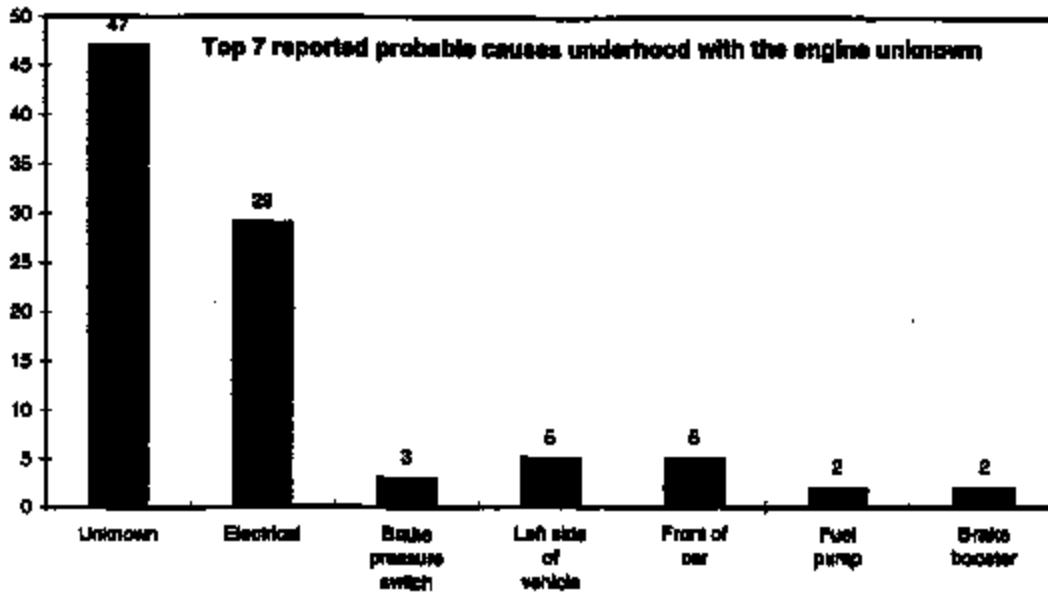
**Verbatim Parato Analysis of Towncar, CV/GM, Econoline and F-series**

Town car	CV/GM	Econoline	F-series	Total
Unknown	11	9	24	3	47
Electrical	4	8	19	0	29
Brake pressure switch	2	1	0	0	3
Left side of vehicle	0	2	3	0	6
Front of car	0	3	2	0	6
Fuel pump	0	0	2	0	2
Brake booster	0	2	0	0	2

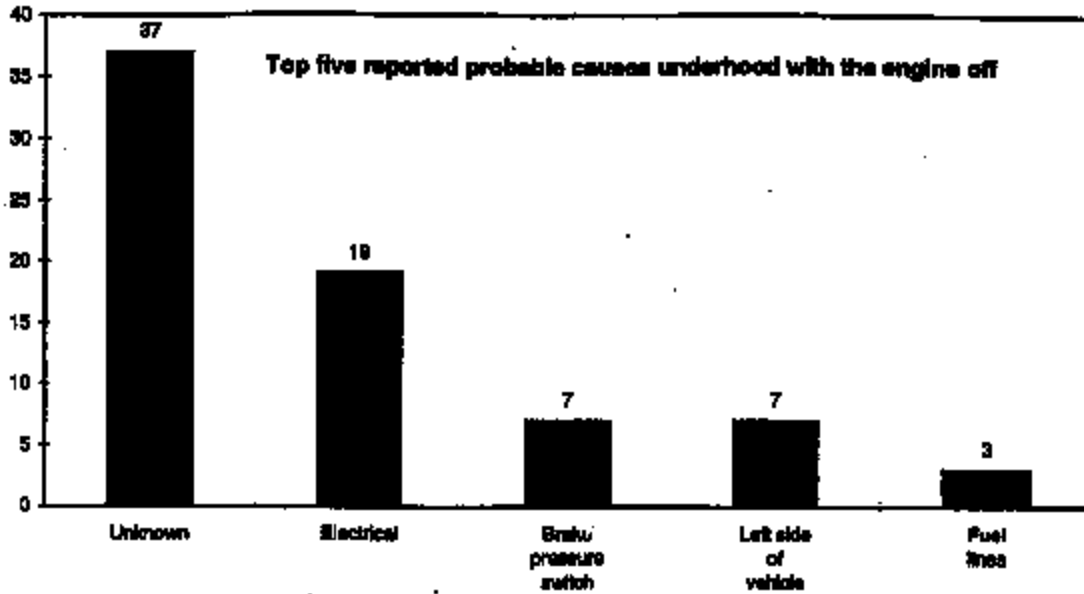
**Verbatim Pareto Analysis of Town Car, CV/GM, Econoline and F-Series**

Town car	CV/GM	Econoline	F-Series	Total
Unknown	15	7	14	1	37
Electrical	7	4	6	2	18
Left Side of Vehicle	4	2	1	0	7
Brake pressure switch	4	1	1	1	7
Fuel lines	0	2	1	0	3

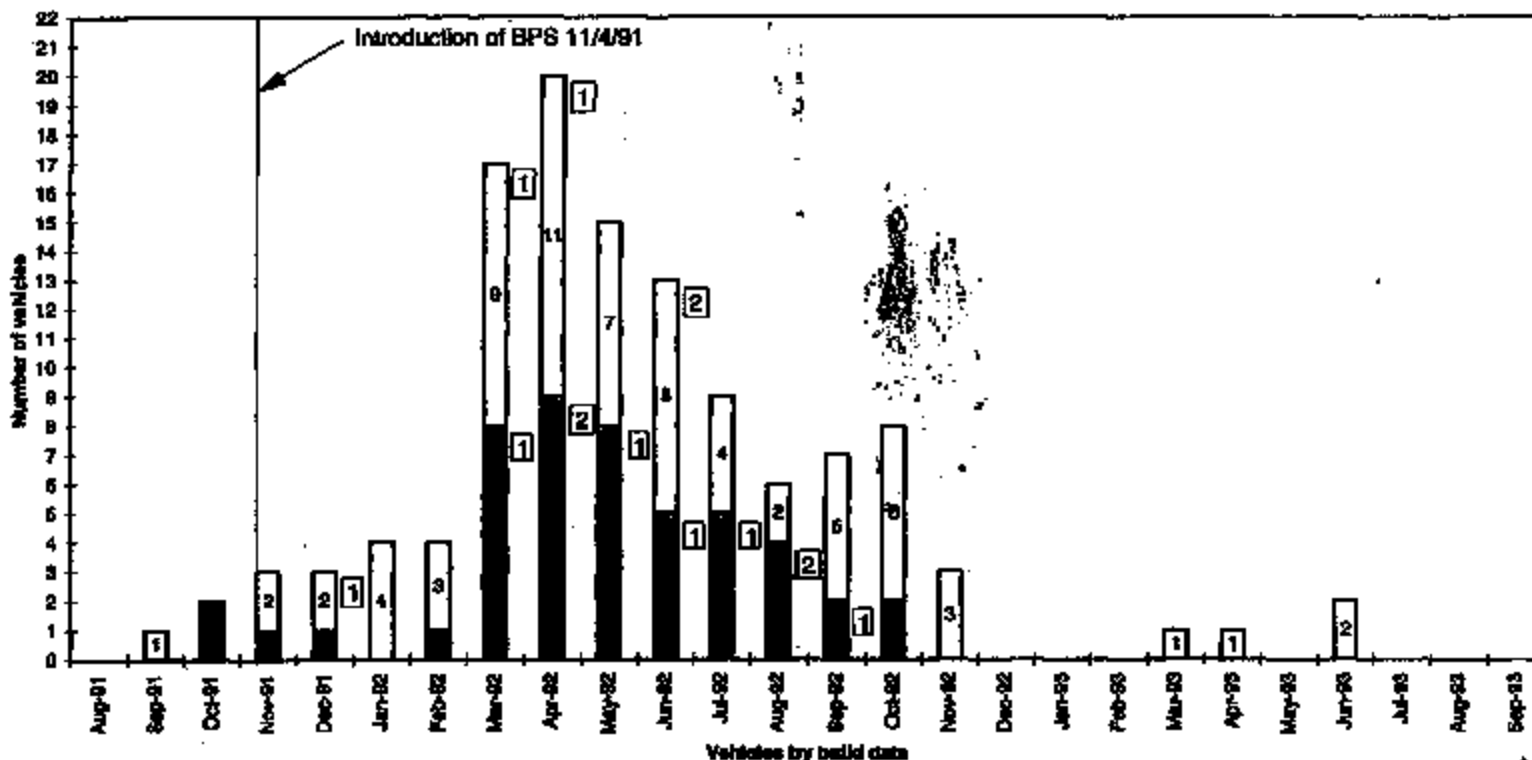
Parato of 92/93 Town Car Underhood Fire Allegations With Engine On/Off/Unknown

- The shaded region represents vehicles with engine off/unknown.
- The unshaded region represents vehicles with engine on.
- Represents BPS symptoms

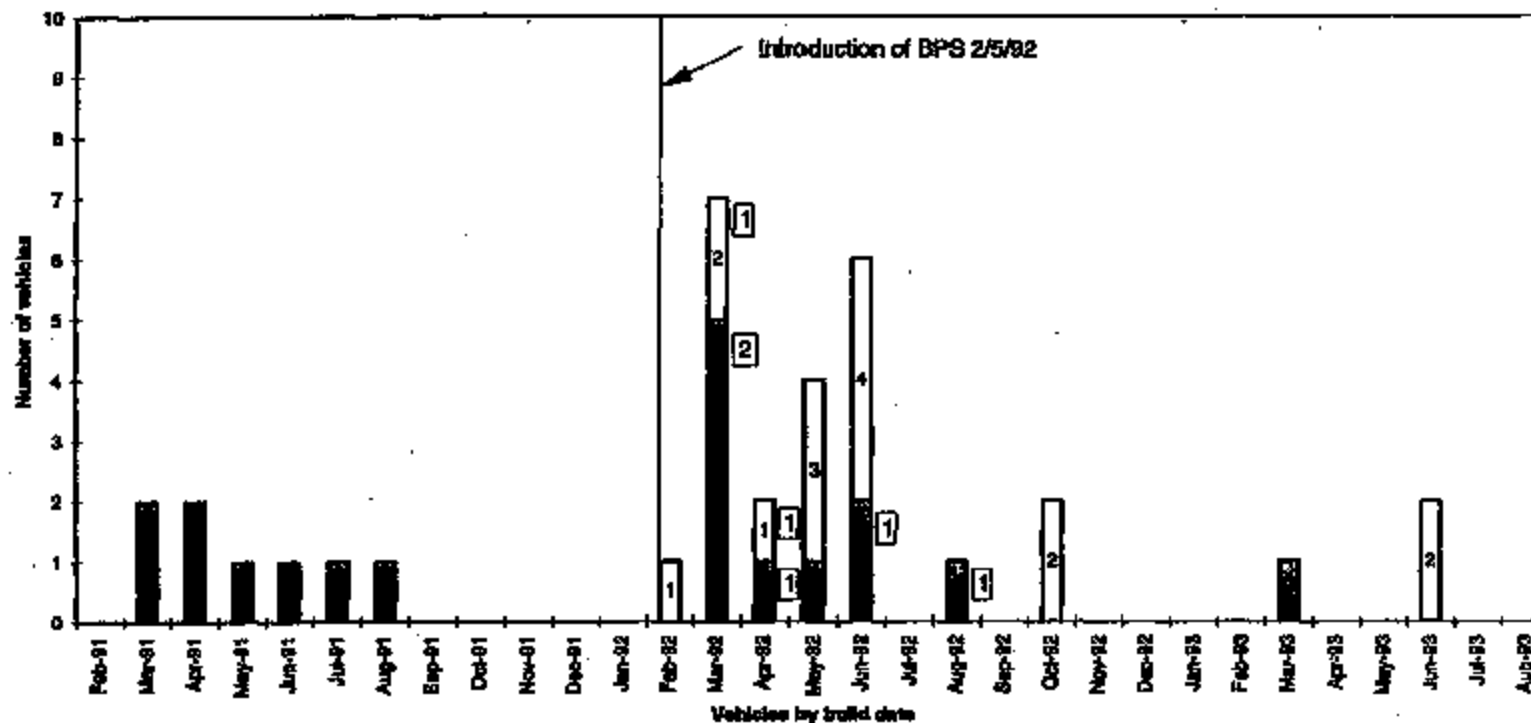
Parato of 92/93 CV/GM Underhood Fire Allegations With Engine On/Off/Unknown

- The shaded region represents vehicles with engine off/unknown.
- The unshaded region represents vehicles with engine on.
- 1 Represents BPS symptoms

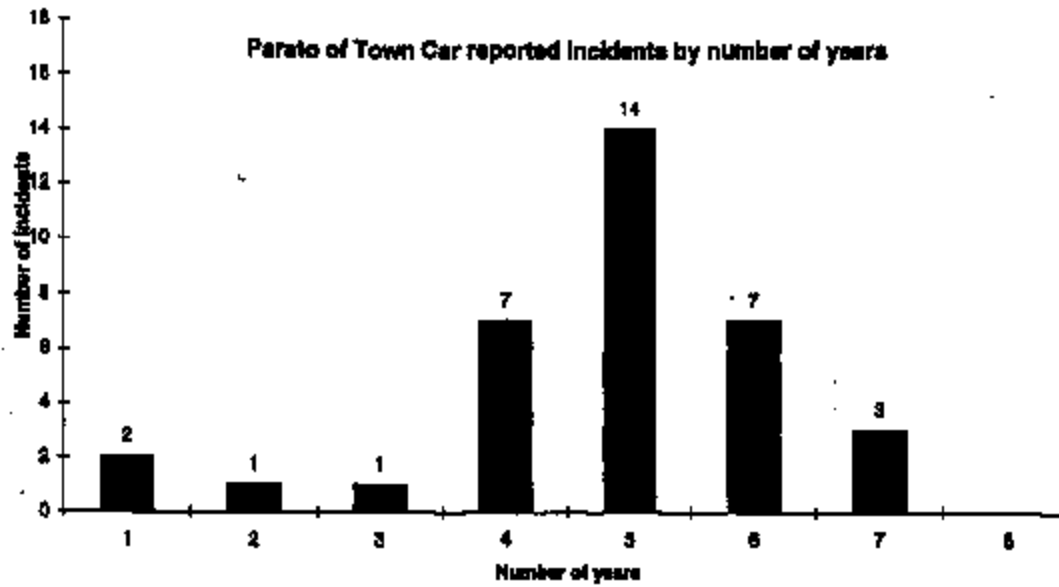
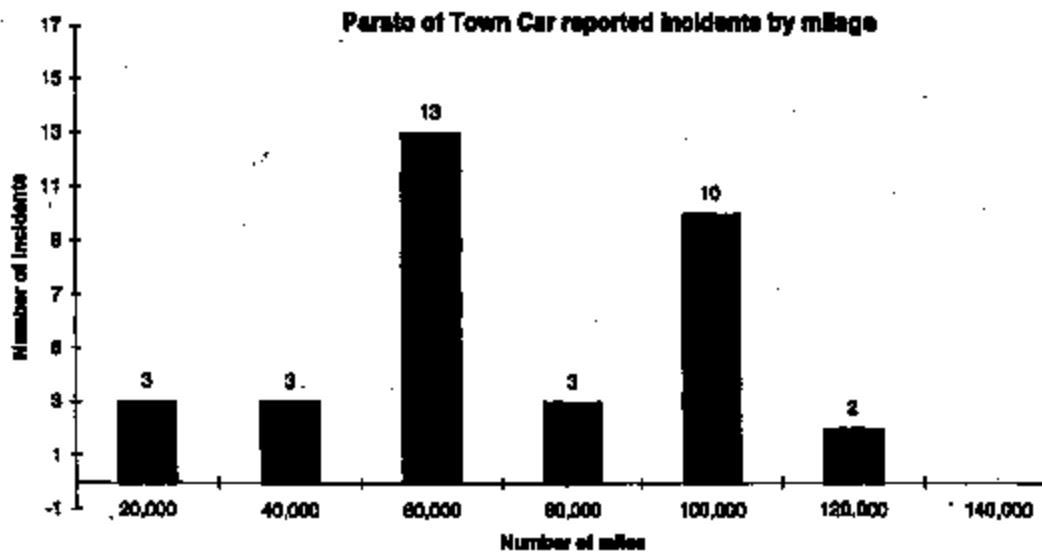
## 92 Lincoln Town Car Reported Incidents Of 40 Vehicles with Engine Off/Unknown

There were 6 vehicles with unknown vins, therefore, years in service were undetermined.  
There were 6 vehicles with unknown miles.
