EA02-025

APPENDIX N

Brake Pressure Switch Questions

Object: Determine cause of burned switch and connector.

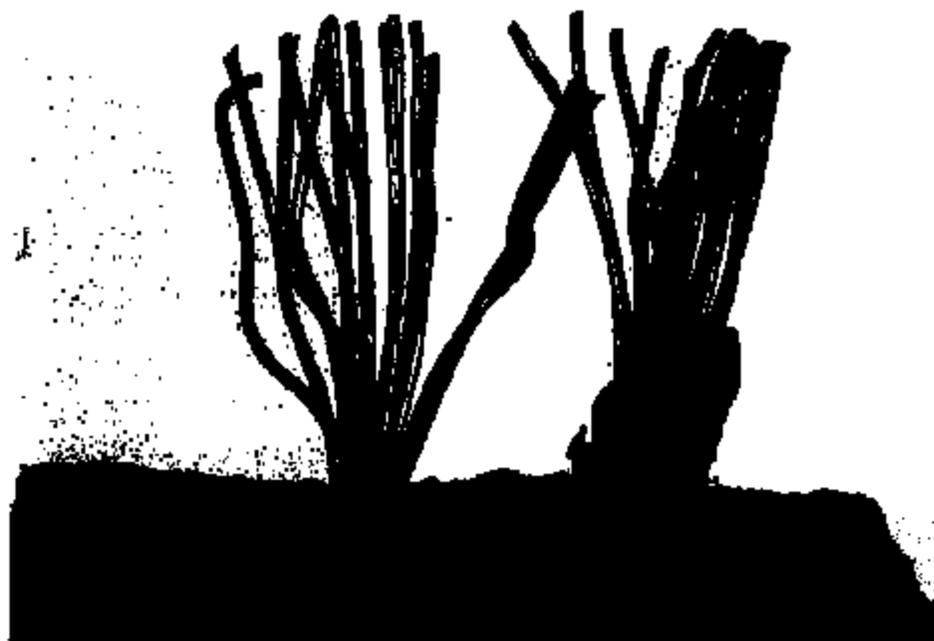
Figure 19: Image showing tarnished condition of wires below insulation.

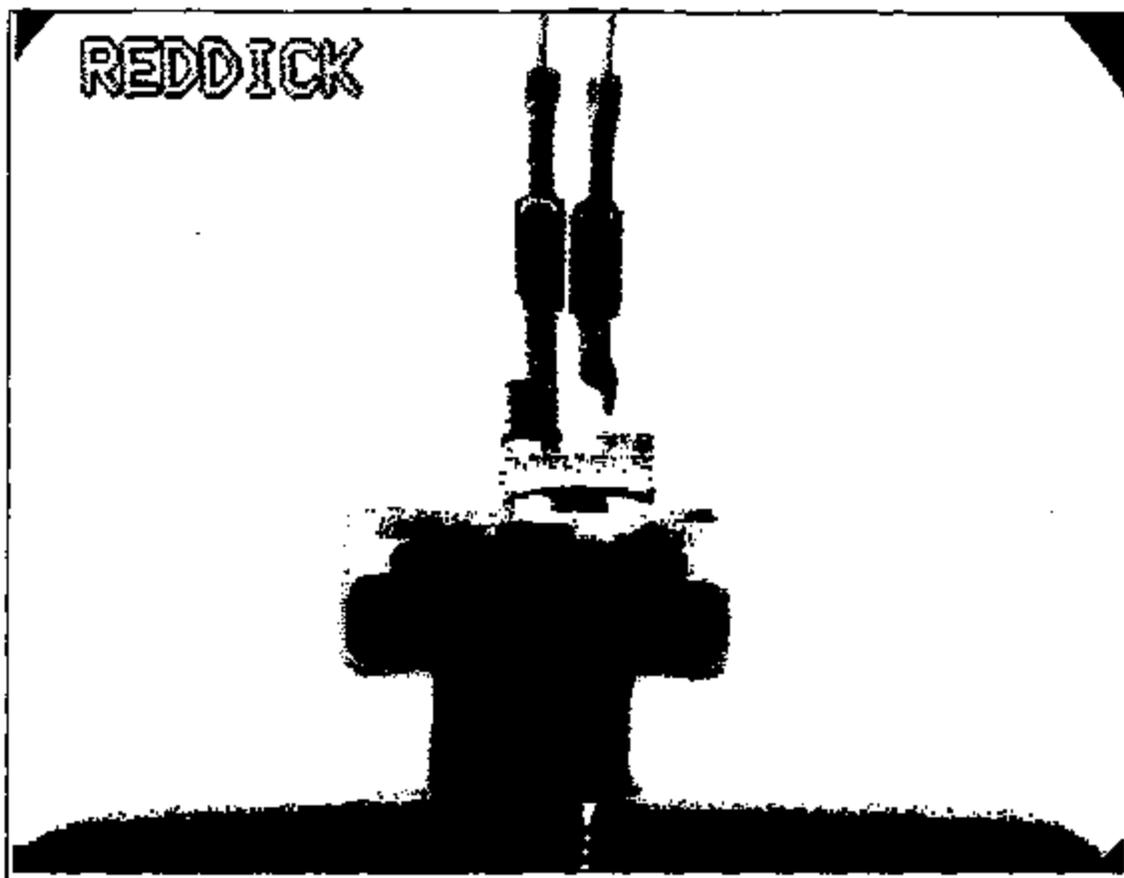
Figure 23: Fluoroscopic image showing switch base and pressure side of switch placed together. Note base of movable contact terminating in large globule.

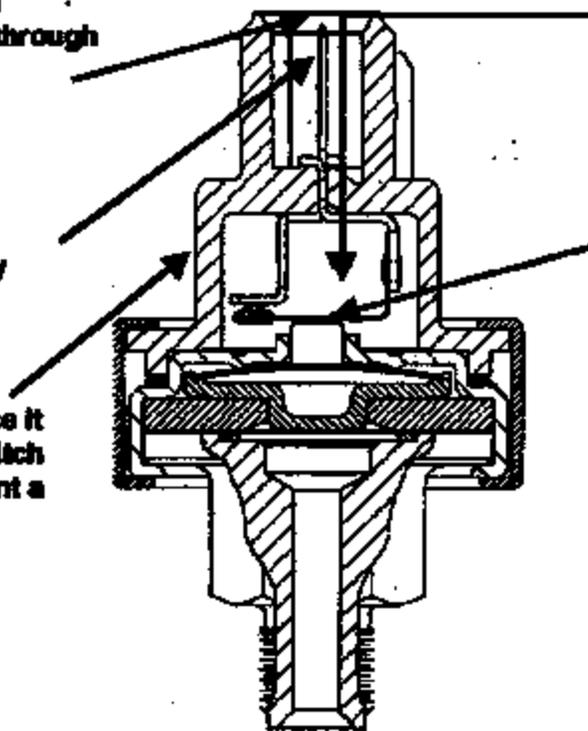
Brake Pressure Switch Potential Thermal Event Theory - 2/24/99

4. Down stream short to ground causes high current to pass through the switch

2. 12V Battery source to drive corrosion and provide energy

5. Plastic connector melts. Once it opens, oxygen enters the switch cavity. If any arcing is present a fire can start, burning the plastic.

1. Water enters the switch cavity

3. Contact arm corrosion increases resistance (heater wire).
