**EA02-025**

**FORD 10/27/03**

**APPENDIX N**

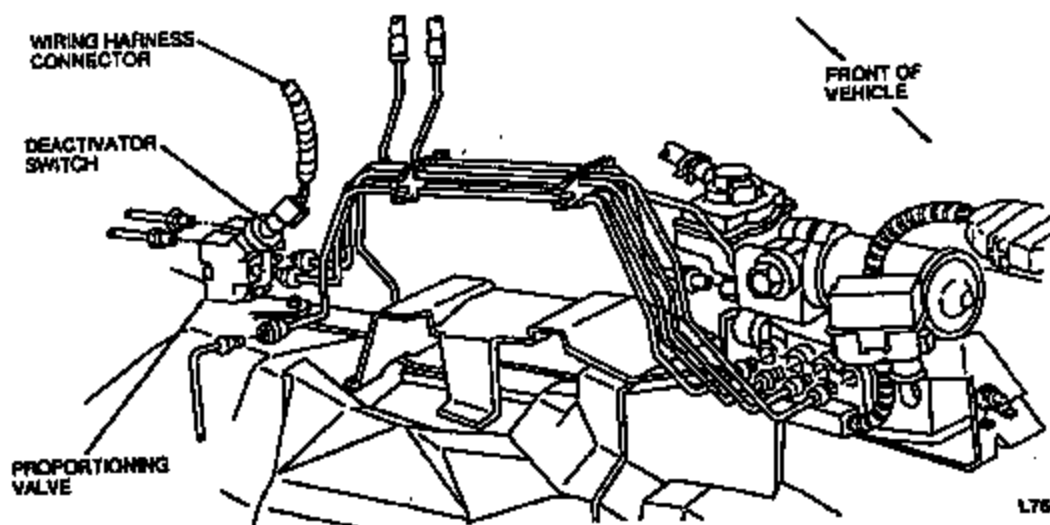
L7665-B

The deactivator switch is a normally closed switch and replaces the vacuum dump valve as a redundant safety feature in the system. Normally when the brake pedal is depressed, an electrical signal from the brakelamp circuit to the speed control servo will disengage the system. Under increased brake pedal efforts (6-10 lbs, engine running), the deactivator switch mounted in the brake line will open and remove power to the speed control servo clutch, releasing the throttle independent of the speed control servo control. The deactivator switch is located at the rear brake proportioning valve (ABS brakes) or junction block (Non-ABS brakes) below the brake booster.

1. Screw switch into proportioning valve or junction block. Tighten to 15-20 N-m (12-14 lb-ft).
2. Attach electrical connector.
3. Bleed brake lines as outlined in Section 06-09 ABS brakes, or Section 06-08, non-ABS brake.

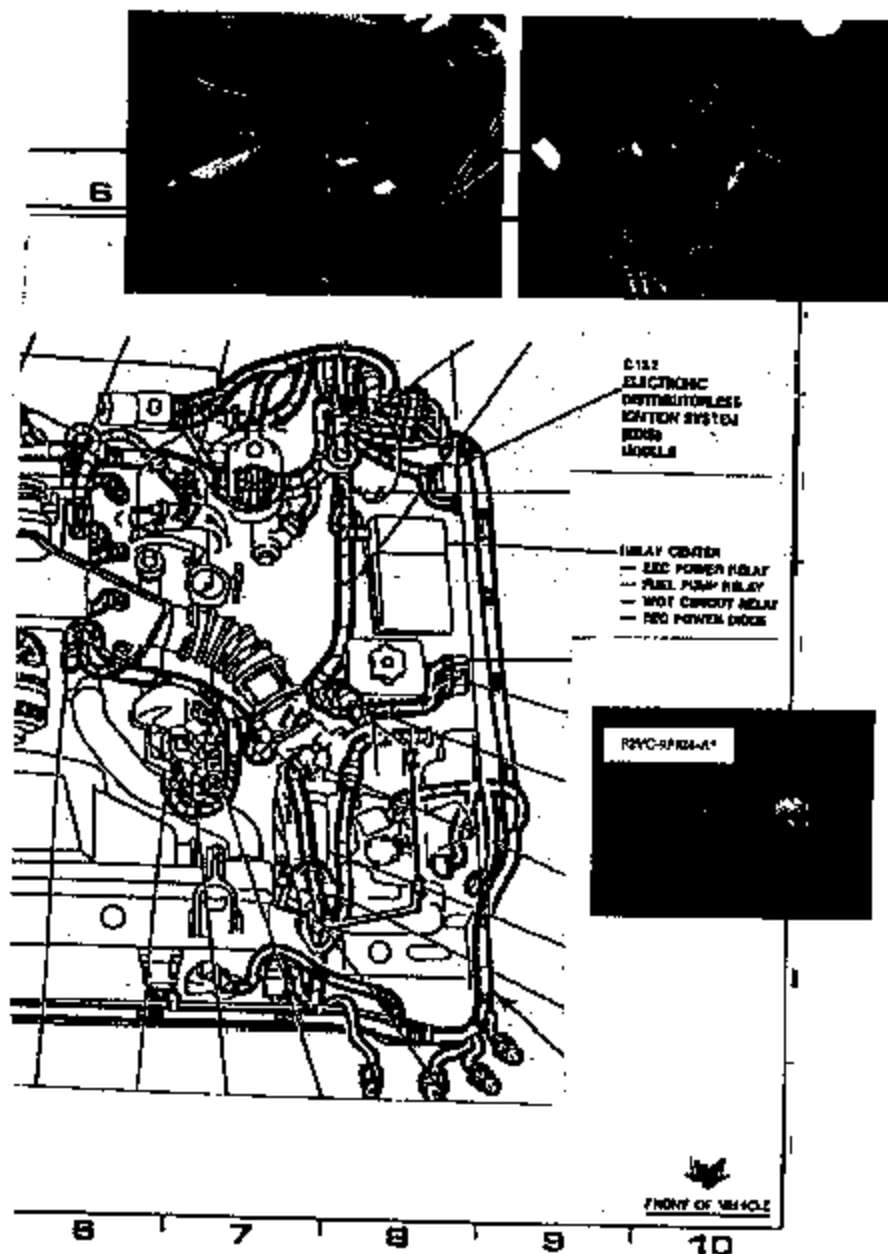
# PE98-055 1992-1993 Lincoln Town Car

1. Speed control deactivation switch F2VC-8F924-A
2. Electronic Distributorless Ignition System (EDIS) module
3. Relay center:
  - a. EEC power relay
  - b. Fuel pump relay
  - c. WOT control relay
  - d. EEC power diode
4. Wiring assembly 12A581
