**EA02-025**

**FORD**

**BOOK 26 OF 61**

## Summary of Chemical Properties

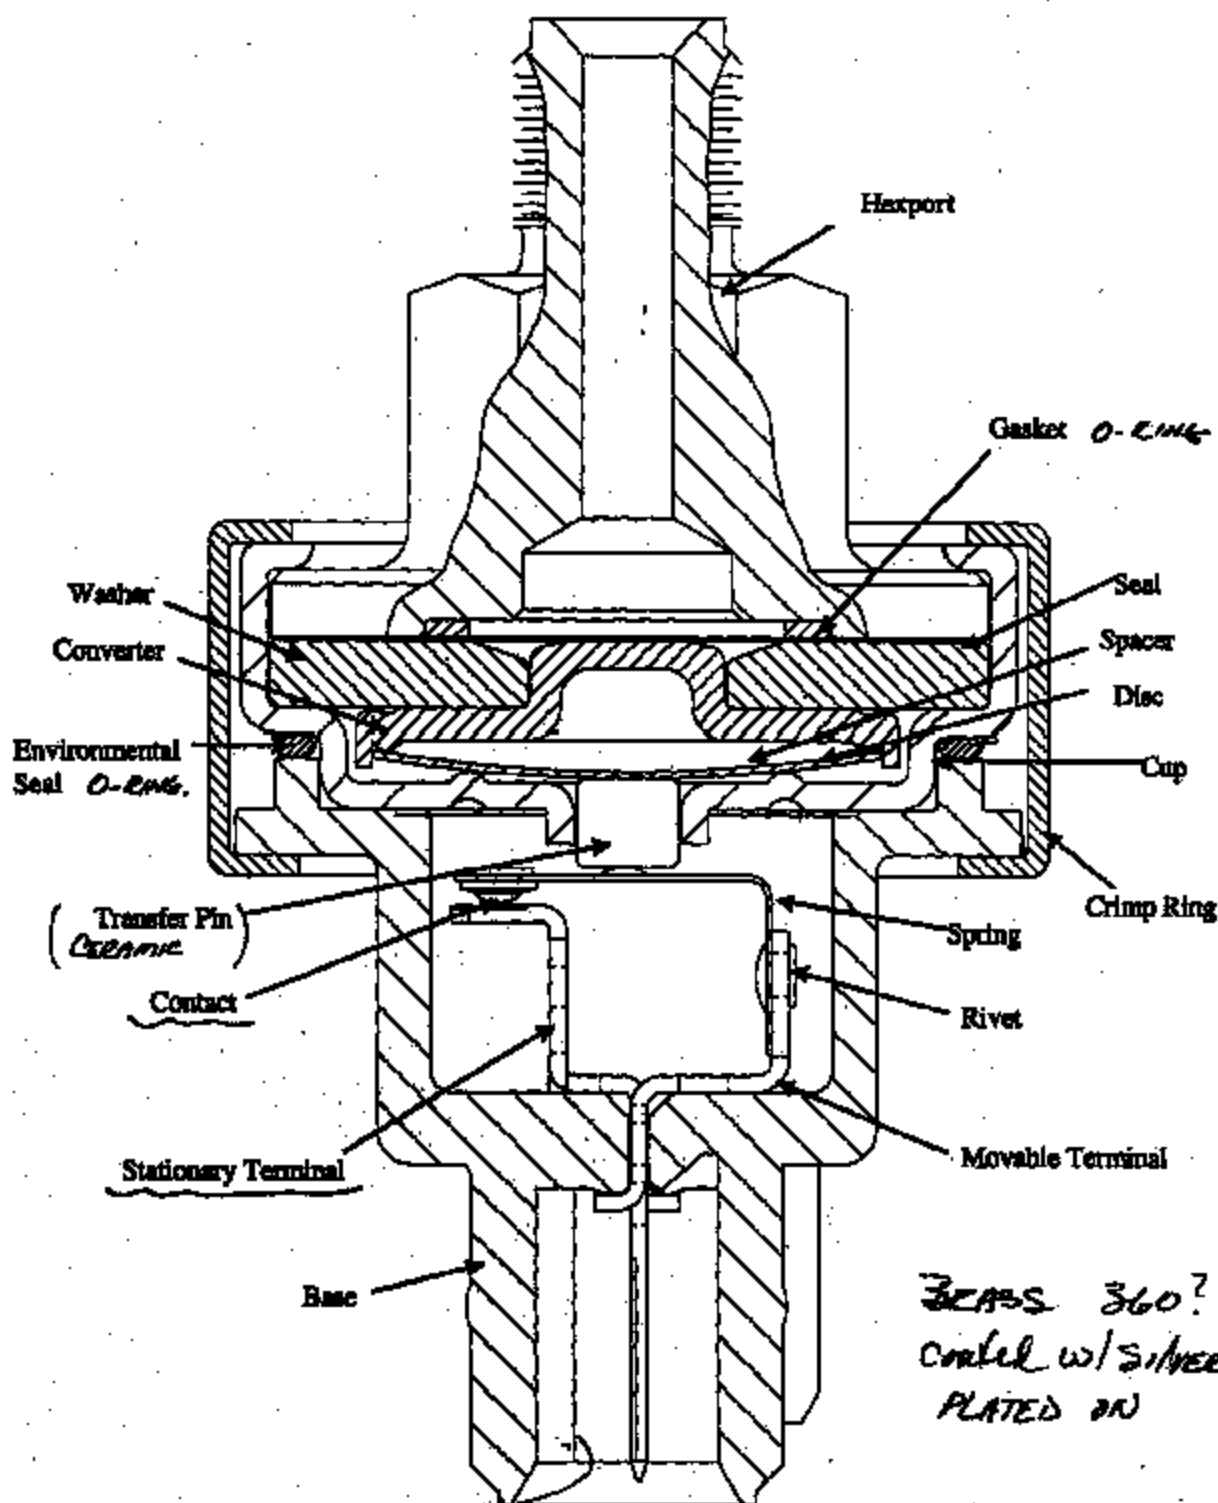
# Hydraulic Pressure Switch Cross Section

① Look for dirt & contaminants
