**EA02-025**

**FORD**

## Improved Methods for Testing the Durability of Corrosion Protection in Brake Fluids

This letter is to advise you that the Office of Defects Investigation (ODI) of the National Highway Traffic Safety Administration (NHTSA) is conducting a Preliminary Evaluation concerning engine compartment fires in certain Lincoln Town Car vehicles manufactured by the Ford Motor Company.

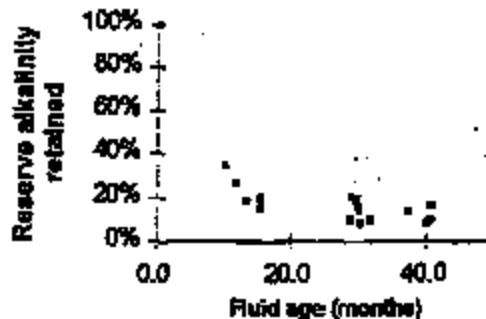
Figure 1 : Decrease in reserve alkalinity of a brake fluid during vehicular use.

Figure 1 shows the residual RA (as % of initial value) of a brake fluid in matched vehicles 0-3.5 years old, plotted as a function of the age of the fluid. By 30 months (about 50,000 km) the RA has dropped to as low as 9% of its initial value, and about half of this small residual RA arises from components other than the amine. The titration data therefore suggest a 20-fold reduction in primary inhibitor concentration over 2-3 years of service.

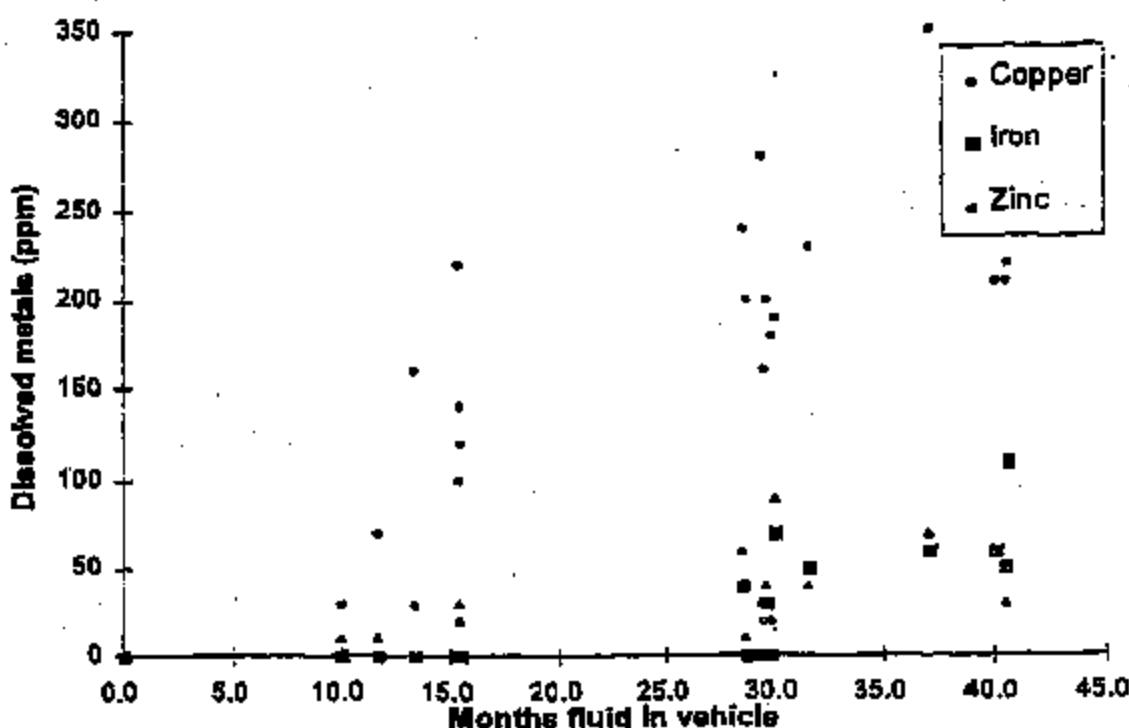
Figure 2: Dissolved metals in a fluid as function of time of use.

Dissolved iron appears in the brake fluid after the initial anti-corrosion inhibitor are significantly depleted and dissolved copper levels rise to around 200 ppm. The apparent induction period for iron corrosion has presented difficulties in testing technological changes designed to minimize this effect; no test protocol employing fresh brake fluid had succeeded in reproducing the iron corrosion observed at times in vehicles after several years' service. Later sections of this paper will show that attention to the chemical changes in brake fluid during use has led to test procedures which reproduce the field vehicular effects within 6 months.

The dissolved zinc levels in Figure 2 show no evidence of the induction time seen for iron. Since testing for corrosion protection of zinc in brake fluid is known to be problematic even in fresh brake fluids<sup>20</sup> (it is not yet a requirement of FMVSS116), it would not be entirely surprising if some Zn corrosion is occurring even after relatively short service. Another possible source of the observed zinc is extraction of Zn compounds from hoses.

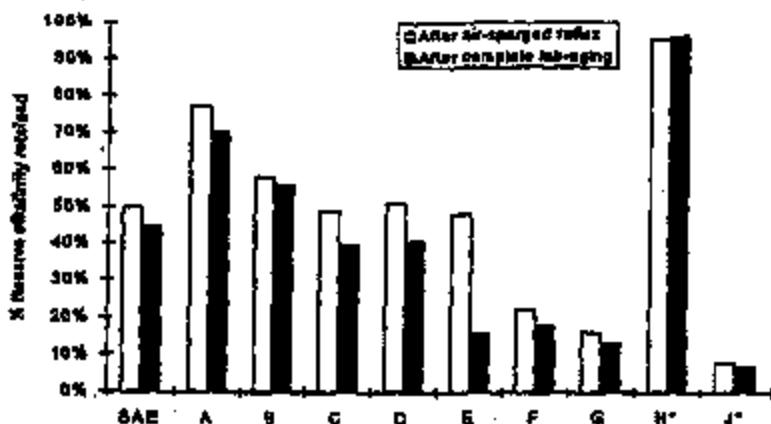
Figure 3: % Reserve alkalinity retained after thermal oxidation and after complete lab-aging procedure were applied to SAE compatibility fluid RM-44-04 and commercially available fluids (\* indicates DOT 4 fluid).

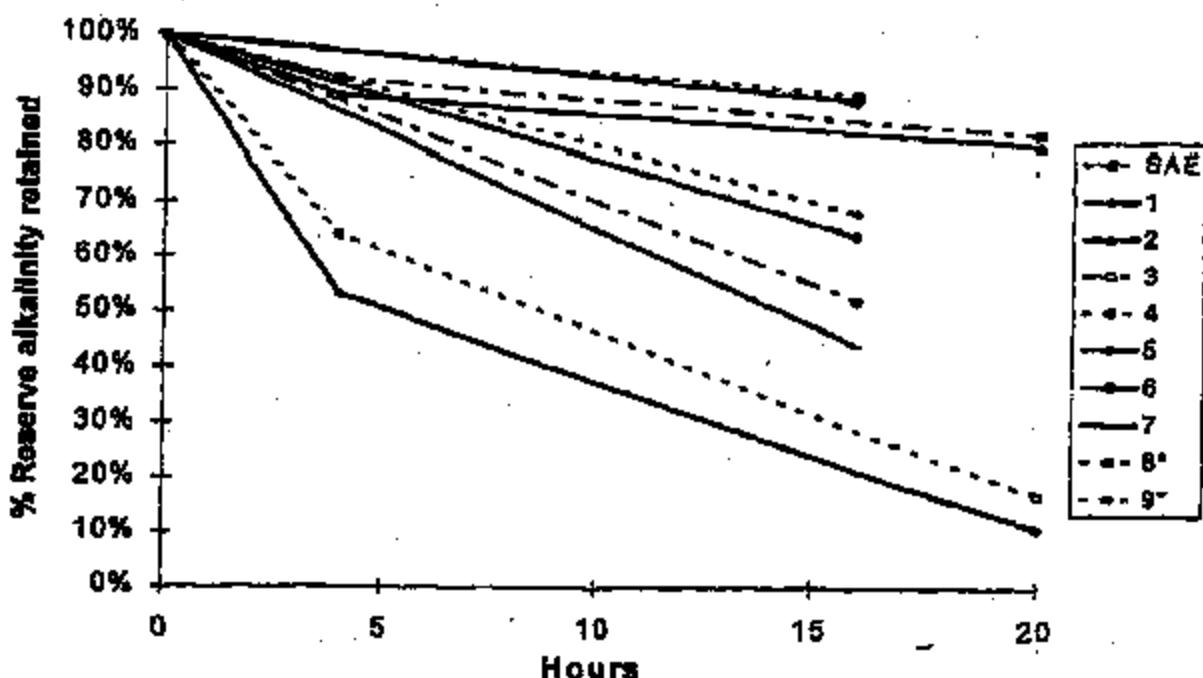
Figure 4: Reserve alkalinity retention as function of heating time (covered) at 100°C for SAE compatibility fluid RM-44-04 and various commercially available fluids (\* indicates DOT 4 fluid).

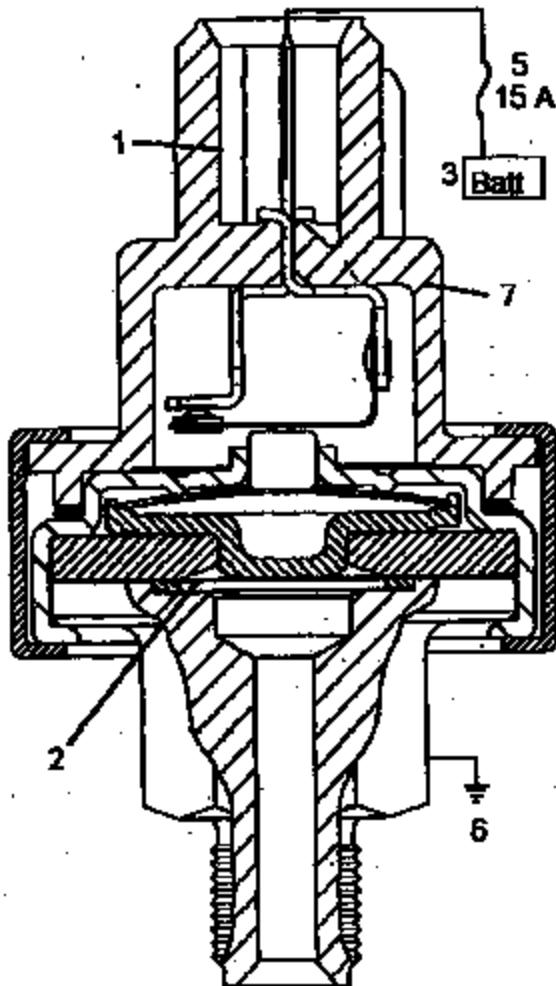
1. Connector Seal
2. Kapton Life
3. Continuous Power
4. Switch Orientation
5. Current Capability
6. Grounded Hex-Port
7. Plastic Parameters

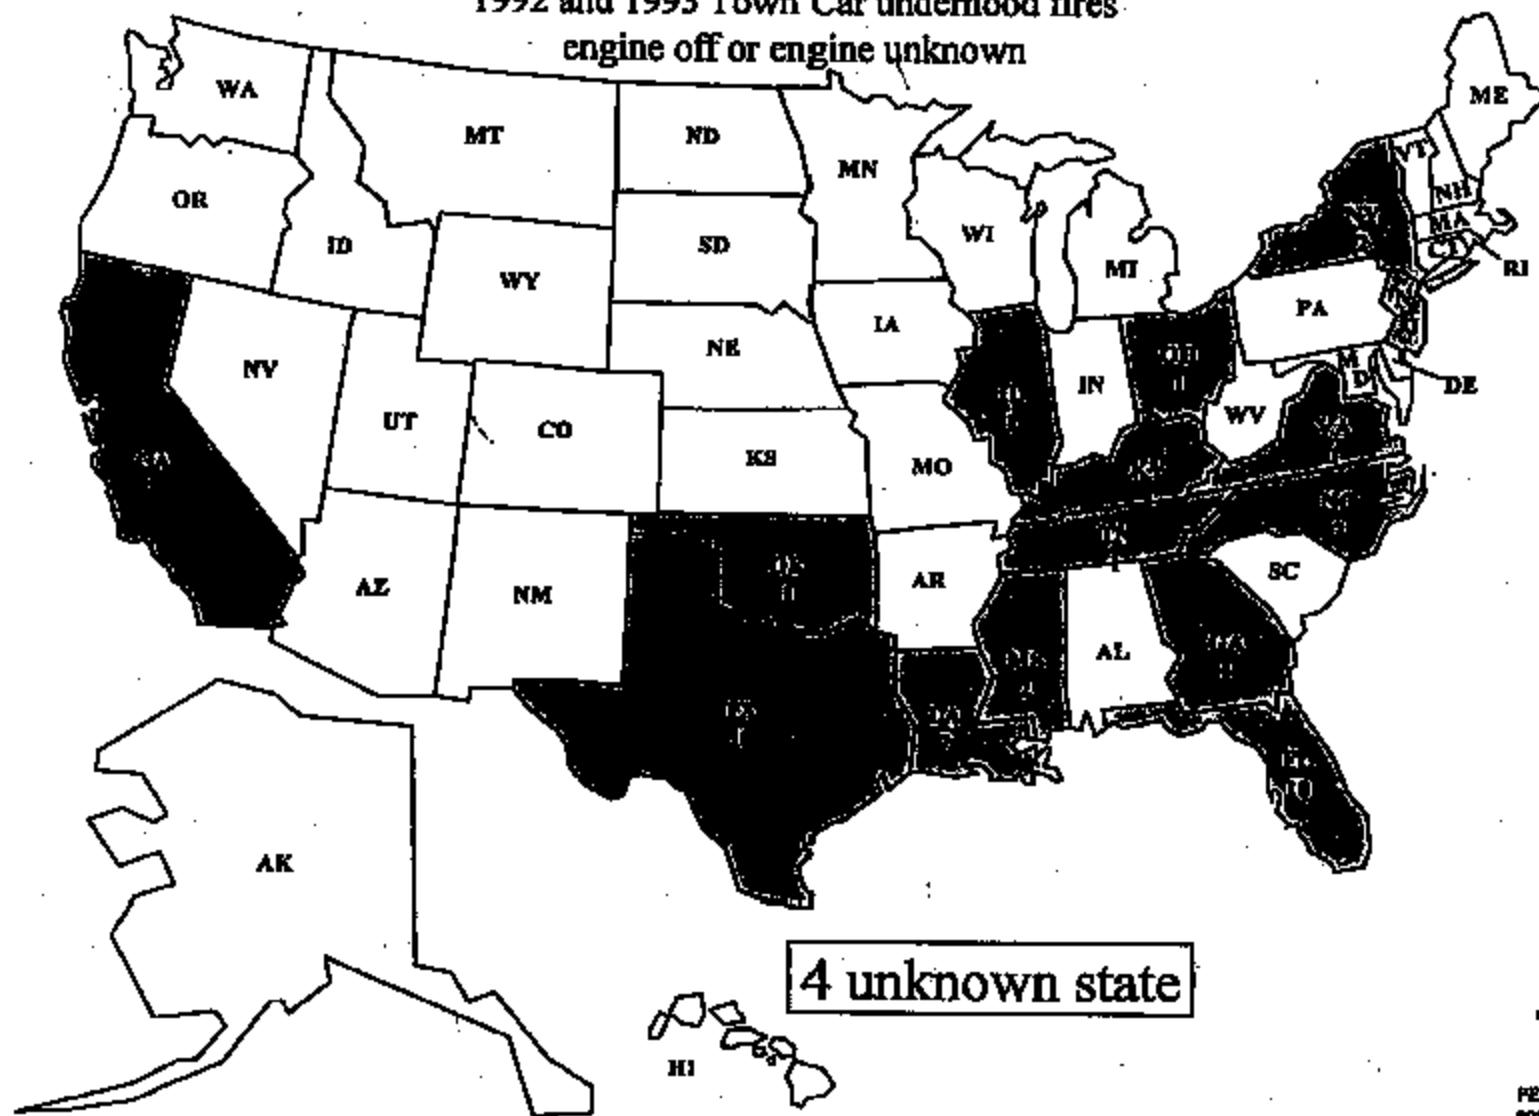
1992 and 1993 Town Car underhood fires  
engine off or engine unknown

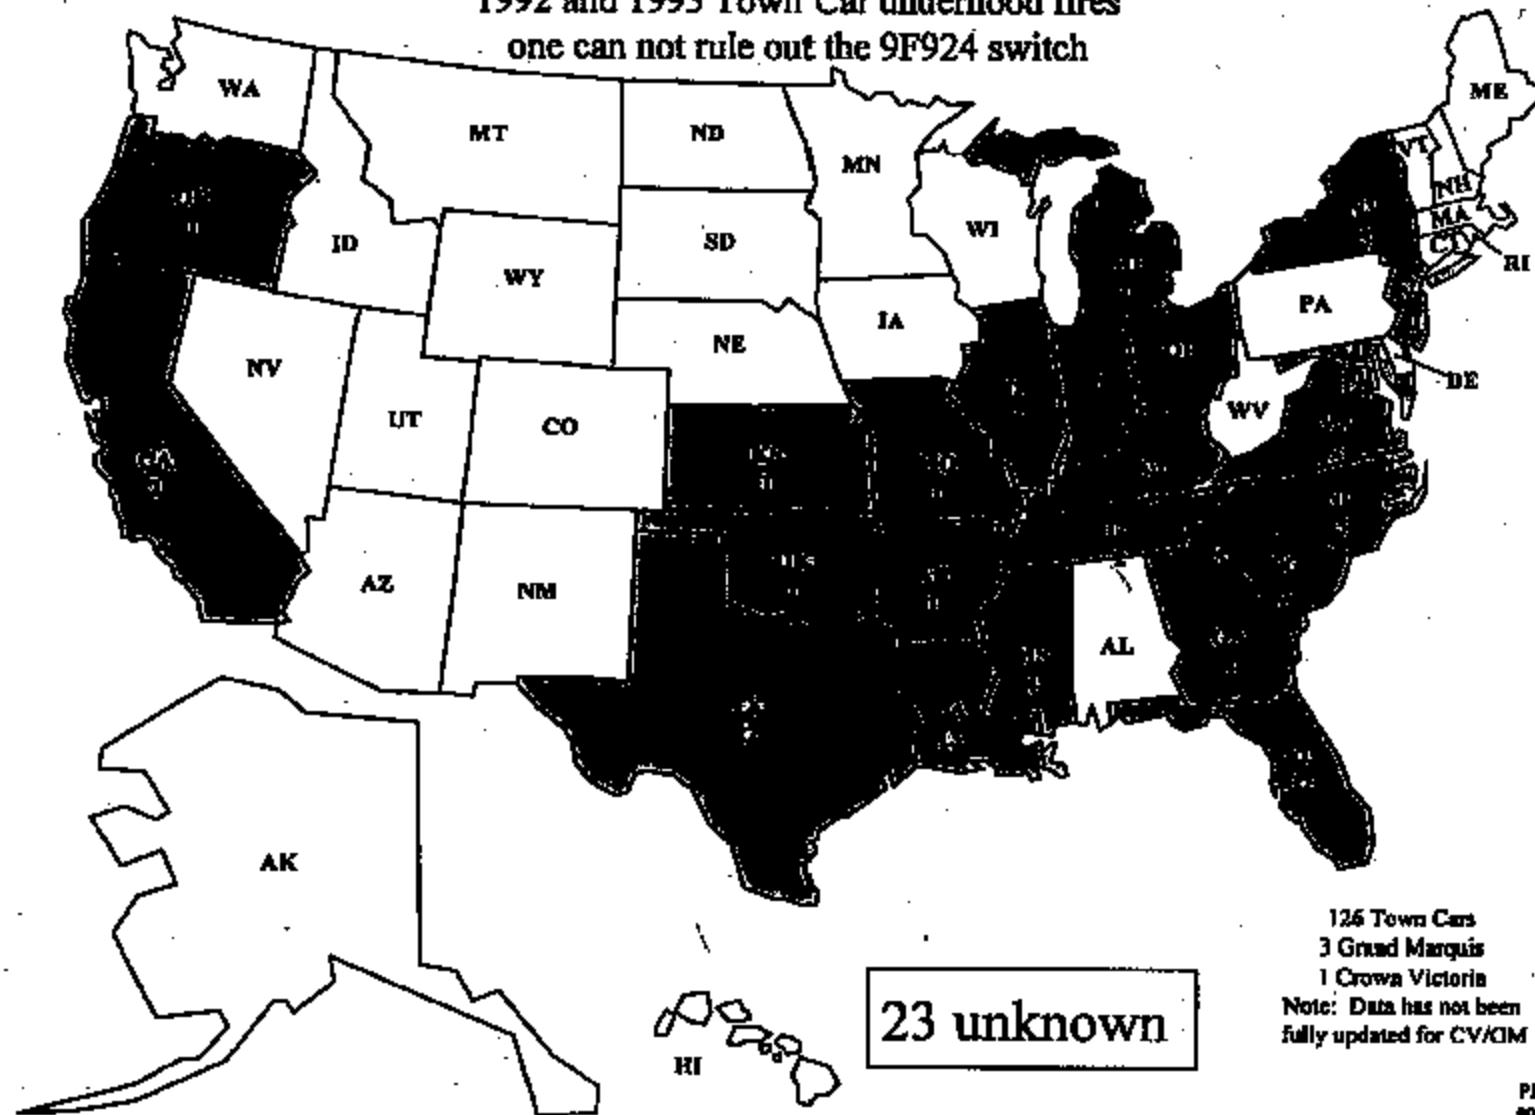
1992 and 1993 Town Car underhood fires  
one can not rule out the 9F924 switch
