**EA02-025**

**FORD**

Report 9903244

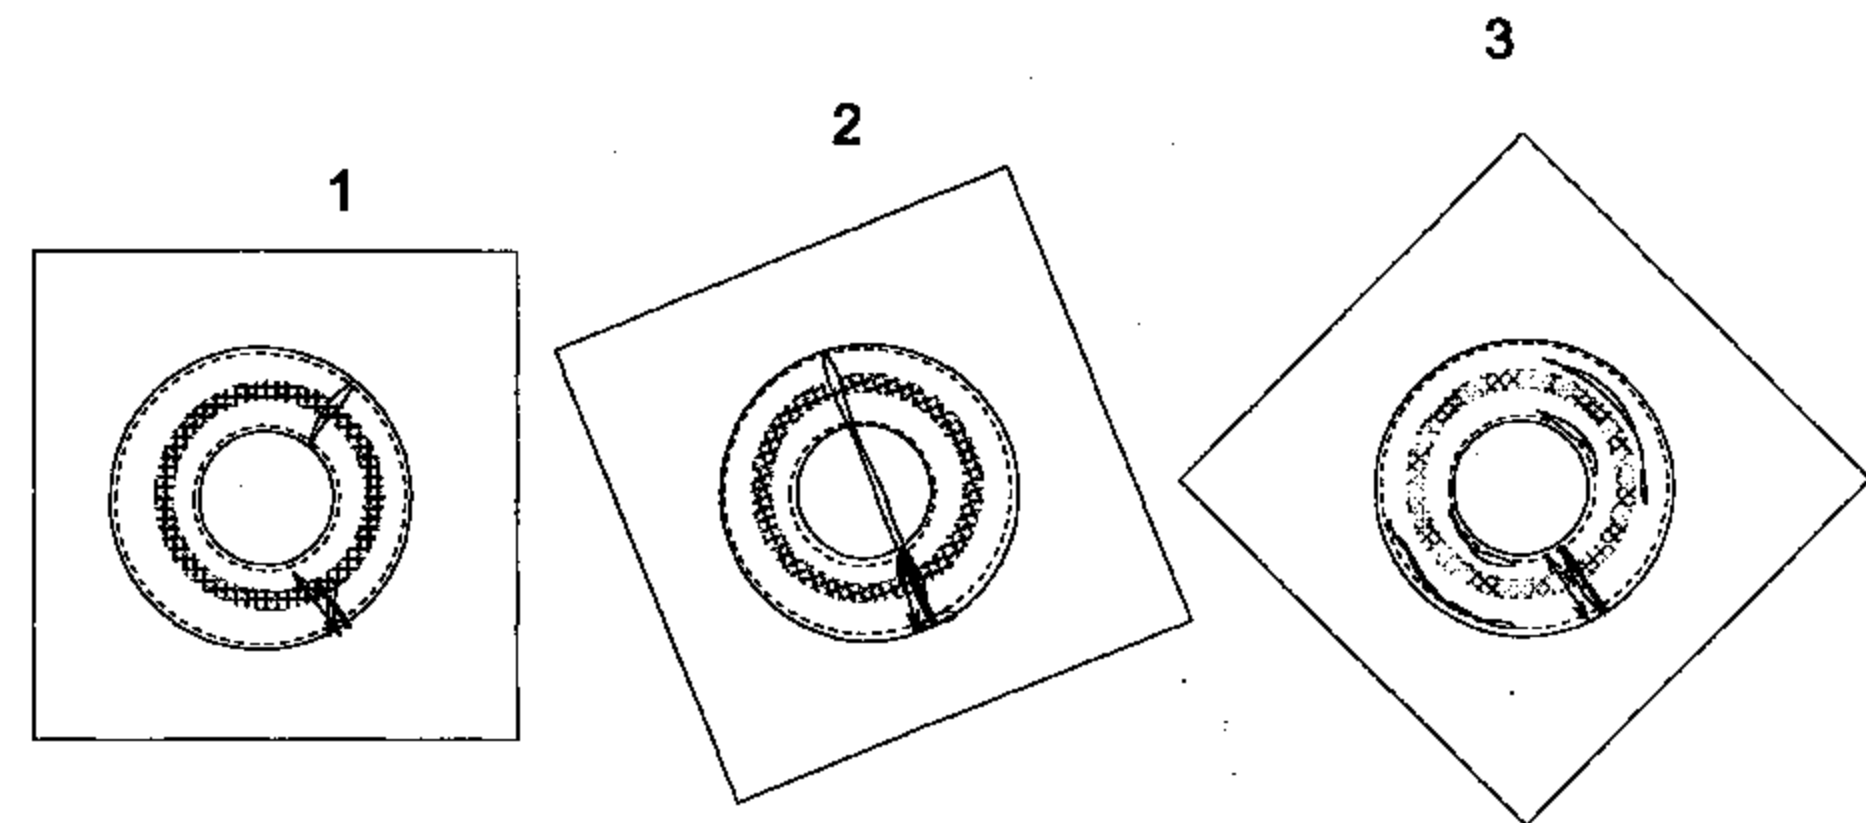
- Figure: 089 -

- ← Indicates buckle in Kapton.
- Indicates crack in Kapton
- Indicates tear in Teflon
- Indicates area in which Teflon has delaminated from Kapton

#2  
Viewed from  
Hexport Side

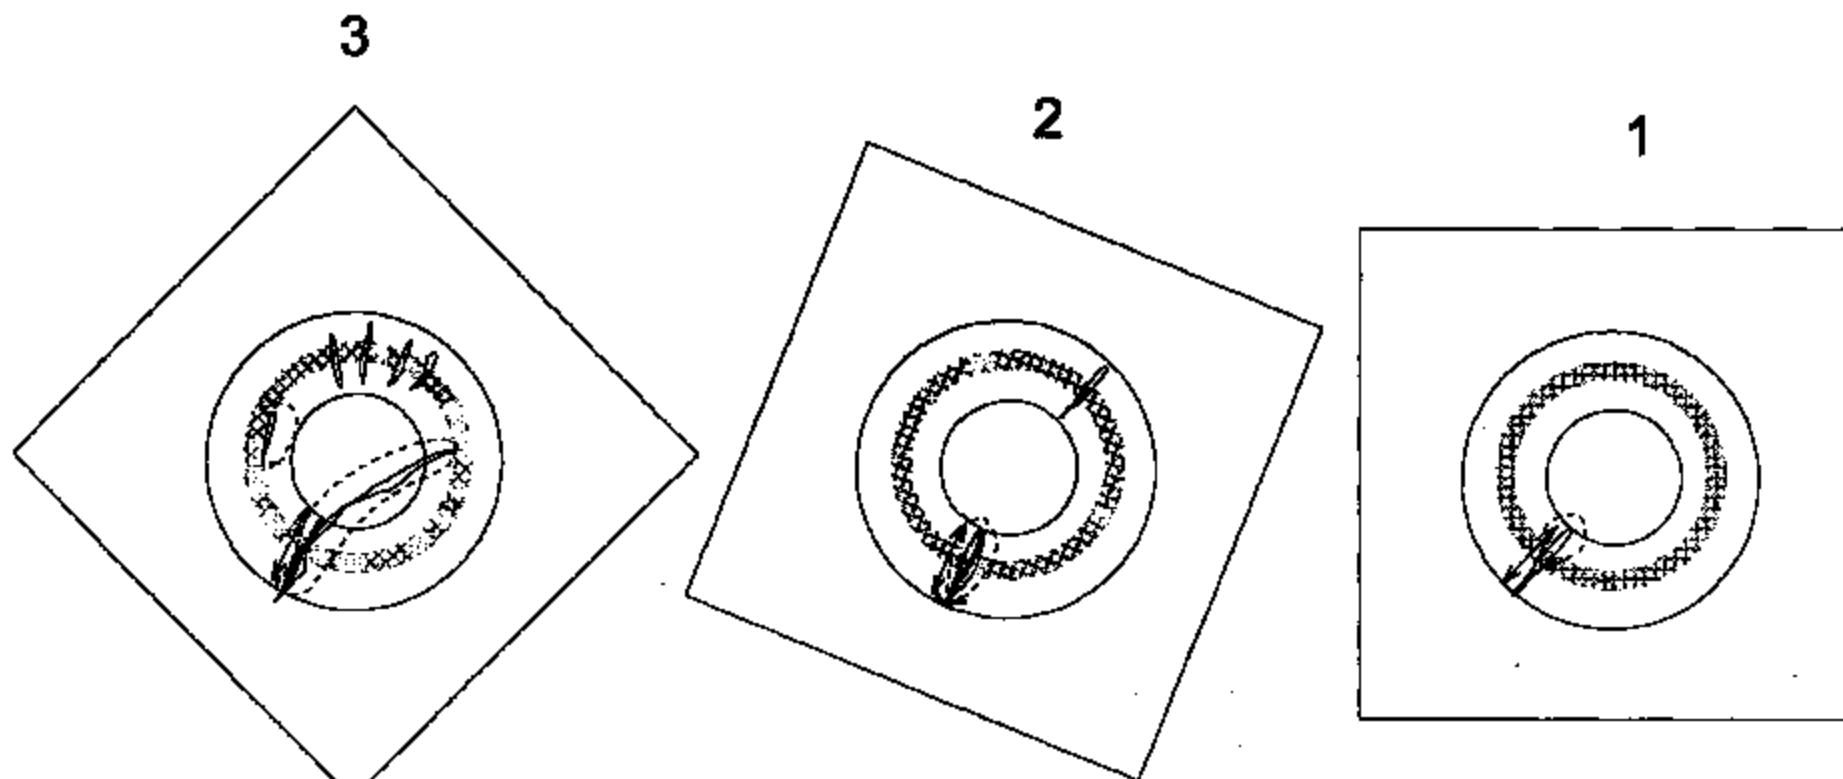
- Figure: 090 -

← Indicates buckle in Kapton.

— Indicates crack in Kapton

- Indicates tear in Teflon

- Indicates area in which Teflon has delaminated from Kapton

#2

Viewed from  
Converter Side

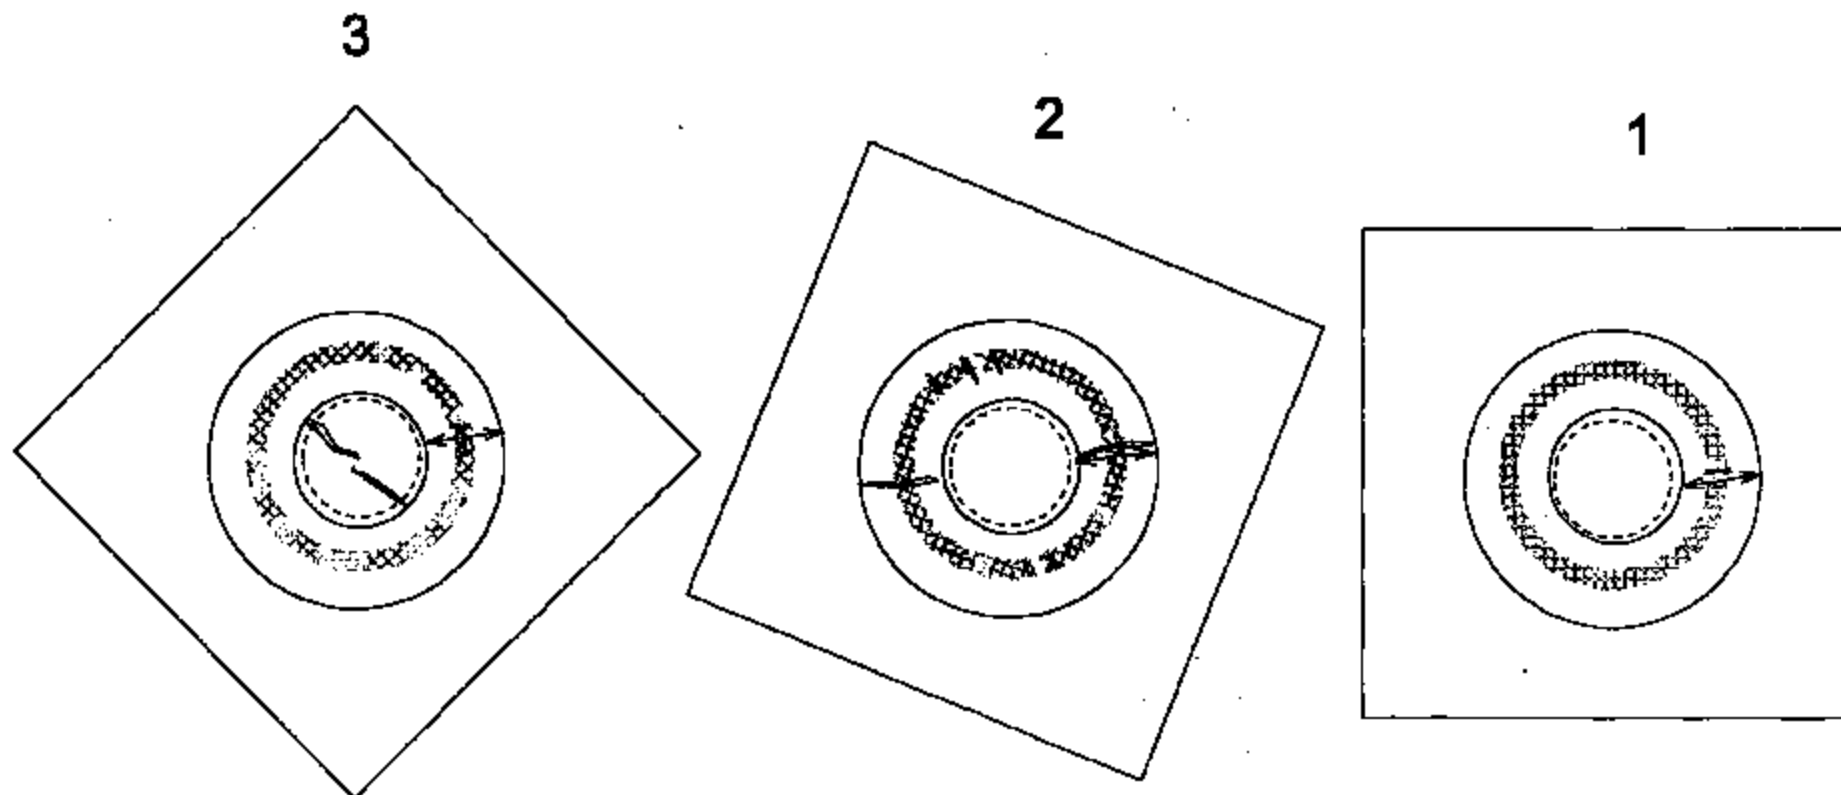
- Figure: 092 -

- ← Indicates buckle in Kapton.
- Indicates crack in Kapton.
- Indicates tear in Teflon
- Indicates area in which Teflon has delaminated from Kapton

#3  
Viewed from  
Converter Side

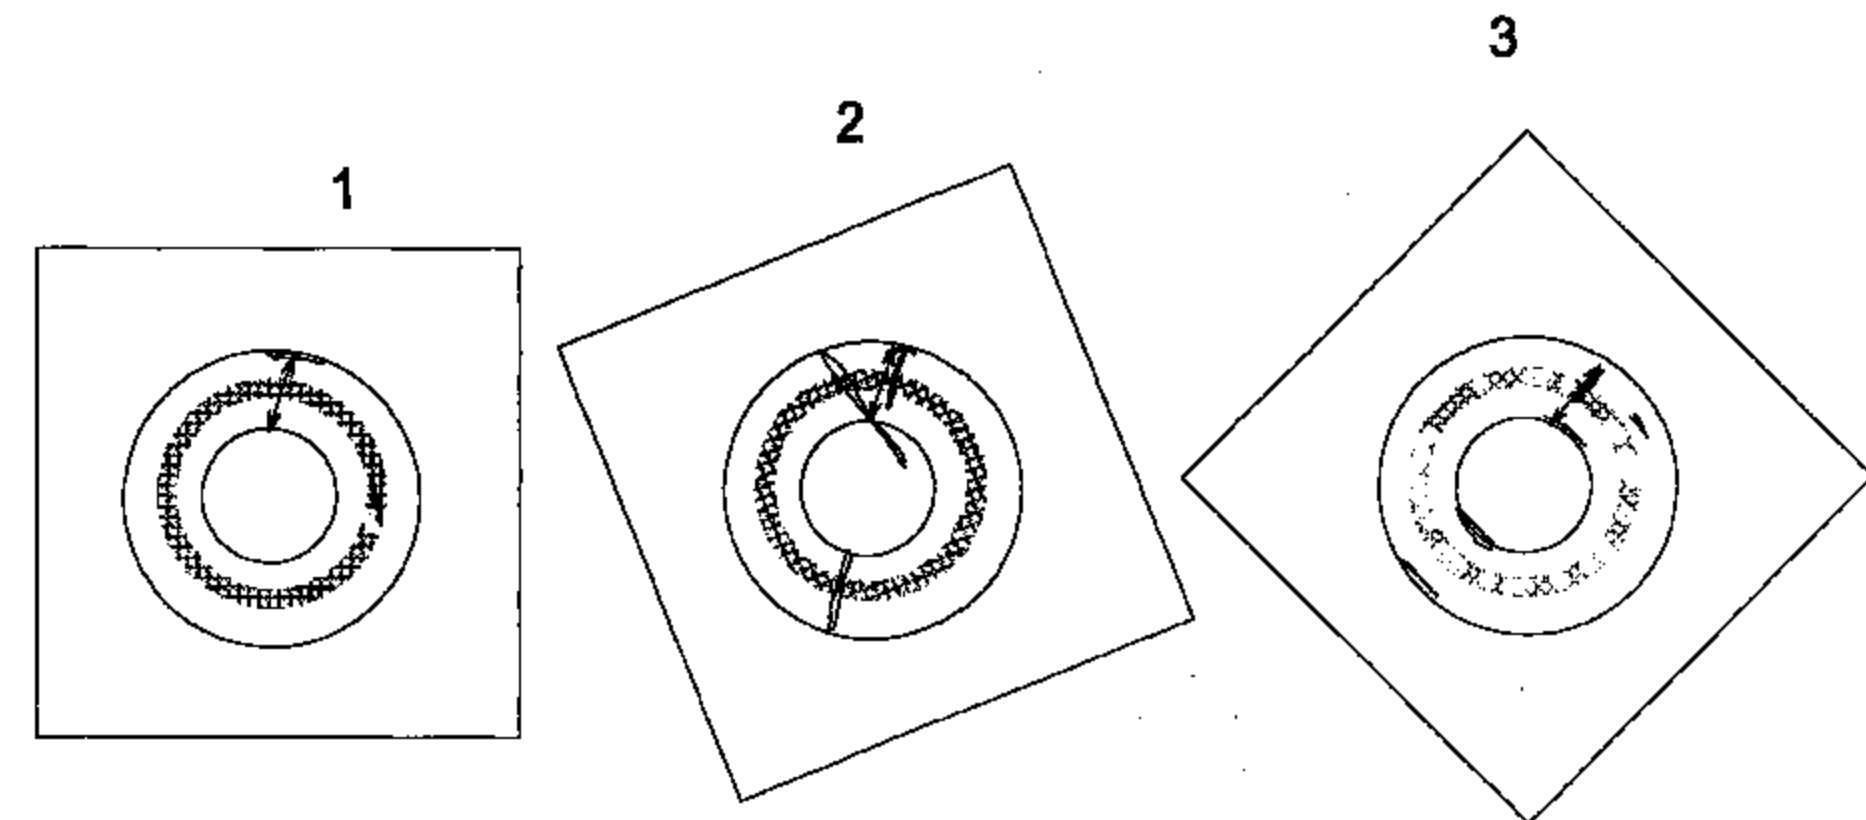
- Figure: 095 -

←→ Indicates buckle in Kapton.

— Indicates crack in Kapton

— Indicates tear in Teflon

--- Indicates area in which Teflon has delaminated from Kapton

#6  
Viewed from  
Hexport Side

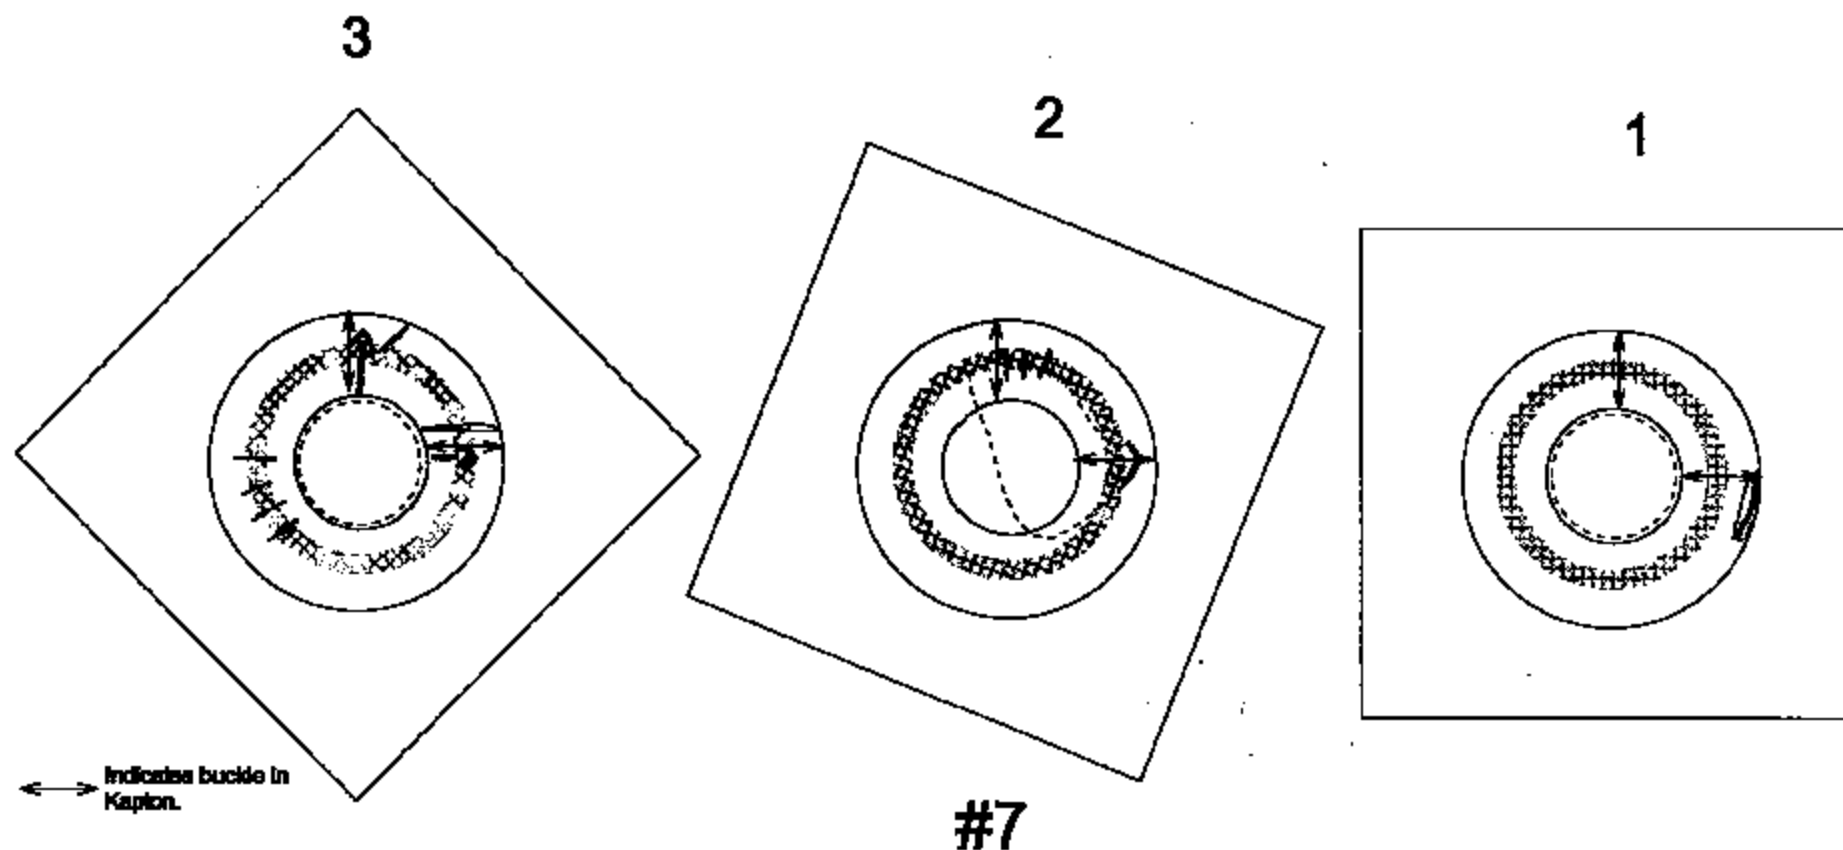
- Figure: 098 -

- ←→ Indicates buckle in Kapton.
- Indicates crack in Kapton
- Indicates tear in Teflon
- Indicates area in which Teflon has delaminated from Kapton

Viewed from  
Converter Side

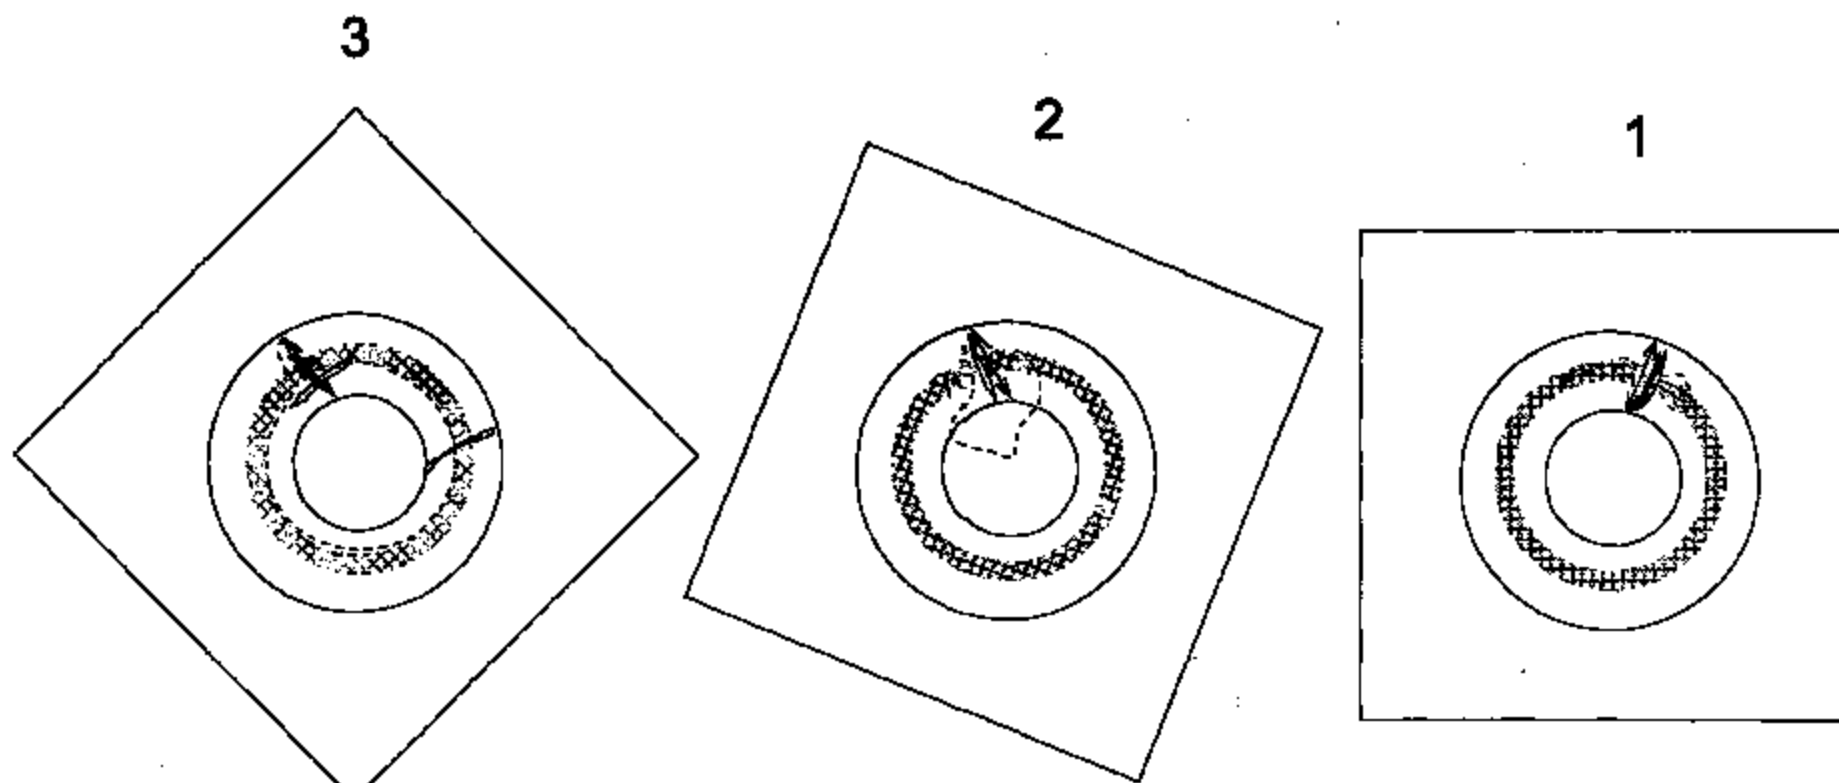
- Figure: 100 -

← Indicates buckle in Kapton.

— Indicates crack in Kapton.

— Indicates tear in Teflon

○ Indicates area in which Teflon has delaminated from Kapton

#8

Viewed from  
Converter Side

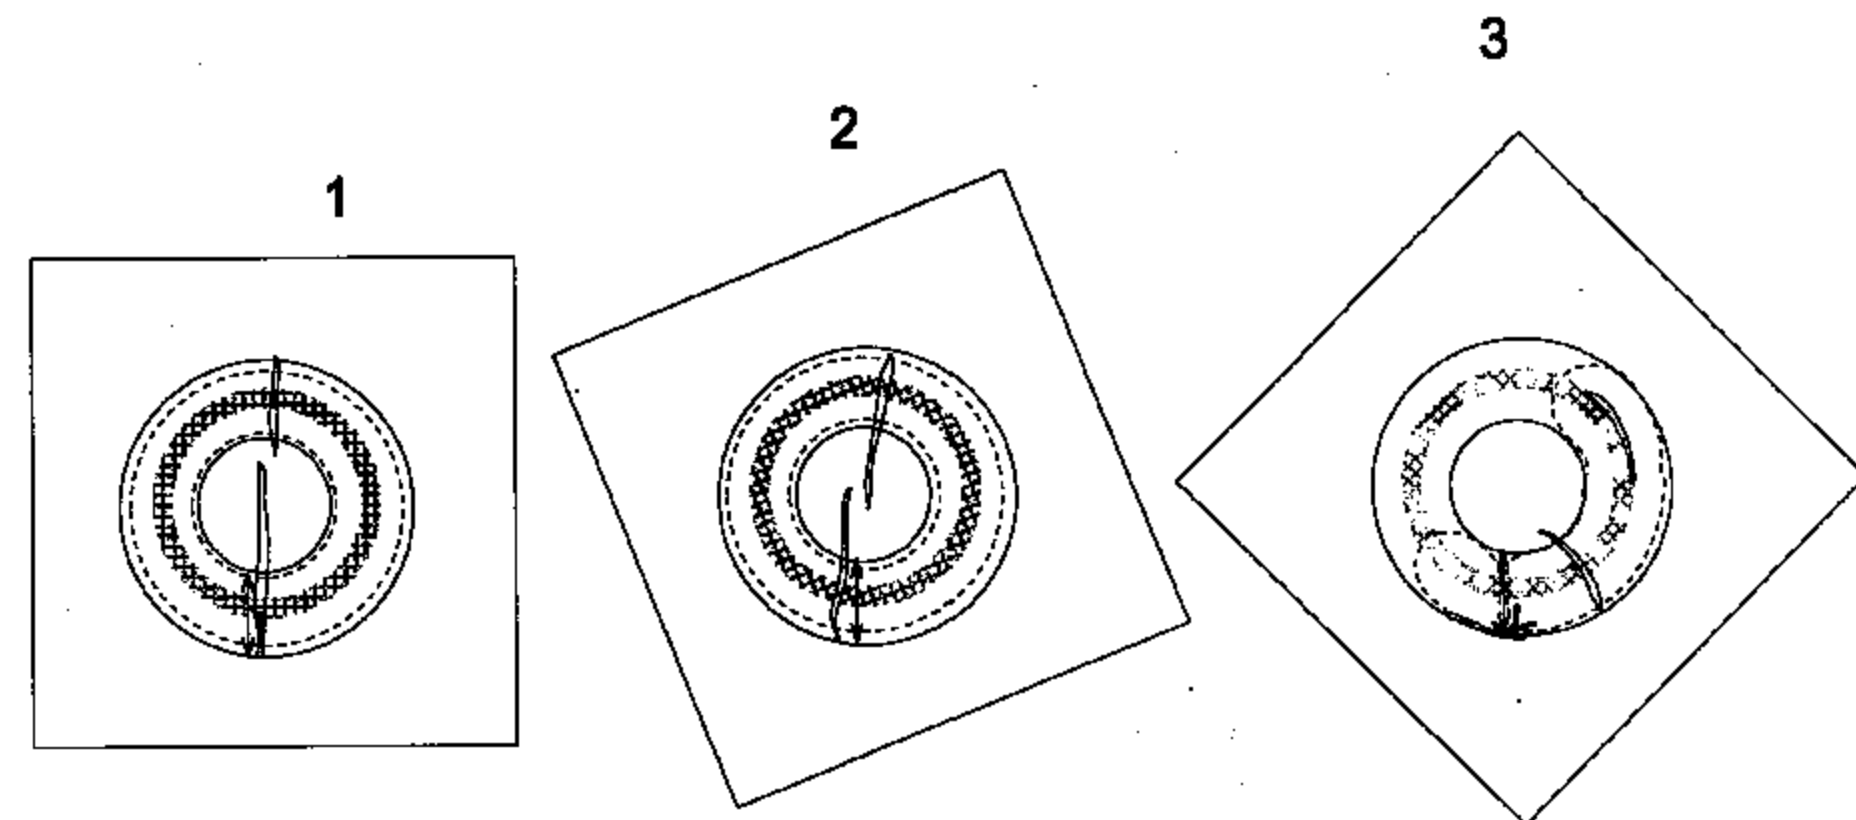
- Figure: 105 -

- ←→ Indicates buckle in Kapton.
- Indicates crack in Kapton
- Indicates tear in Teflon
- Indicates area in which Teflon has delaminated from Kapton

#11  
Viewed from  
Hexport Side
