EA02-025

APPENDIX N

NHTSA Inquiry PE98-055 Kickoff Meeting
Subject Vehicles: All 1992 and 1993 Lincoln Town Car vehicles

Alleged Defect: all under hood fires, or other thermal anomalies, from any source or origin, of any description, level degree, or magnitude, occurring in the left, or drivers side, of the engine compartment. This would include fires in the area of the left front wheel, or left front fender

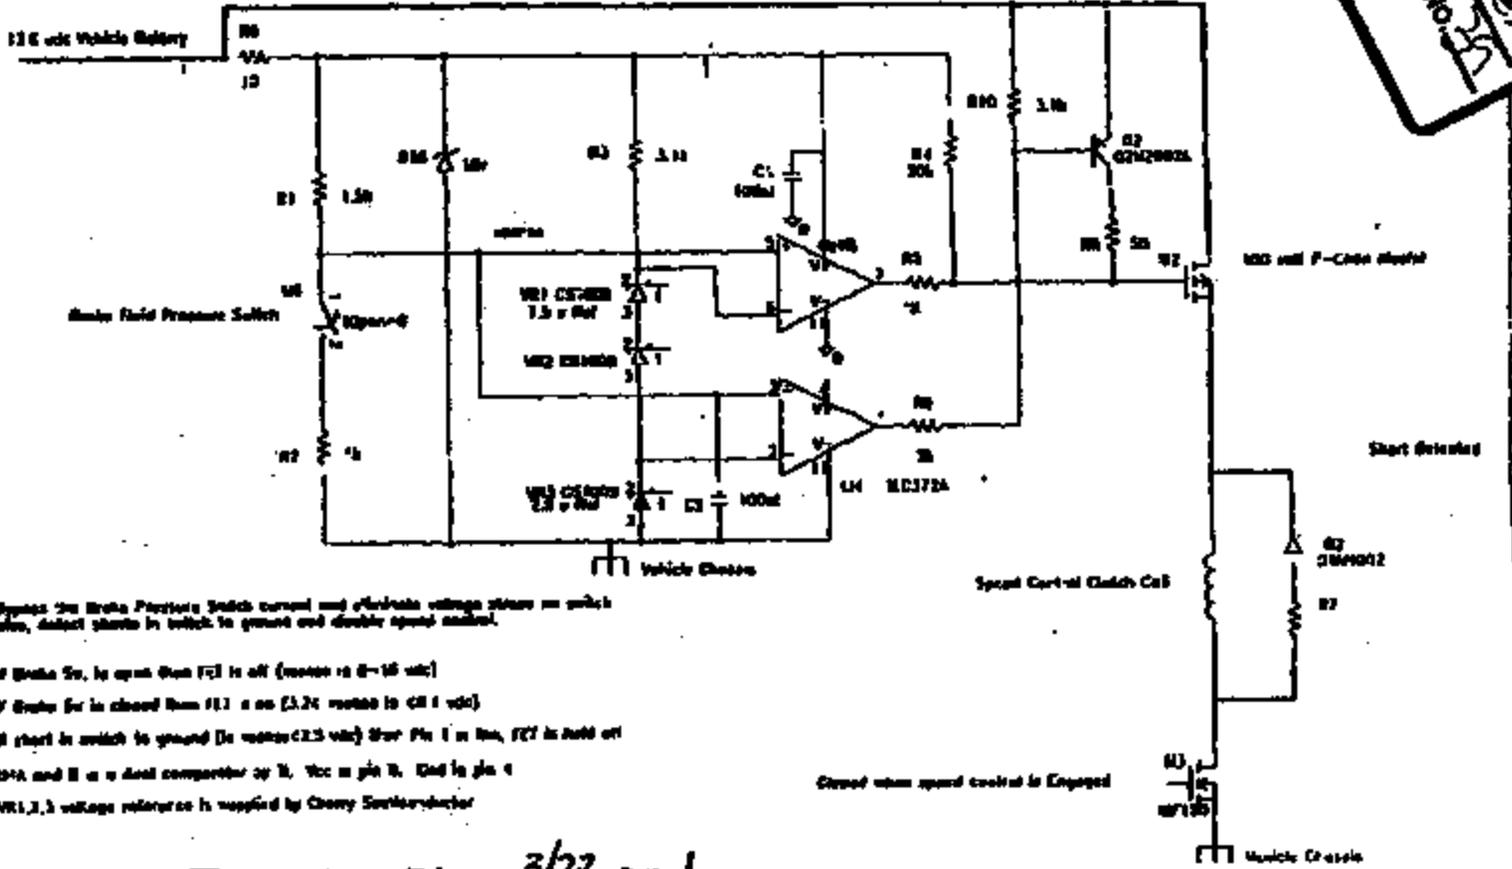
By-pass the Brake Pressure Switch current and reference voltage sense on switch when, defect shows in switch to ground and double speed control.

- A Brake Sw. is open than FC1 is off (resistor is 0-10 vdc)
- F Brake Sw. is closed than FC1 is on (1.2v voltage to CH1 vdc)
- If short in switch to ground (is resistor 2.5 vdc) than Pin 1 is low, FC1 is hold off
- U1A and U1B is a dual comparator of U1. Vcc is pin 8. Gnd is pin 4
- U1A, U1B voltage reference is supplied by Chevy Semiconductor

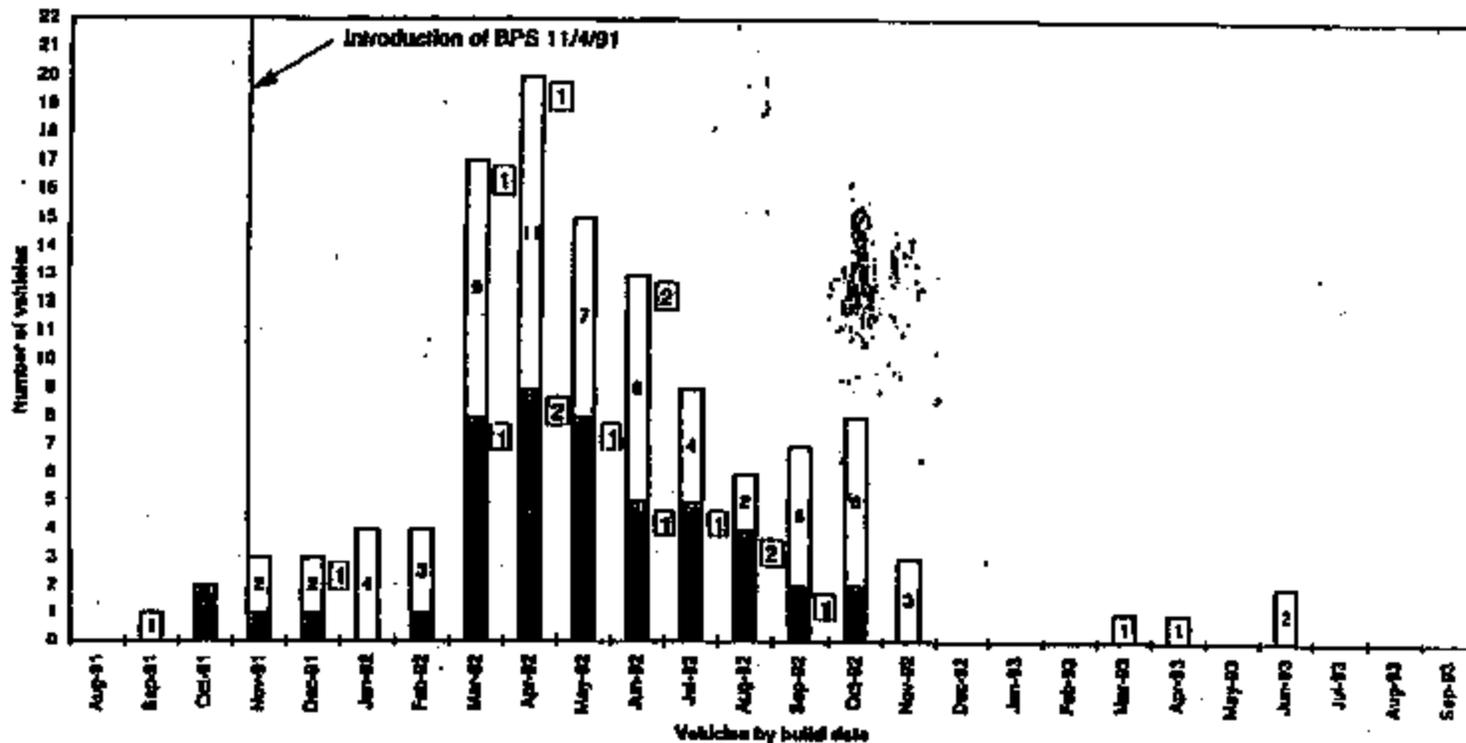
Parade of 92/93 Town Car Underhood Fire Allegations With Engine On/Off/Unknown

There were 11 vehicles in the unknown category, 3 engine off/unknown, [1] relates to a BPS symptom, 8 engine on.

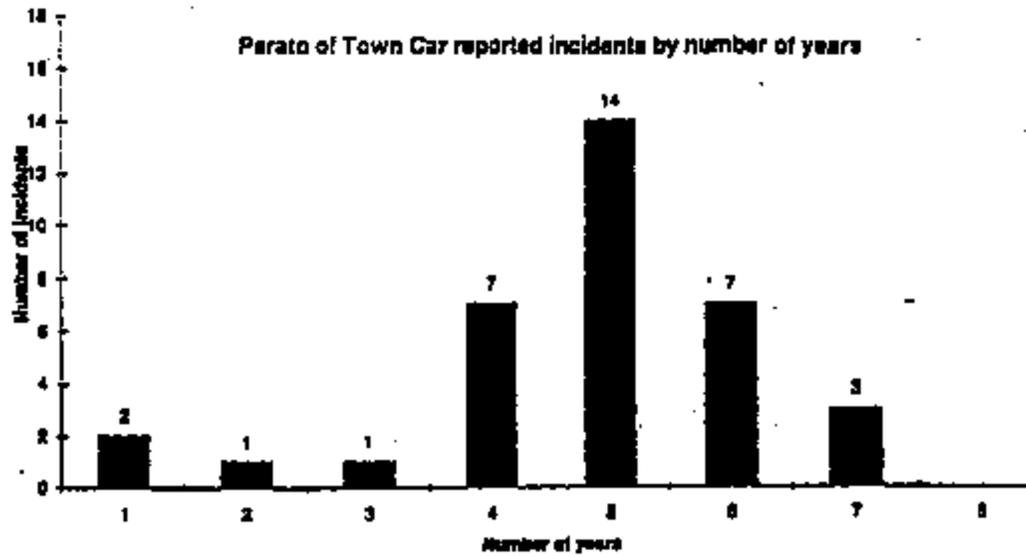
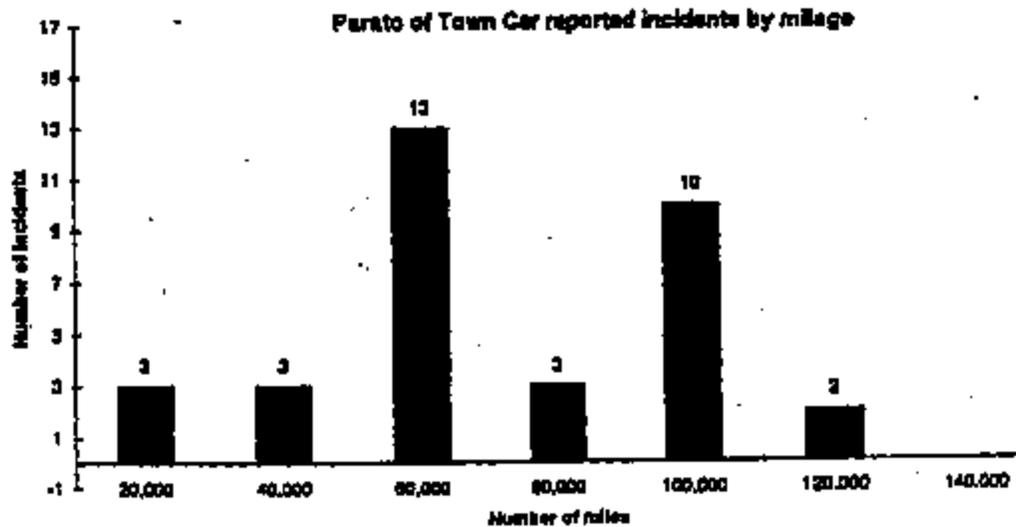
82 Lincoln Town Car Reported Incidents Of 40 Vehicles with Engine Off/Unknown

There were 5 vehicles with unknown vins, therefore, years in service were undetermined.
 There were 8 vehicles with unknown miles.

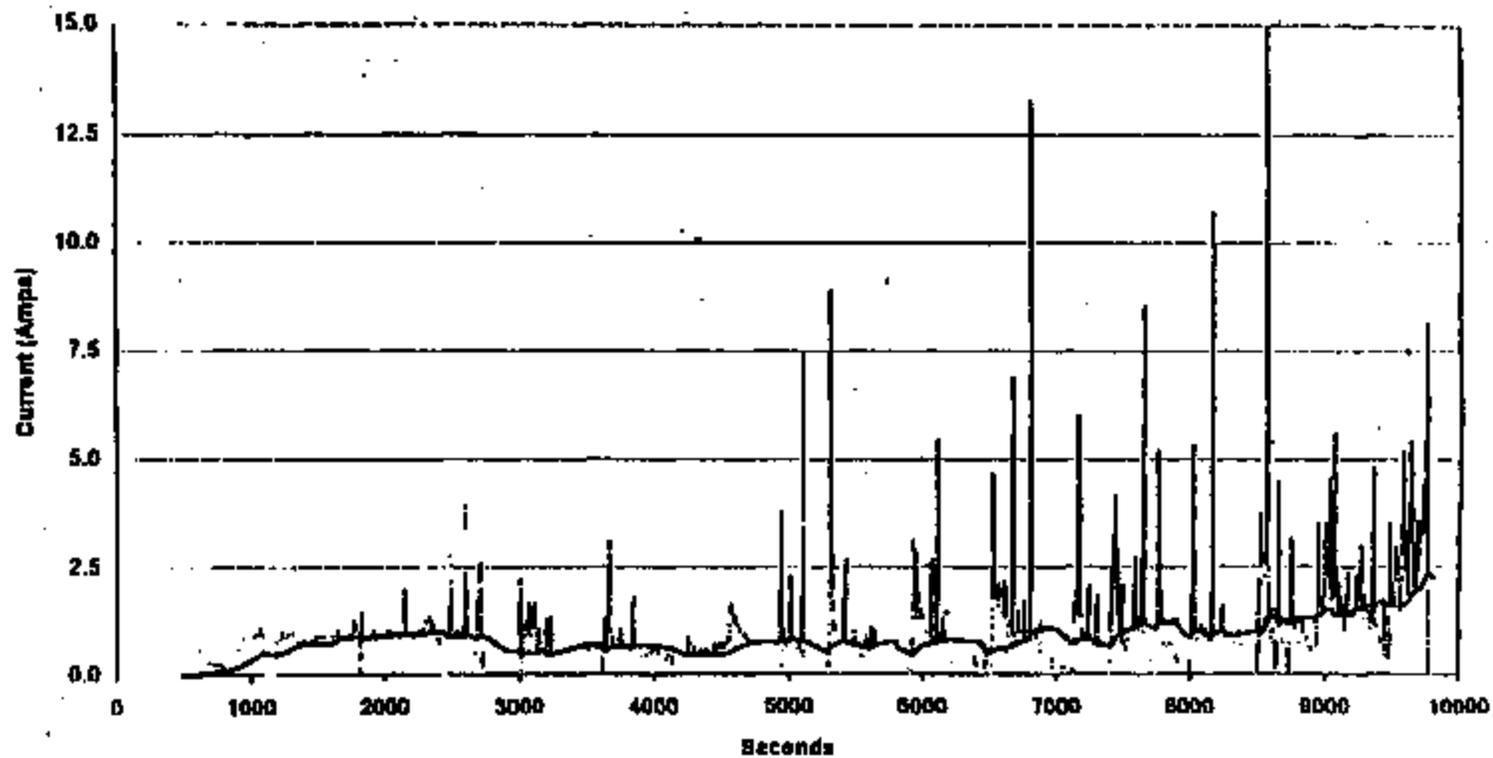
Hexport Current vs. Time Fluid Ingress Experiment

Conclusion: 0.75 Watts, the maximum power in the proposed circuit design, is not enough power to cause switch terminal heating sufficient for ignition. In previous tests, using a resistor as the heating element, approximately 5 Watts of power was necessary to create an ignition. There is not enough power in the proposed circuit to create ignition.
