**EA02-025**

**APPENDIX N**

# RECALL

**SUBJECT:** Safety Recall 99S15: Certain 1992 and 1993 Crown Victoria, Grand Marquis, and Lincoln Town Cars with Speed Control - Speed Control Deactivation Switch

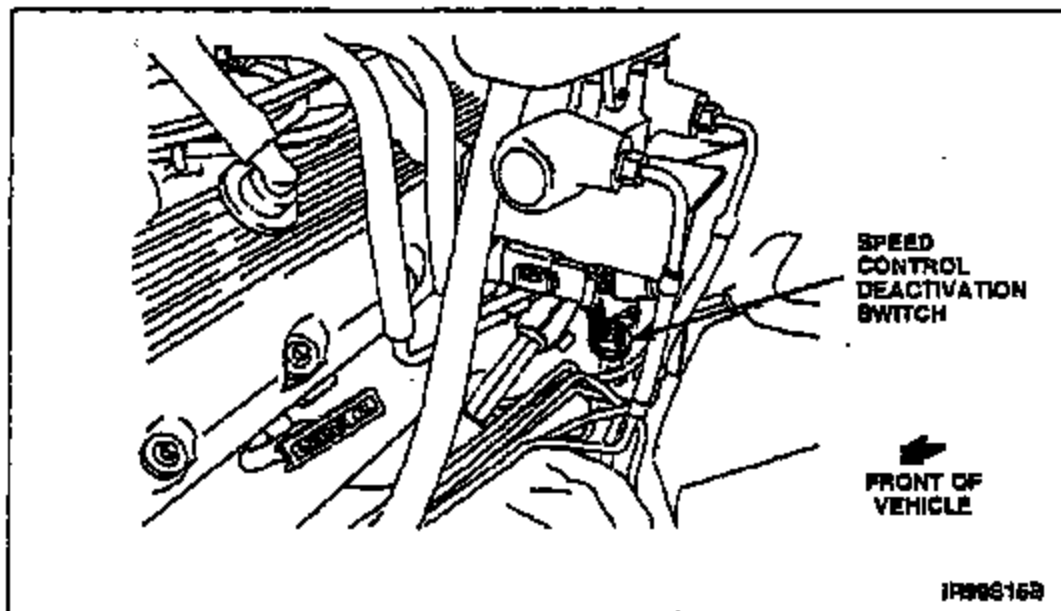
**FIGURE 2**

1. Install a memory saver and disconnect the negative battery terminal.
2. Disconnect the electrical connector from the speed control deactivation switch. See Figure 2.

This repair involves replacement of the speed control deactivation switch and the hard shell of the switch electrical connector. The connector terminals will be removed from the old connector hard shell and inserted into the new connector hard shell.

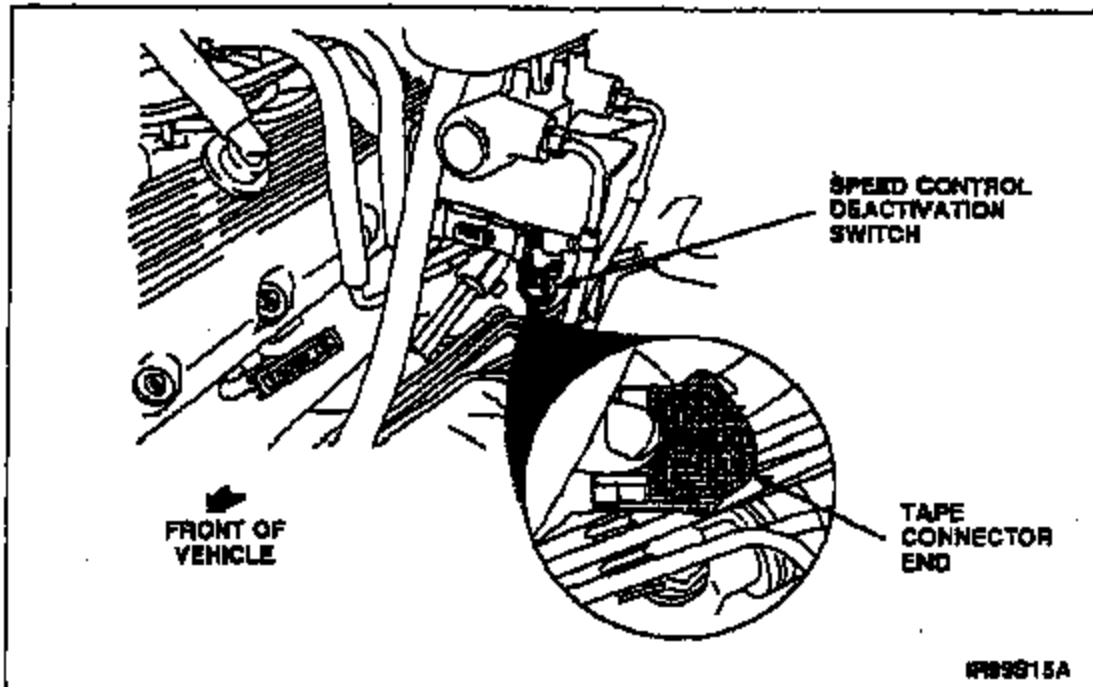
FIGURE 1

1. Disconnect the electrical connector from the speed control deactivation switch. See Figure 1.

2. Tape the end of the connector to prevent contamination from entering the end of the connector.
3. Tie strap the connector to the wiring harness located on the left splash shield.

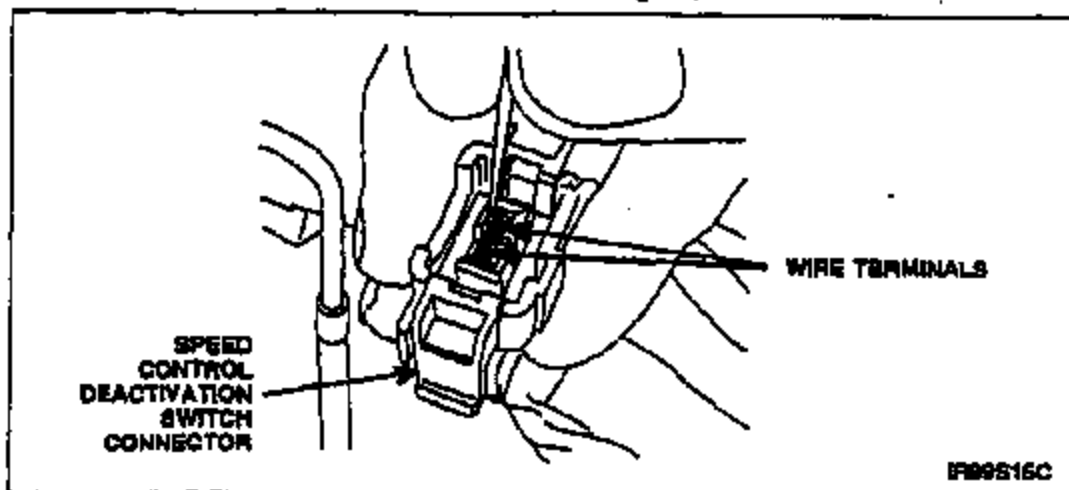
FIGURE 3

3. Remove the locking wedge from the end of the connector. Then, disengage the locking tabs and remove the wire terminals from the connector. See Figure 3.

4. Obtain the new connector from the kit. Insert both wire terminal ends through the connector seal and into the connector hard shell. (The wire terminal ends may be installed into either of the connector cavities).

5. Check the connector to make sure the locking tabs have engaged both terminal ends. Also, make sure the seal is fully seated in the back of the connector. Then, install the red locking wedge to secure the terminals in the connector.
