EA02-027

LETTER TO ODI

APPENDIX A

I have a lemon law demand letter at M. Finnin Ford in Dubuque, IA. The concern is for a stalling at about 30 miles per hour with a 2001 Escape. The customer alleges this has happened three times. The dealership has never been able to duplicate but has attempted two repairs. I am unable to send you the file I received from legal on this - too large and my computer just froze when I attempted.

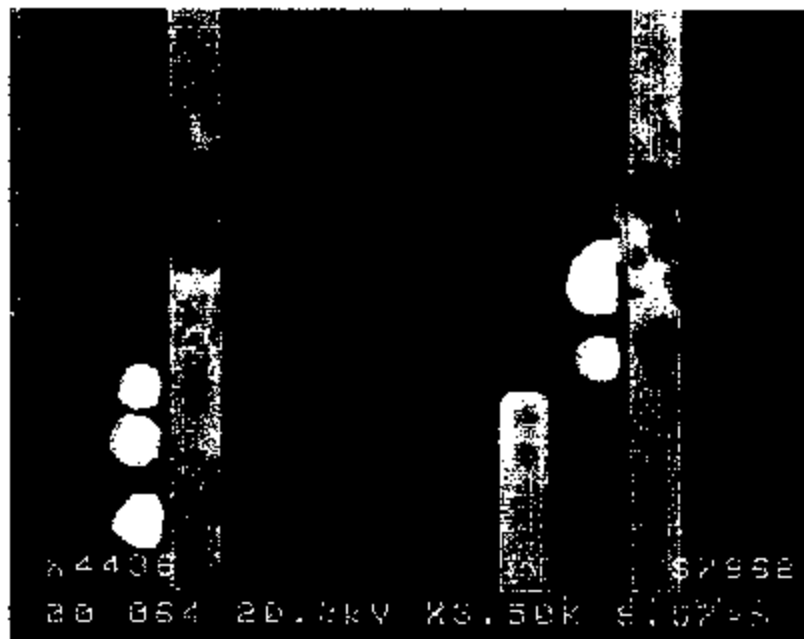
- Aluminum spheres
- Cracking of insulator material (silicon nitride/silicon dioxide)
- Significant voiding of interconnect metal
- Fracturing and lifting of insulator to release metal
- Most often occurs in top level metal

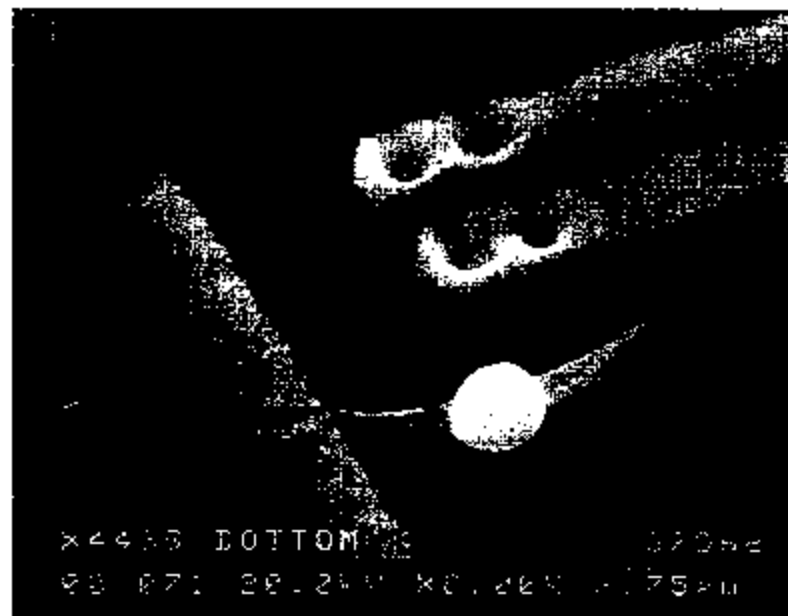
Data: Latent Damage Signatures

- Aluminum spheres
- Cracking of insulator material (silicon nitride/silicon dioxide)
- Significant voiding of interconnect metal
- Fracturing and lifting of insulator to release metal
- Most often occurs in top level metal

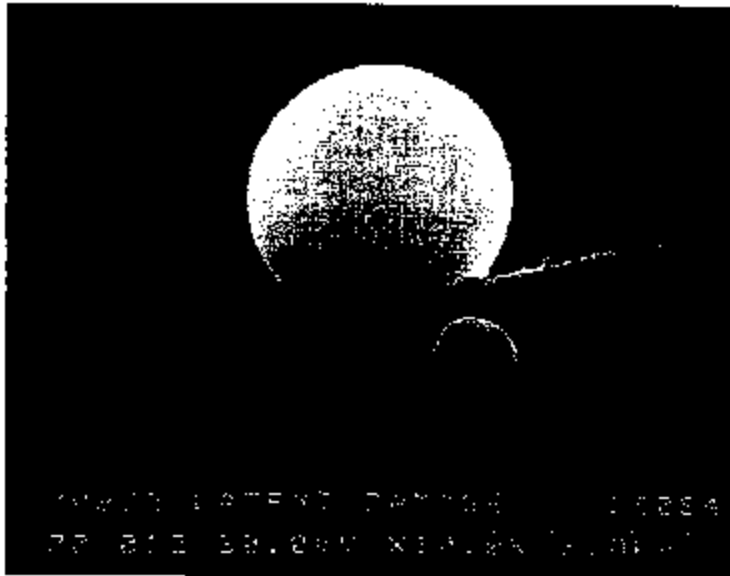
Analysis: A Physical Interpretation

- Critical current density is held long enough to melt interconnect
- Differences in thermal coefficients of expansion of metal and insulator puts mechanical stress on insulator
- Cracking of insulator and eruption of metal occur, often to the point of catastrophic voiding
- As extruded metal cools it forms most efficient spherical shape

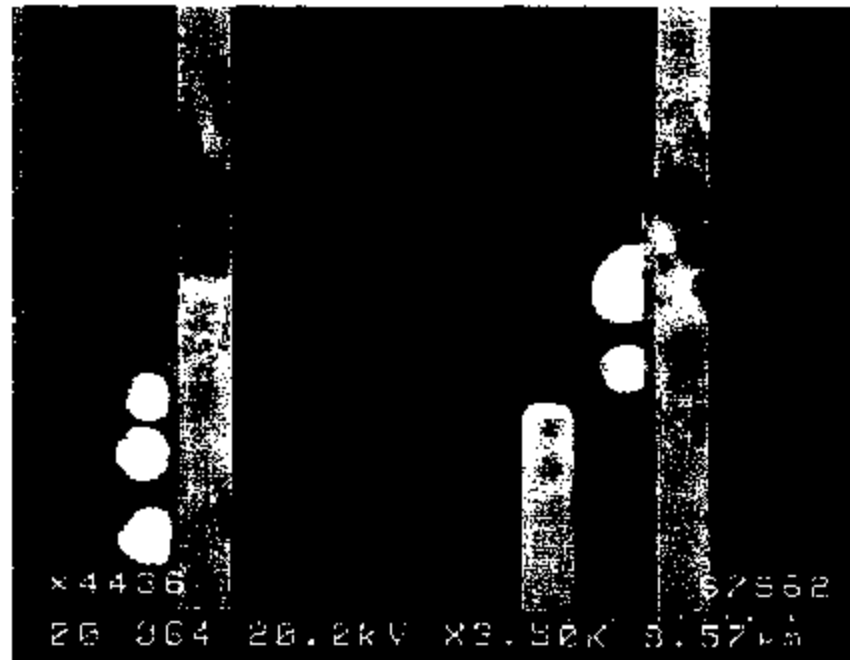
- Aluminum spheres
- Cracking of insulator material (silicon nitride/silicon dioxide)
- Significant voiding of interconnect metal
- Fracturing and lifting of insulator to release metal
- Most often occurs in top level metal

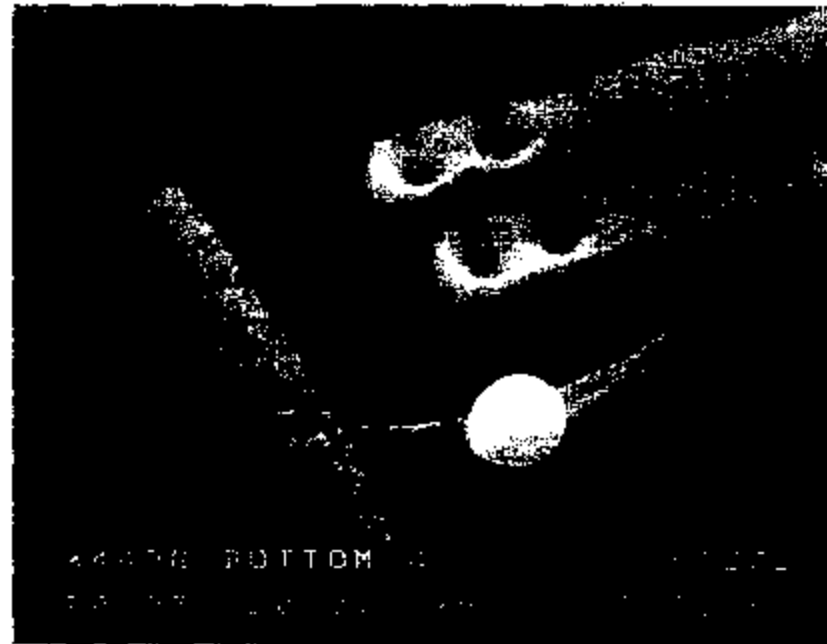
Data: Latent Damage Signatures

- Aluminum spheres
- Cracking of insulator material (silicon nitride/silicon dioxide)
- Significant voiding of interconnect metal
- Fracturing and lifting of insulator to release metal
- Most often occurs in top level metal

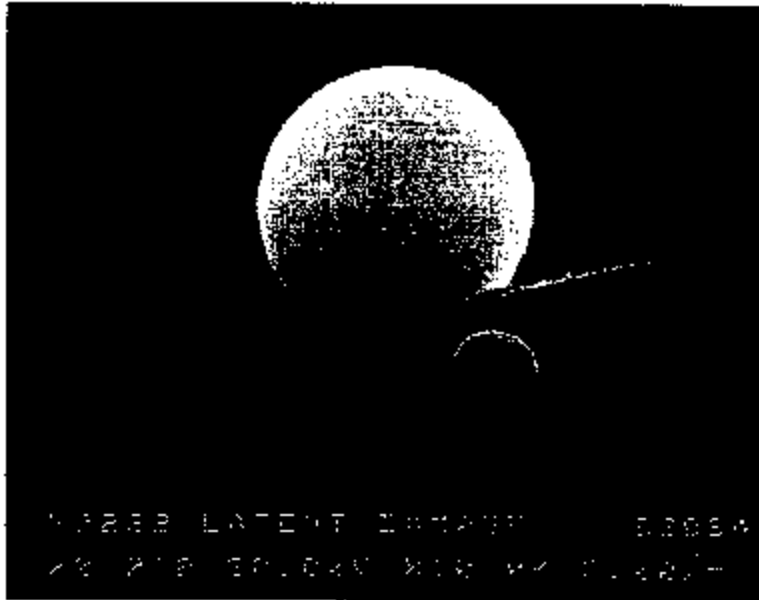
Analysis: A Physical Interpretation

- Critical current density is held long enough to melt interconnect
- Differences in thermal coefficients of expansion of metal and insulator puts mechanical stress on insulator
- Cracking of insulator and eruption of metal occur, often to the point of catastrophic voiding
- As extruded metal cools it forms most efficient spherical shape
