From: Marchlewicz, Carl (C.E.)
Sent: Tuesday, April 02, 2002 10:23 AM
To: Bogema, John (P.); Dalbo, Bob (R.J.); Fournelle, Gilbert (G.); Hurley, Robert (R.E.); Jenkins, Eric (E.J.); Mandziuk, Roger (R.S.); Marchlewicz, Carl (C.E.); Matasa, John (J.); Shanahan, John (J.L.); Smith, Tony (T.R.)
Subject: Today's U204 3.0L 4V 2005 Dyno Status meeting is cancelled for 4/2/02

From: Fournelle, Gilbert (G.)
Sent: Wednesday, May 29, 2002 5:21 PM
To: Khalil, Imran (I.)
Cc: Woodings, Andrew (A.T.)
Subject: Calvin installation

From: Lewis, Dennis (D.J.)
Sent: Thursday, July 11, 2002 2:32 PM
To: Fournelle, Gilbert (G.); 'Mcos@vstec.com'; Lewis, Dennis (D.J.)
Cc: Shelton, Randy (R.); Huck, Dave (D.E.); Dalbo, Bob (R.J.)
Subject: RE: X5_dcv4 and yet another request

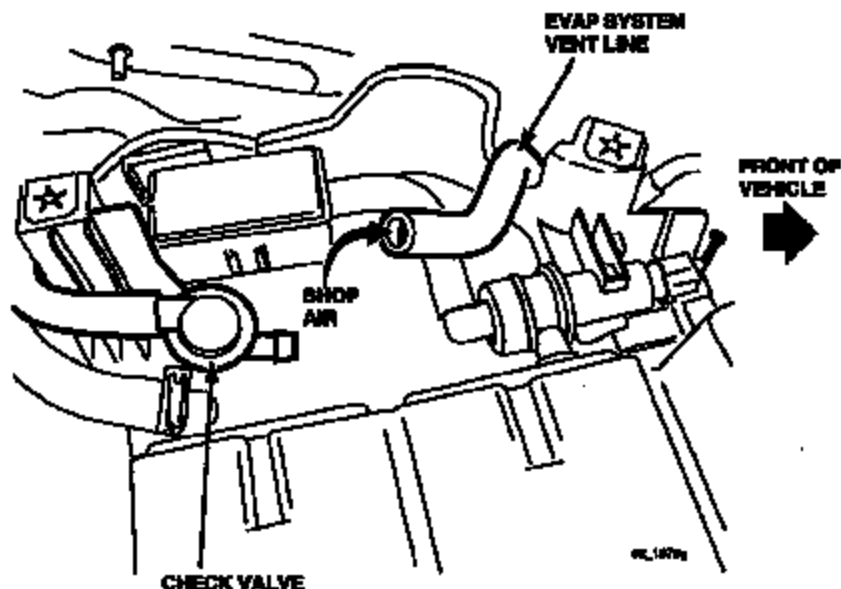
CANISTER ASSEMBLY WITH BRACKET REMOVED
(VIEW FROM UNDERNEATH VEHICLE)

- b. Using shop air, blow the vent line from the check valve side forward (towards the brake booster). In the past, spiders have been known to construct webs in vent lines, so handle with caution. Possible obstructions in the vent line can prevent the evaporative emissions system from purging properly, and in some cases, can cause the condition to occur.
- a. Verify corrective action, then proceed to Step 3.

- a. Disconnect the vent line in the evaporative emissions system from the check valve side. This connection is located just forward of the evaporative emissions canister assembly, underneath the vehicle in the area of the driver side rear seat.
