GENERAL MOTORS NORTH AMERICA
Structure & Safety Integration

This letter is General Motors (GM) response to your information request (IR), dated January 22, 2003, regarding alleged lockup of the steering column in 1997-2001 model year (MY) Chevrolet Corvette vehicles.

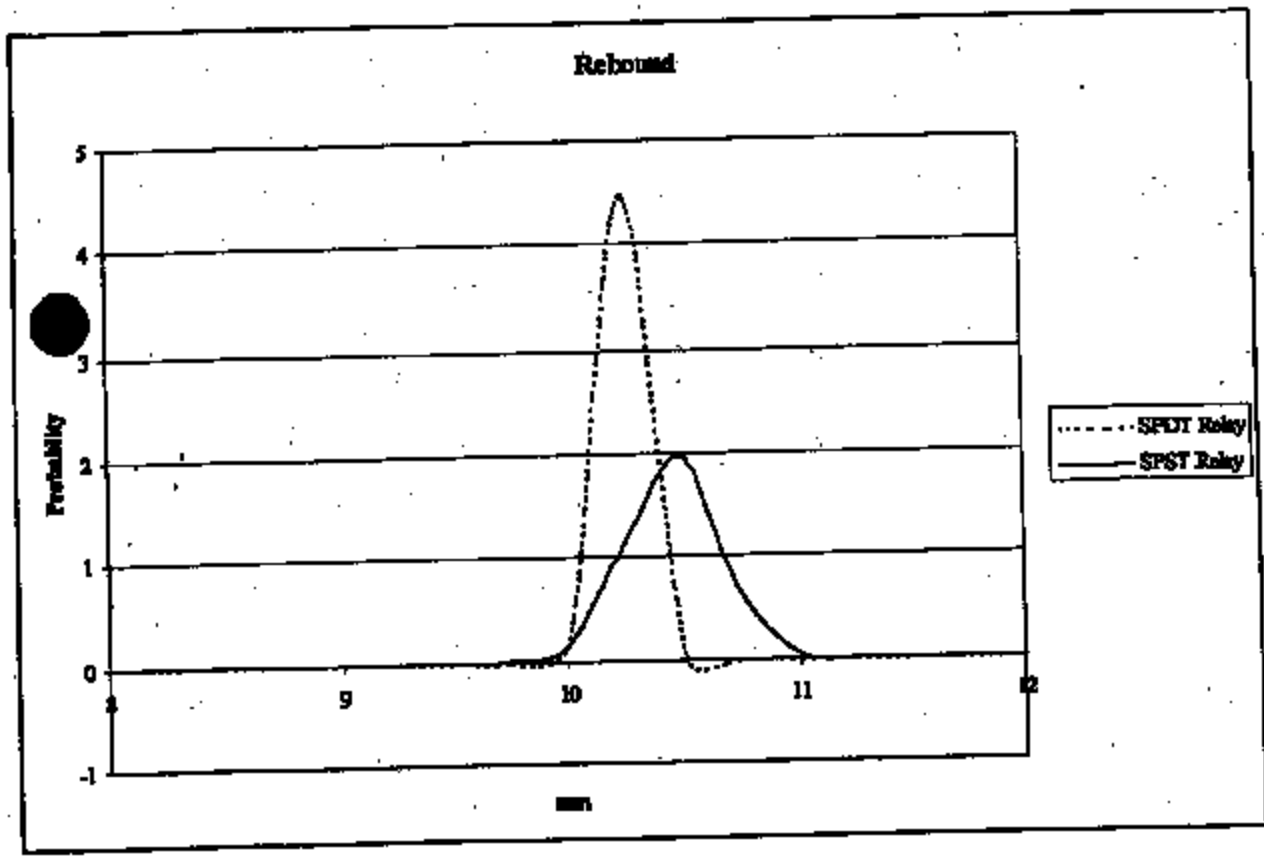
To: David R. Lach@US_GM_WRN_MTC01
cc:
Subject: ECL SPDT vs SPST

Attached is a curve taken from 6 pc SPDT and 6 pc SPST. 3 trials each sample. Note that the Standard Deviation of the SPDT is smaller and the mean is also smaller...
Call with any questions.
