Subject: FINAL MEMORANDUM REPORT – VRTC-DCD2042
“A Determination of Throttle Performance Degradation
on Certain 1999-2002 GM Pickup Trucks (EA02-015)”

A Determination of Throttle Performance Degradation on Certain 1999-2002 GM Pickup Trucks

VRTC-DCD2042 (EA02-015)

Throttle Control Sticking on Certain 1999-2002 GM Pickups and SUVs

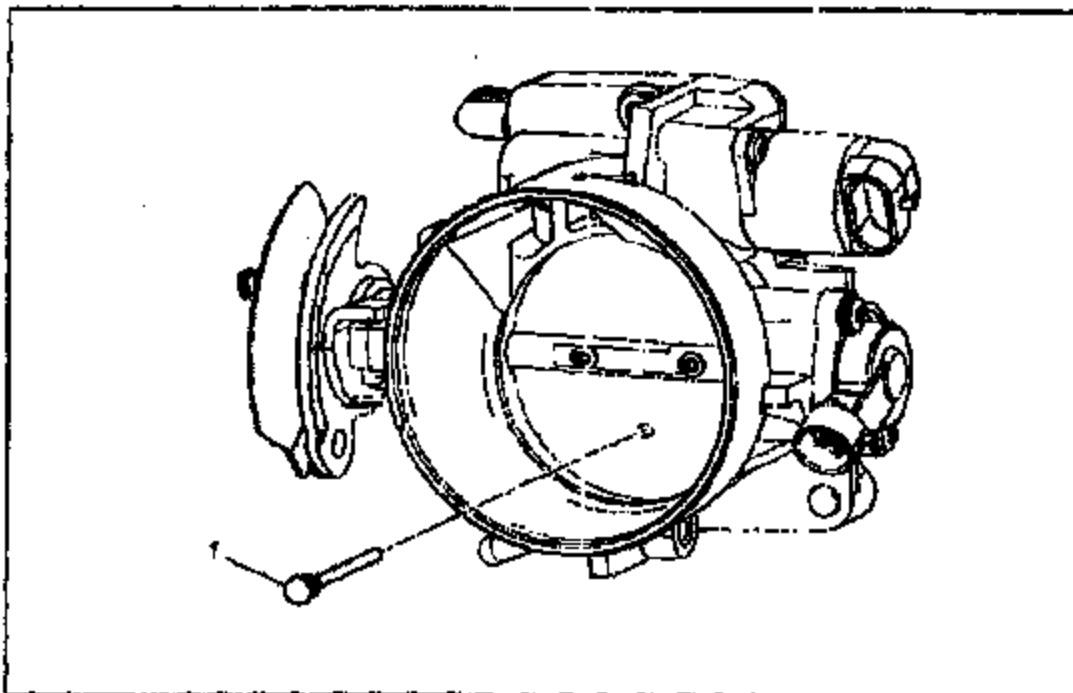
Condition may be caused by deposits in the throttle body bore and on the throttle plate.

8. Insert the appropriate plug (1) into the air bypass hole in the throttle plate. Insert the "tail" end of the plug through the throttle plate air bypass hole.
