Memorandum Report

Hood Safety Catches on 1997 Jeep Grand Cherokees

December 2004

VRTC-DCD3050 (EA02-029)
Hood Latch on 1997 Jeep Grand Cherokee

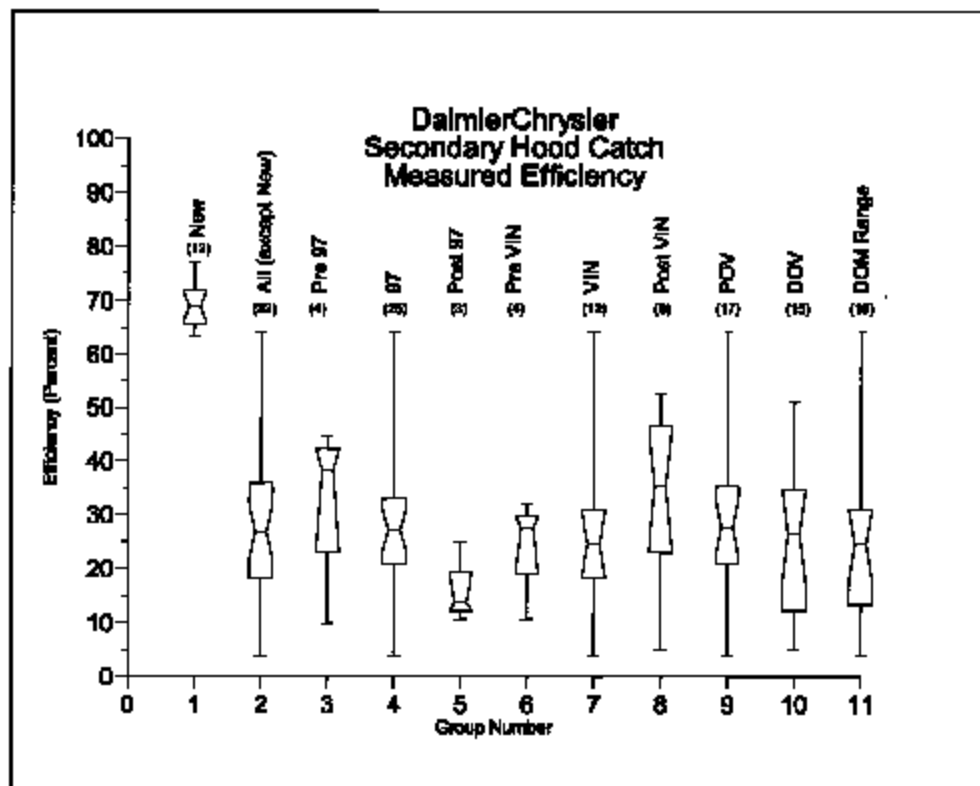
Figure 8- Bench Test Results.

An examination of the information contained in Figure 8 quickly reveals that the catch efficiency of only Group 1 can be readily judged, with 95 % statistical probability, to be different and distinct from the catch efficiencies all of the other groups.

The information contained in Figure 8 suggests that all of the subject vehicle groups depicted (POV, DOV, MY 1996, MY 1997, MY 1998, DOM range, and VIN serial range) exhibit the "stickiness" problem. It is likely, therefore, that the "stickiness" problem is caused by the design of this type catch, and not by an intermittent process or assembly control problem.

The mean efficiency of the 12 new service replacement safety catches was 69.0% with a standard deviation of 4.2%. The mean efficiency of the 32 subject vehicle safety catches was 27.8% with a standard deviation of 14.5%. This result suggests that the subject catches have deteriorated and no longer operate as smoothly and efficiently as the new replacements.

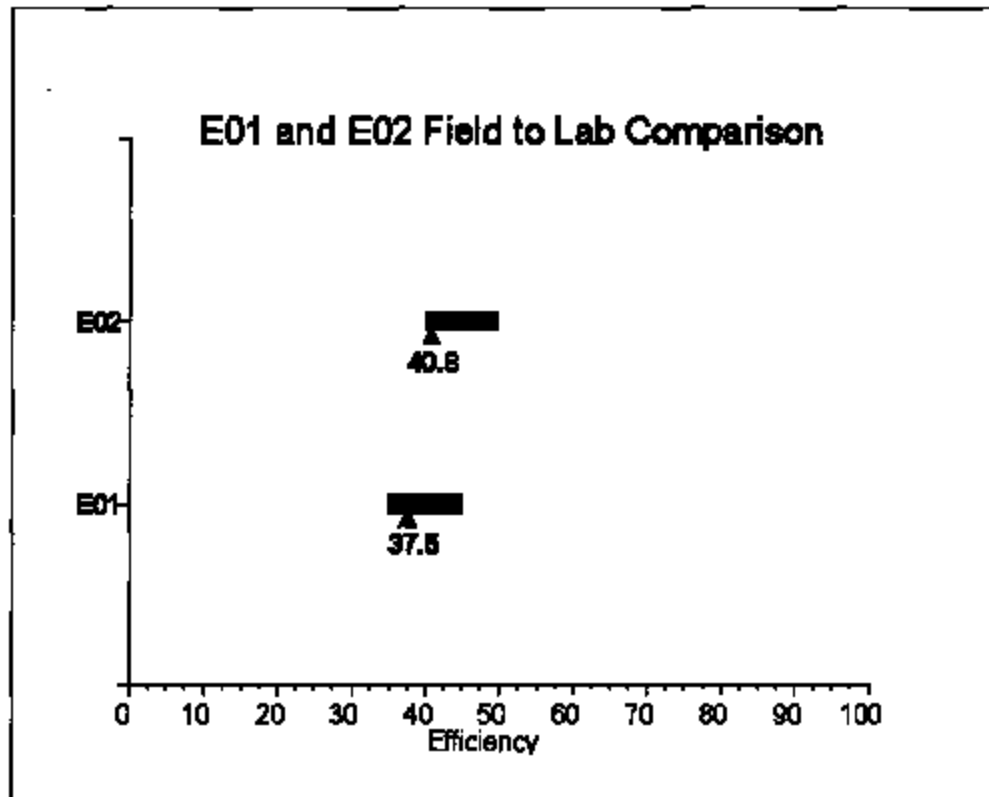
Figure 10- Field Efficiency Estimates Compared to Bench Test Result

An examination of Figure 10 reveals the authors' estimates (blue bars) were very close to the bench test results noted below the bars. This validation indicates that the field estimates may be considered reliable enough for peer vehicle comparisons.

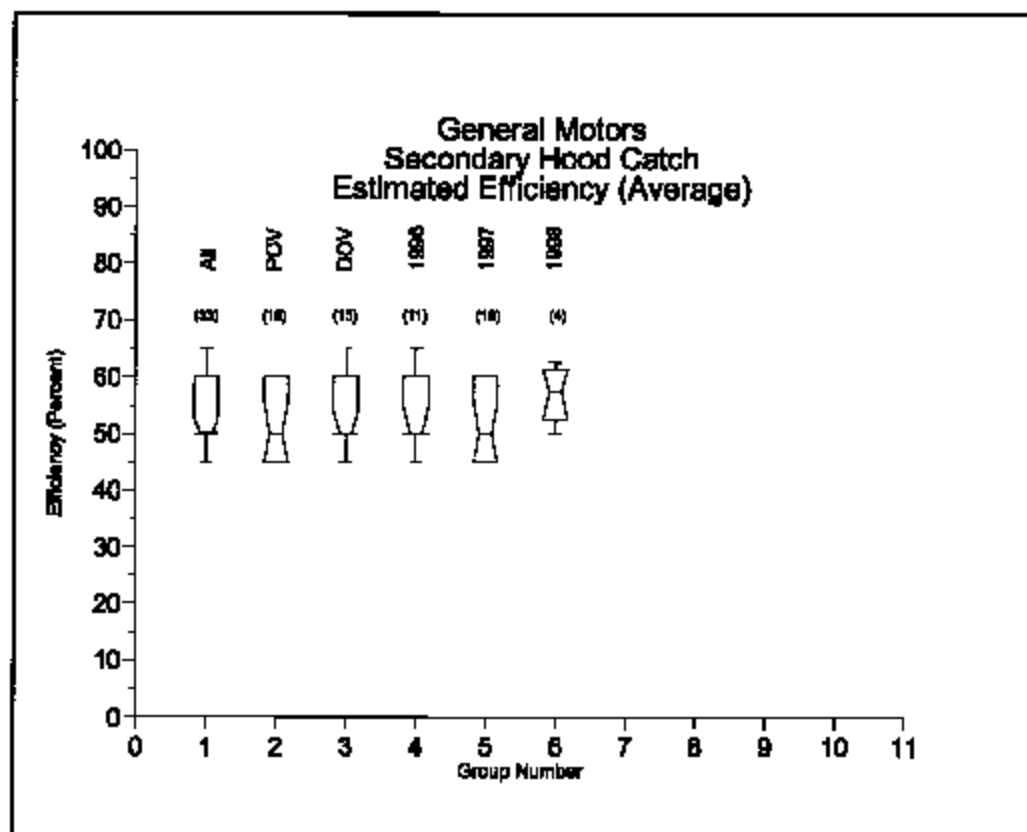
Figure 11 - Estimated Efficiencies of Peer Vehicle Safety Catches

An examination of the information contained in Figure 11 quickly reveals that the catch efficiency of none of the groups can be judged, with 95 % statistical probability, to be different and distinct from the catch efficiency of any other group.

All of the peer vehicle safety catches returned smoothly and forcefully to the closed position. The mean of the estimated efficiencies of the 32 peer vehicle safety catches was approximately 54 %.
