ODI RESUME

Investigation: EA 03-004
 Prompted By: PE02-085
 Date Opened: 04/10/2003 Date Closed: 08/30/2004
 Principal Investigator: Chris Lash
 Subject: Wheel Stud Fracture

Manufacturer: Ford Motor Company
 Products: MY 1997-2000 Windstar
 Population: 811,429

ENGINEERING ANALYSIS CLOSING REPORT

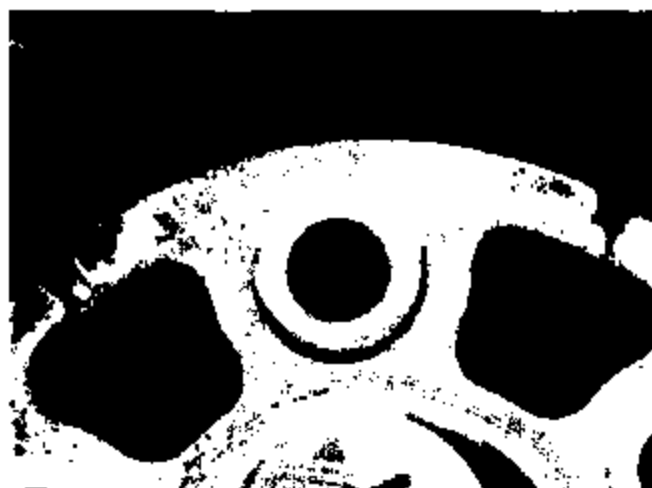
Figure 7. MY99 alloy wheel rear surface (interface with brake rotor surface).
