U.S. Department  
of Transportation  
**National Highway  
Traffic Safety  
Administration**

## ODI RESUME

Investigation: RQ 03-008  
 Prompted By: IE-03-053  
 Date Opened: 10/23/2003 Date Closed: 03/05/2004  
 Principal Investigator: Cheryl Tuosto  
 Subject: Brake Light Switch Failure

**RQ03-008 CLOSING REPORT**

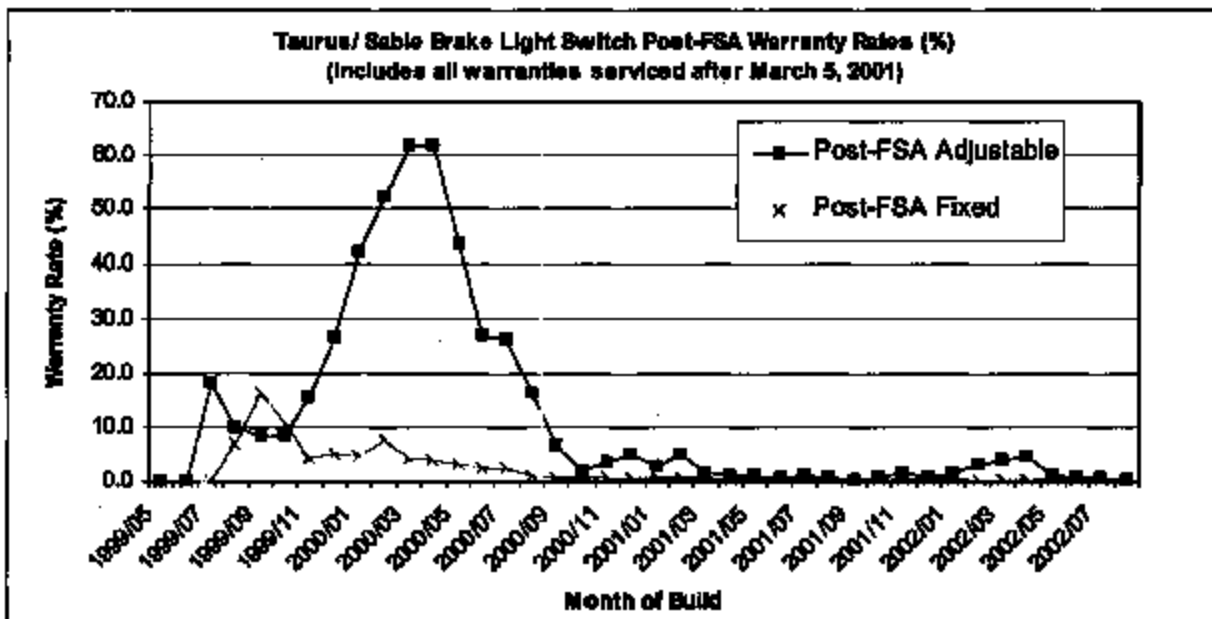
**ODI'S ANALYSIS:** As shown in Figure 1 below, the Post-Recall warranty rates, those calculated from warranty claims serviced after Recall 01V-078 was implemented (March 5, 2001), for 2000 MY vehicles with adjustable and fixed brake pedals were high.

The analysis also showed that the warranty rates for 2001 and 2002 MY vehicles with adjustable pedals were higher than expected.
