Subject: FINAL MEMORANDUM REPORT - VRTC-DCD4069
"Evaluation of Front Suspension Coil Spring Failure in Certain
MY 1999 Pontiac Grand Am and Chevrolet Malibu Vehicles
(EA03-021)" **Date:** JAN 20 2005

VRTC FIELD REPORT

Inspection of a 1999 Pontiac Grand Am

VRTC-DCD4089 (EA03-021)
(Front Suspension Coil Spring Fracture)

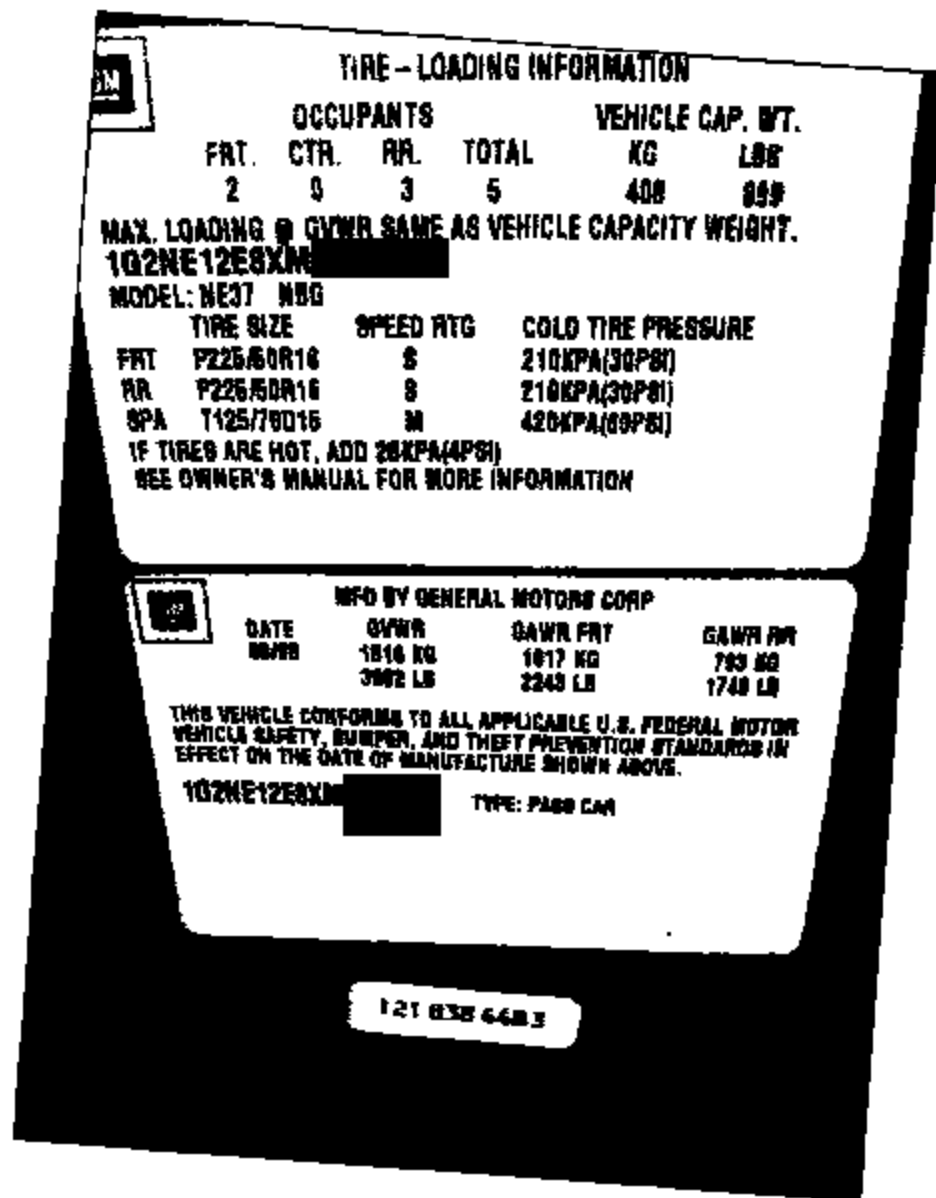
Figure 2 is a photograph of the FMVSS label of the subject vehicle. Clearly visible in this view are the vehicle identification number and the date of manufacture.

Figure 2 - FMVSS Door Label on the Subject Vehicle

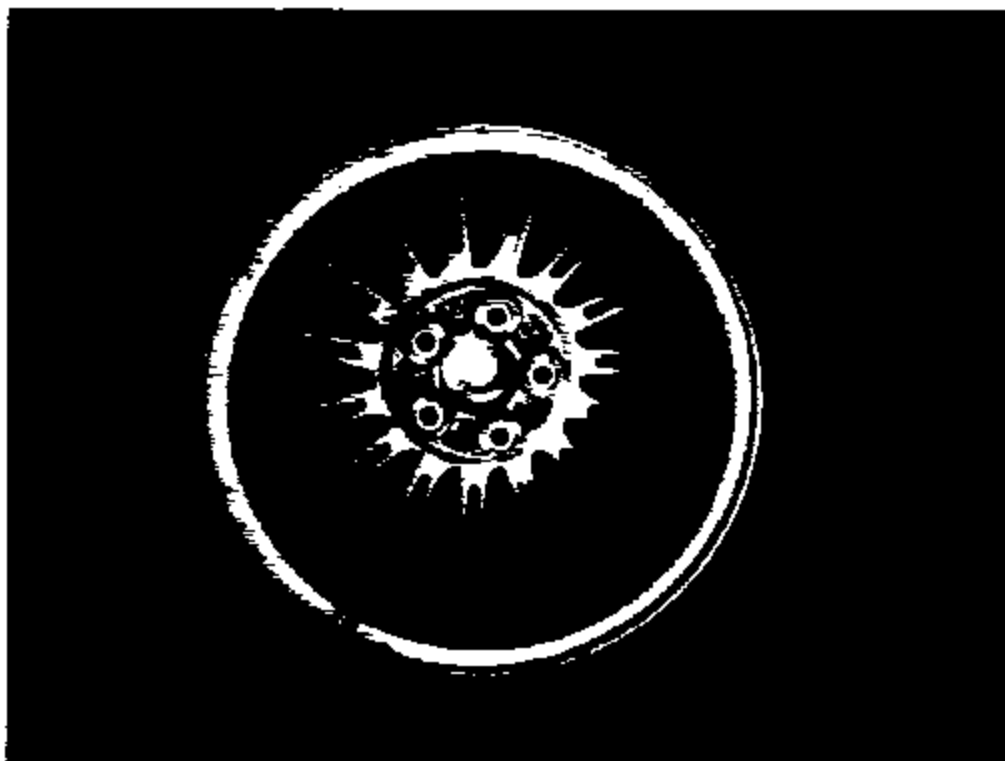
Figure 4 - Right Front Wheel of the Subject Vehicle

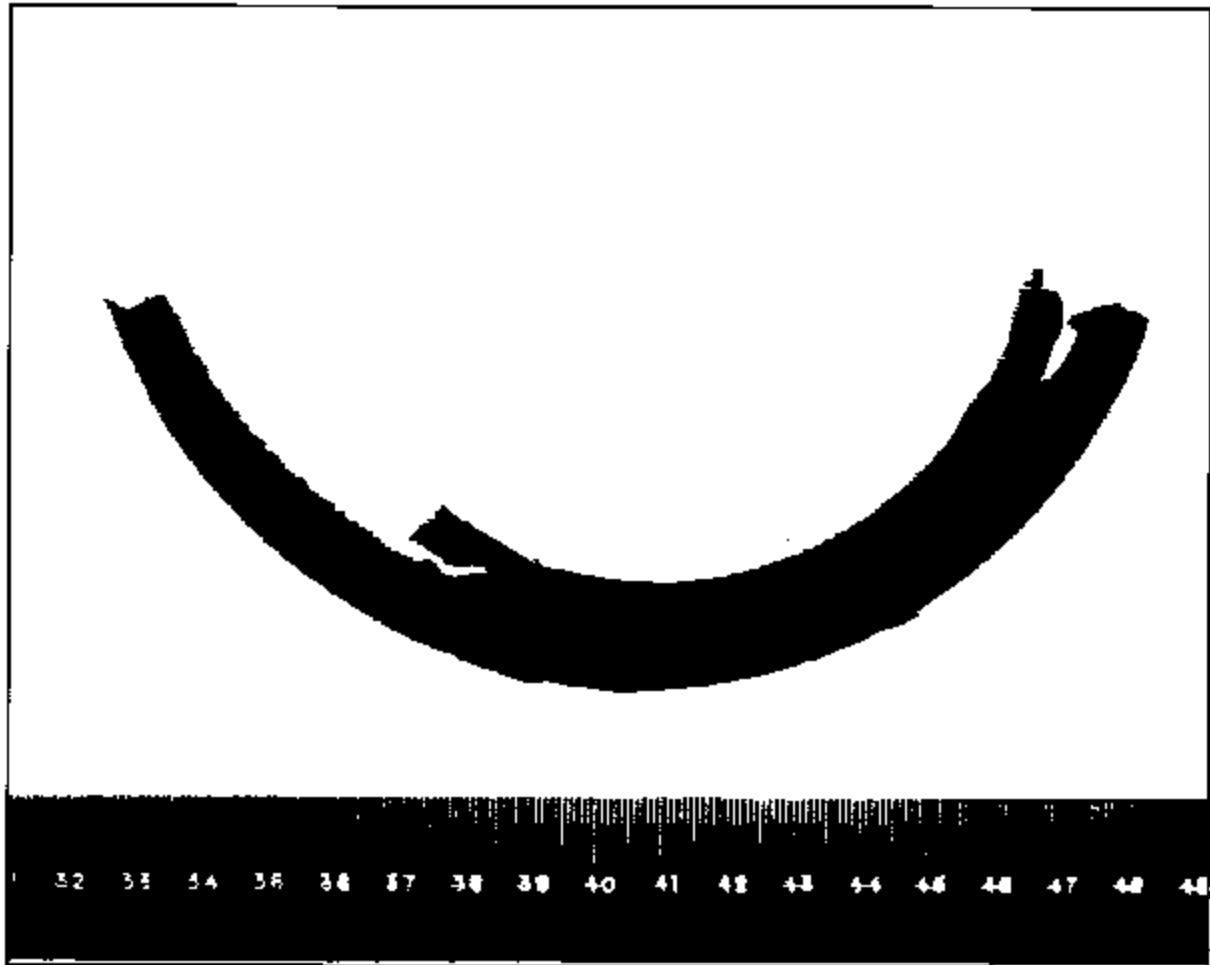
The owner gave the authors a piece of a broken coil spring that was allegedly found on the roadway behind the vehicle after the incident. Figure 5 is a photograph of this piece of the broken coil spring.

Figure 5 - Piece of Broken Spring Recovered From the Scene of the Incident

It is the opinion of the authors that the right-front suspension coil spring did indeed break in an unusual manner, and probably caused part of the broken spring to

contact the right-front tire. The tire was probably pierced by the broken spring, causing it to deflate rapidly. The combination of the broken spring and deflated tire caused the right-front of the vehicle to contact the roadway surface, which rendered the vehicle inoperative.
