## ENGINEERING ANALYSIS CLOSING REPORT

**EA No:** EA03-024

**Subject:** Alleged braking system failure or malfunction of certain model year (MY) 2002-2003 Subaru Impreza WRXs (Subject Vehicles) manufactured by Fuji Heavy Industries U.S.A., Inc. and Subaru of America, Inc (collectively, "Subaru"). Drivers and owners have alleged that the brakes on their vehicles intermittently malfunction, resulting in extended stopping distance. The malfunctions allegedly occurred in conjunction with activation of the Anti-lock Brake System (ABS).

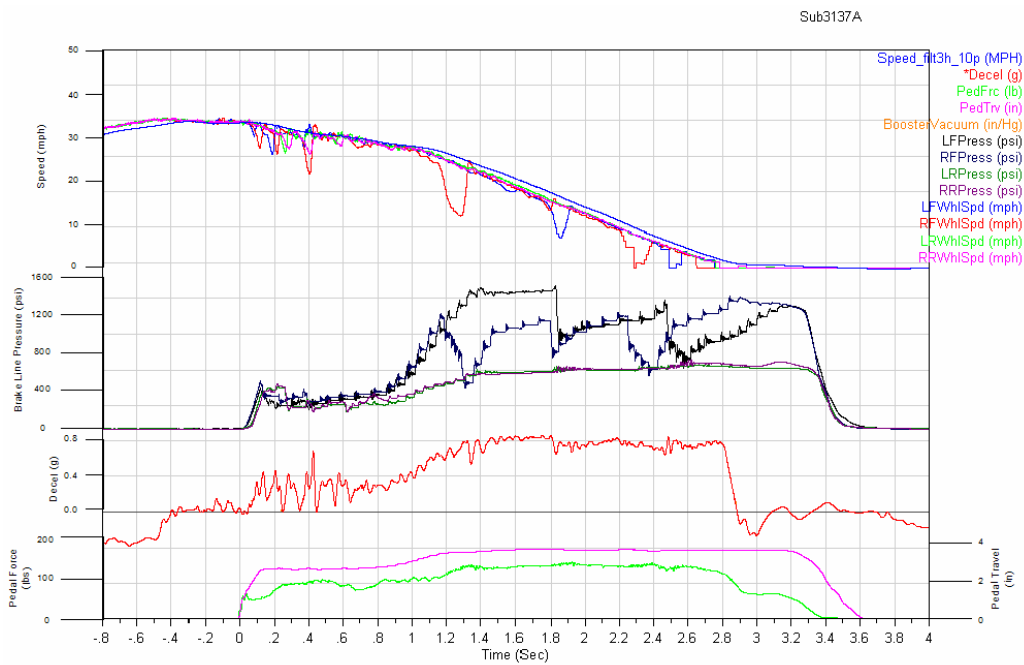
**Figure 1 – Delayed Build of Vehicle Deceleration on WRX03 at Railroad Tracks**

The third test vehicle (WRX03 – not a complaint vehicle) was leased in March 2004 for approximately one month. This vehicle was outfitted with a complete instrumentation package and tested for 230 test runs, including tests conducted on the public roadway. After crossing a set of railroad tracks, this vehicle took 0.75 seconds to build brake line pressure and, consequently, experienced vehicle deceleration, as shown in Figure 1 (delay from 0.40 to 1.15 sec). This was the first indication of a possible long duration, slow deceleration event, reported by some owners to last 4 to 10 seconds.

35 mph, braking at the railroad tracks, brake pedal force 100 lb, and stopping distance 96 ft

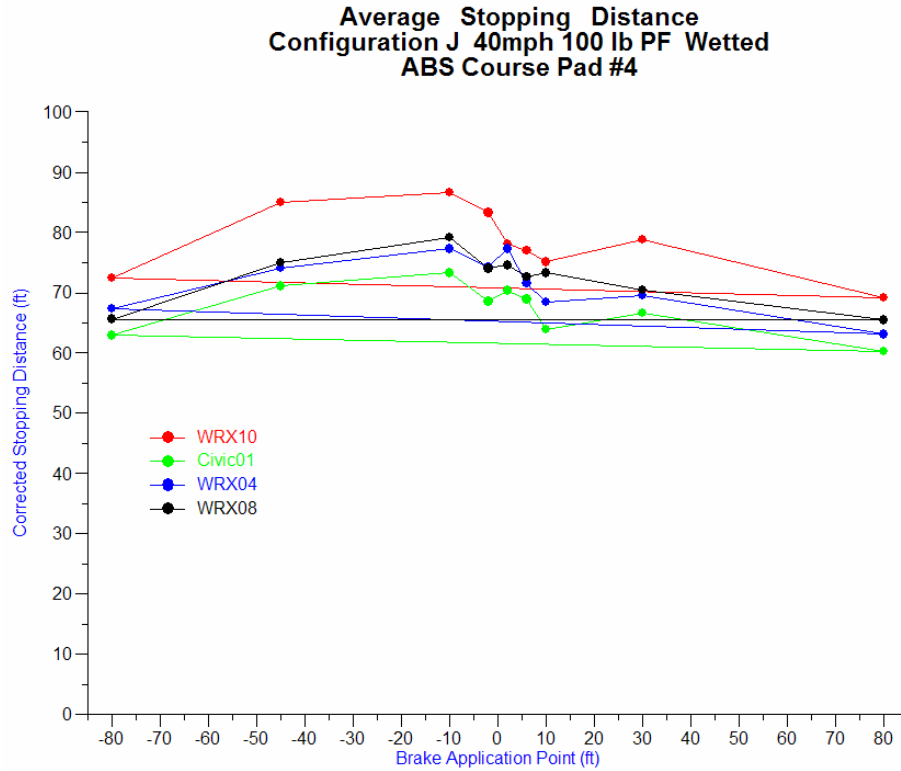
**Figure 2 – Config J Course on Variable-co ABS Course Pad #4**

The overall response trend of the stopping ability of the test vehicles along the course described in c., above, is shown in Figure 2. The graph shows that the trend of the stopping ability of the test vehicles is longer and more variable in the complaint vehicles and shorter and more consistent in the Honda peer vehicle. The Honda is consistently the best at every location and Subaru WRX10 is consistently the worst.

The Honda stopped shorter than the other vehicles for all braking locations along Pad #4. Two of the complaint vehicles stopped within the same range as the Honda, but subject vehicle Number WRX10 (which was a complaint vehicle) took the longest at every location. At the -10-ft location the Honda took 75 ft to stop while the WRX10 needed 87 ft to stop.

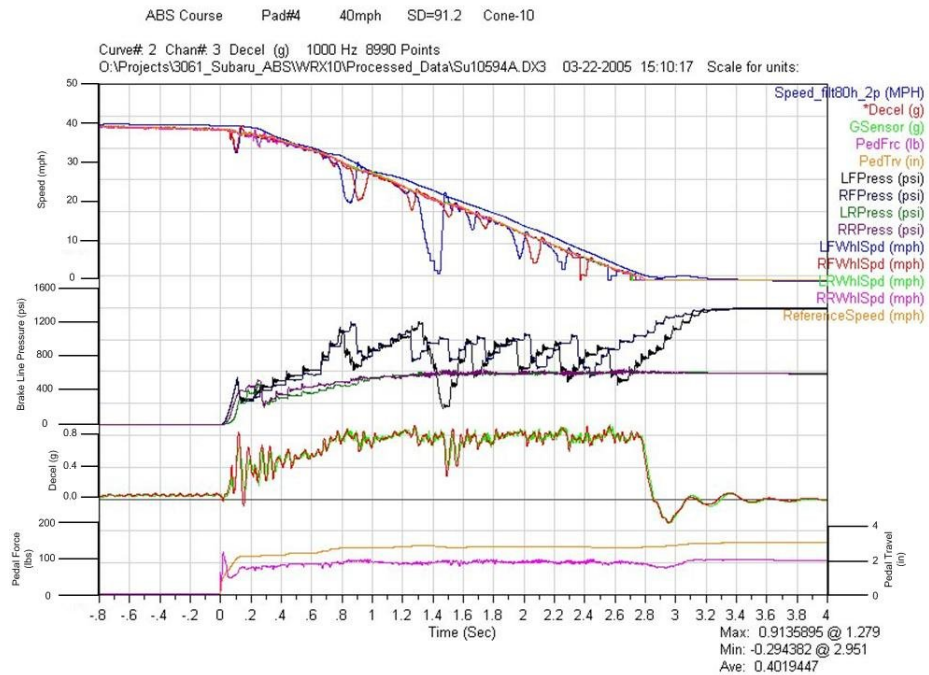
**Figure 3 – Time History Plot of Complaint Vehicle WRX10 with Decel Delay**

A time/history plot that presents the data collected by the transducers reveals the delay in the build rate of the brake line pressures that causes delays in overall vehicle deceleration in the test vehicle (WRX10) and is shown in Figure 3 (Test Run No. SU10594). The time between the initial significant wheel slip and failure to build is 0.5 sec (0.25 sec to 0.75 sec) as the brake line pressure slowly builds in what looks to be a more appropriate response for a low-co condition than the pad 4 variable-co with a bump. After the 0.75-sec point, the ABS is working the surface with adequate pressure modulation.

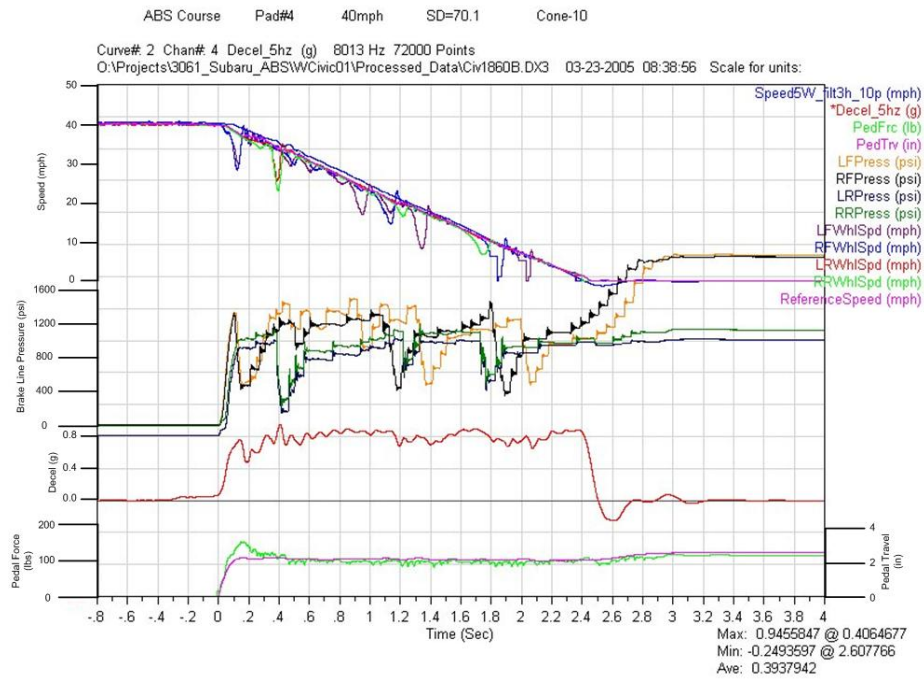
**Figure 4 – Time History Plot of the Peer Vehicle CIV01 without Decel Delay**

The Honda Civic, in contrast, utilizes the surface coefficient of friction from the beginning, as shown in Figure 4. The Honda's vehicle deceleration after 0.3 seconds is at the steady state 0.8-g point, and the braking sensation to the driver of this vehicle meets the normal feel of "input brake-pedal force equals the vehicle deceleration output."

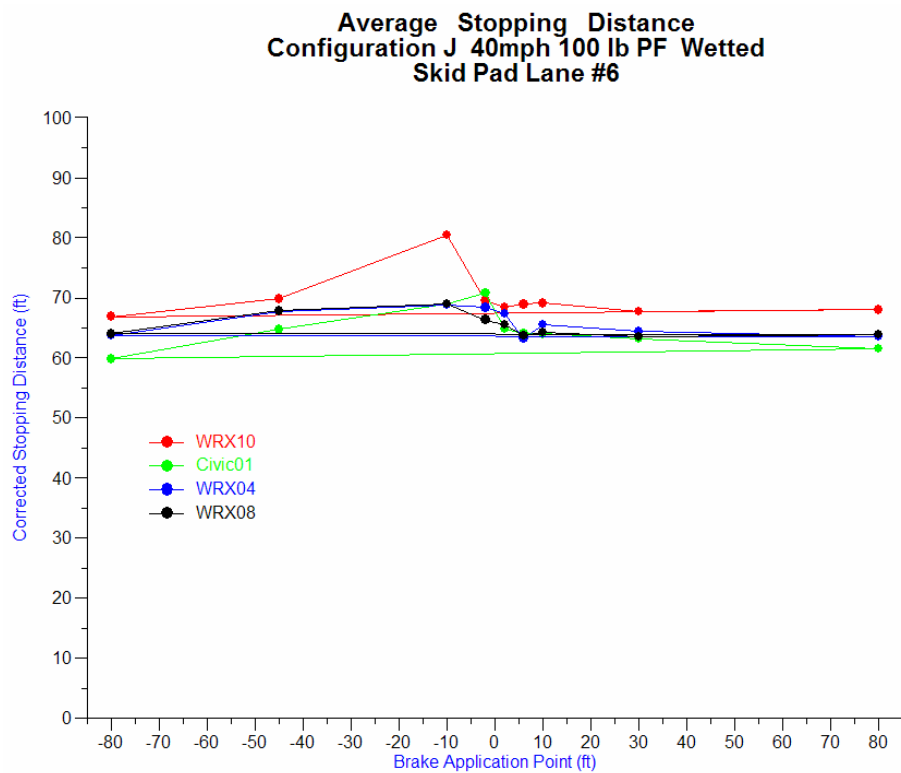
**Figure 5 – Config J Course on Medium-co Polished Concrete**

During the testing on Skid Pad Lane #6, the WRX10 again had longer stops at the -10 ft brake location, as shown in Figure 5. The Civic stopping distance (average of three test runs, actual "stopping distances" are approximately 7% longer) was 70 ft and the WRX10 was 81 ft.
