**EA03-004**

**FORD 8/27/03**

**CRITICAL CONCERNS REVIEW GROUP (NORTH AMERICA)**

<b>MODELS:</b>	<b>1999-2000 WINDSTAR</b>
<b>Input Source:</b>	<b>LITIGATION PREVENTION / FCSD</b>
<b>Concern Description:</b>	<b>Wheels falling off</b>

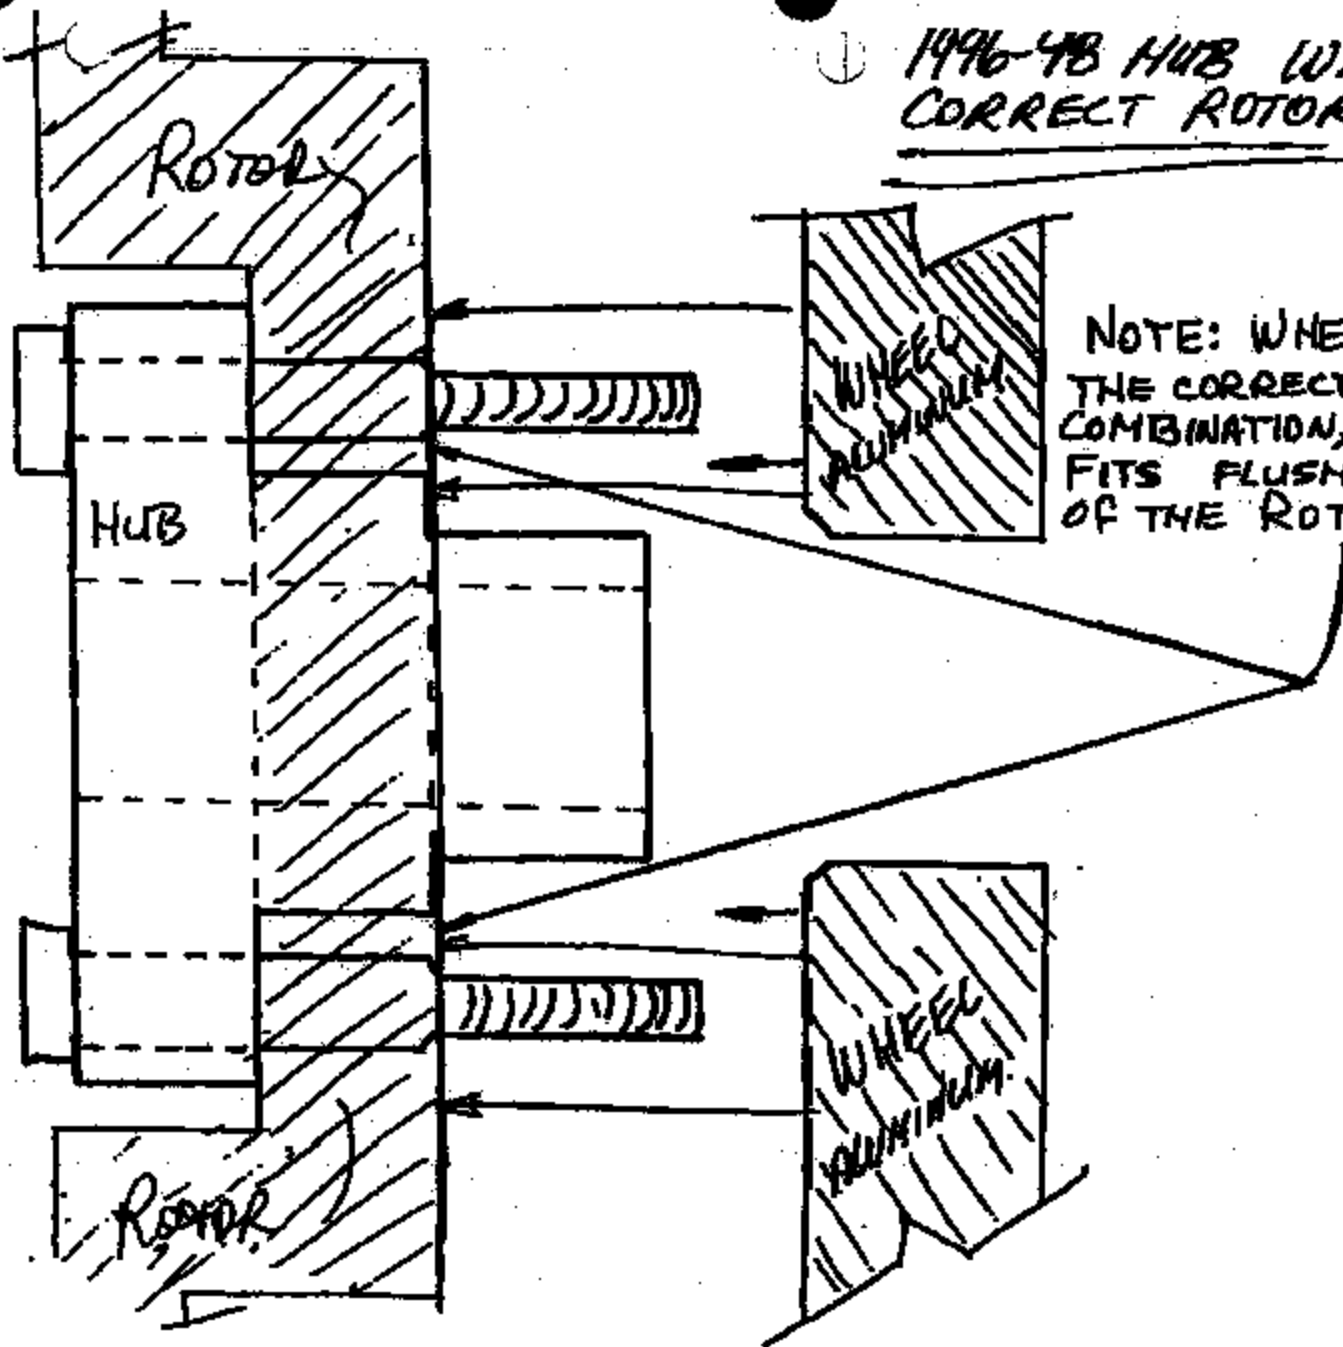
NOTE: WHEN YOU HAVE  
THE CORRECT ROTOR & HUB  
COMBINATION, THE WHEEL  
FITS FLUSH ON THE FACE  
OF THE ROTOR

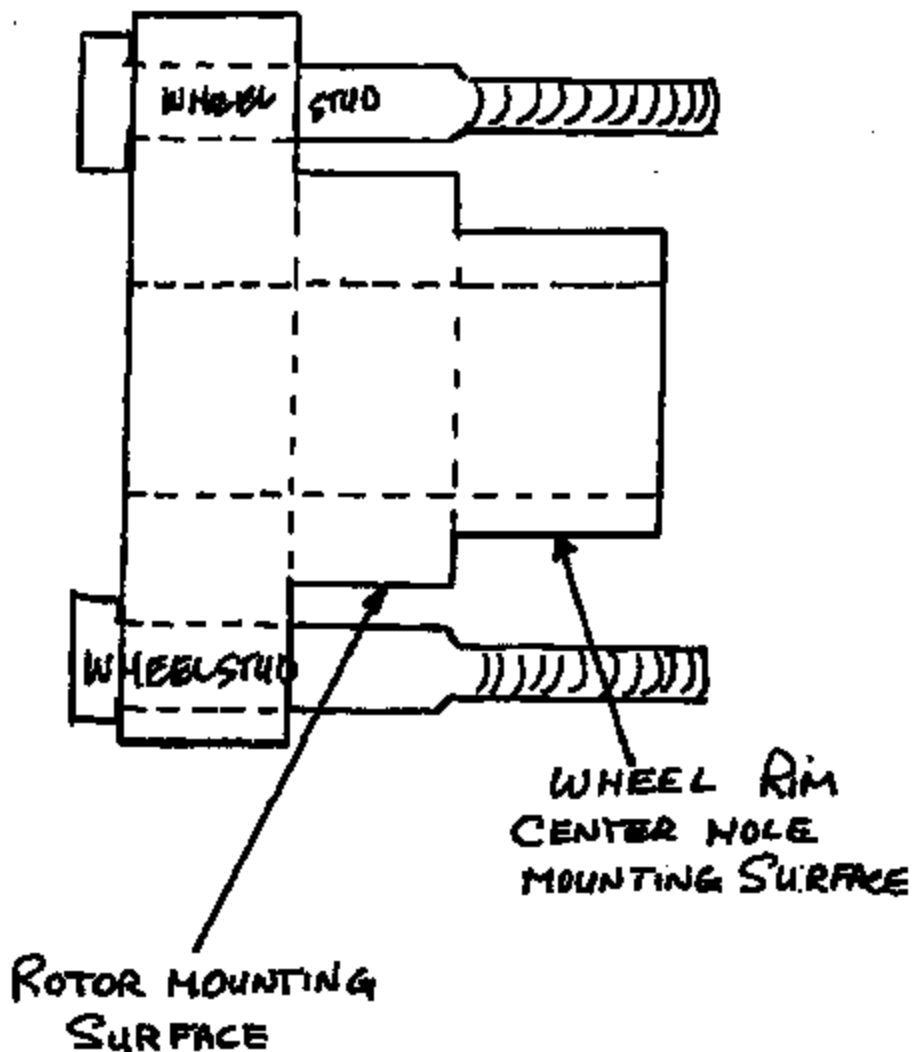
- When the customer drives the vehicle for a period of time the wheel rim distorts more and the sharp edge of the hub cuts into the aluminum wheel. The end result is loose wheel nuts and eventually the studs break.

1996-98 HUB WITH 1995  
LEVEL ROTOR F5BZ.1125.A  
INCORRECT COMBINATION

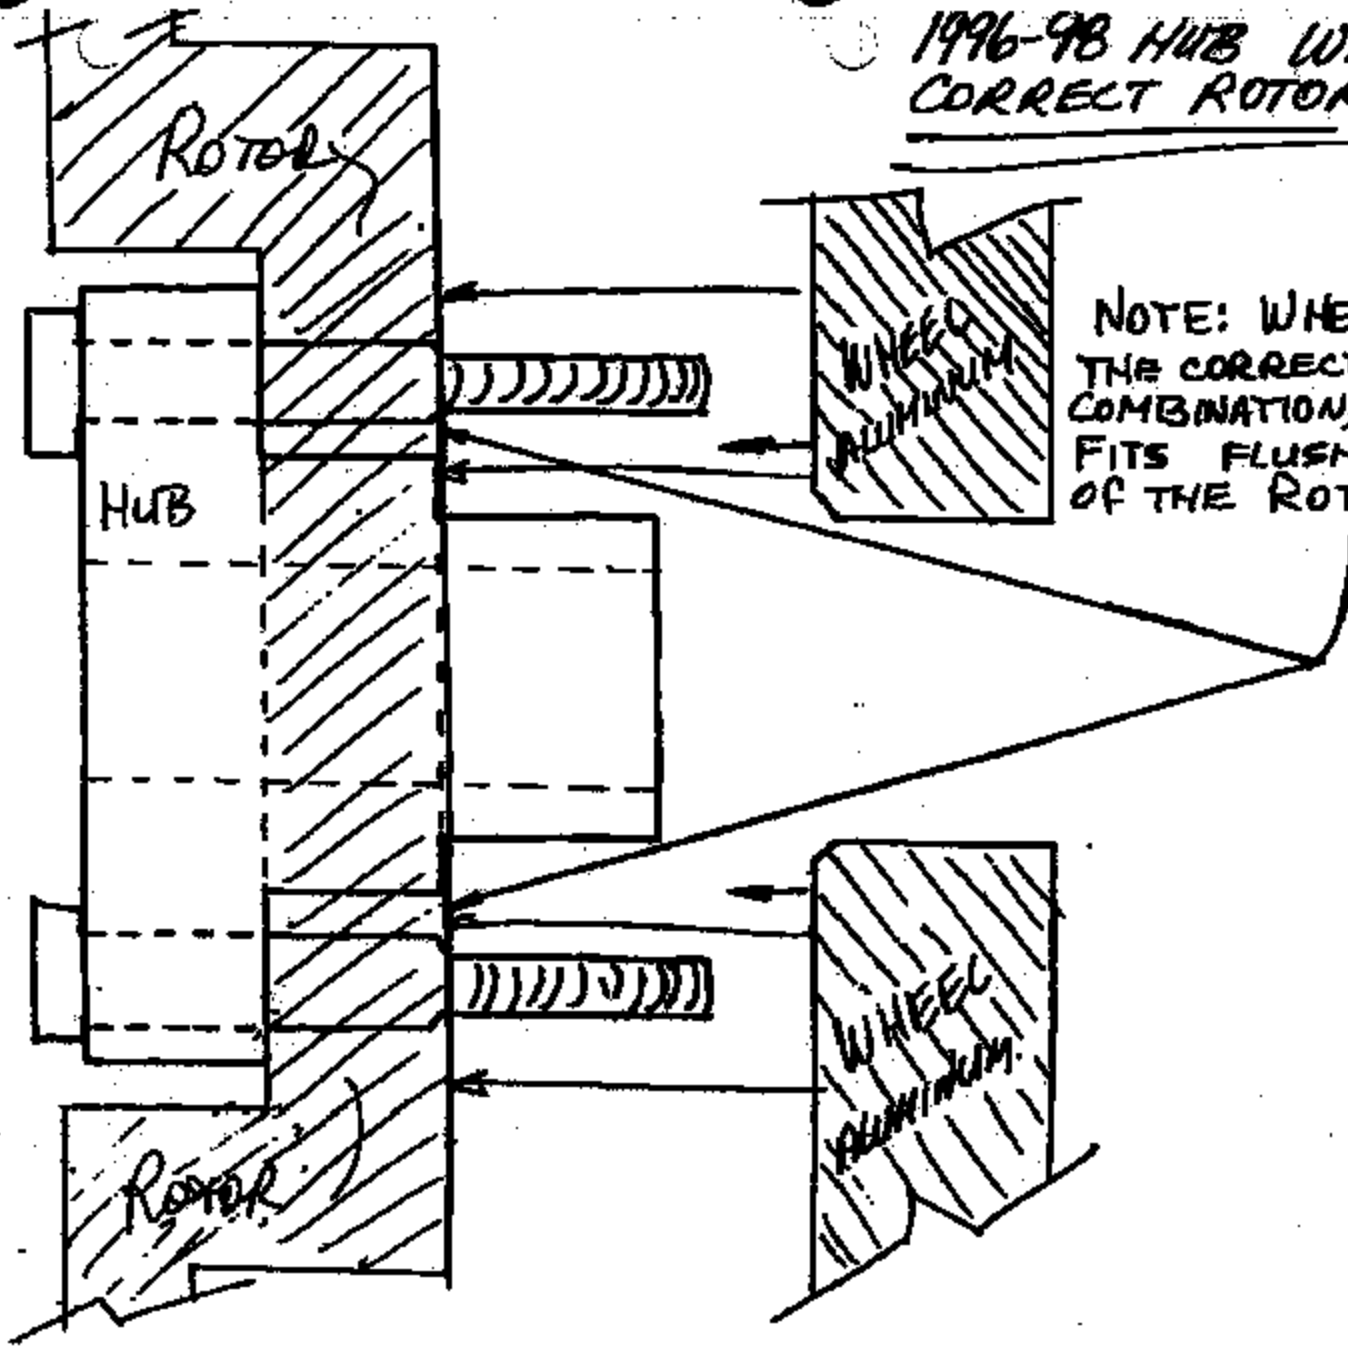
1996-98 HUB WITH FEBZ-2588  
CORRECT ROTOR.

NOTE: WHEN YOU HAVE  
 THE CORRECT ROTOR & HUB  
 COMBINATION, THE WHEEL  
 FITS FLUSH ON THE FACE  
 OF THE ROTOR.

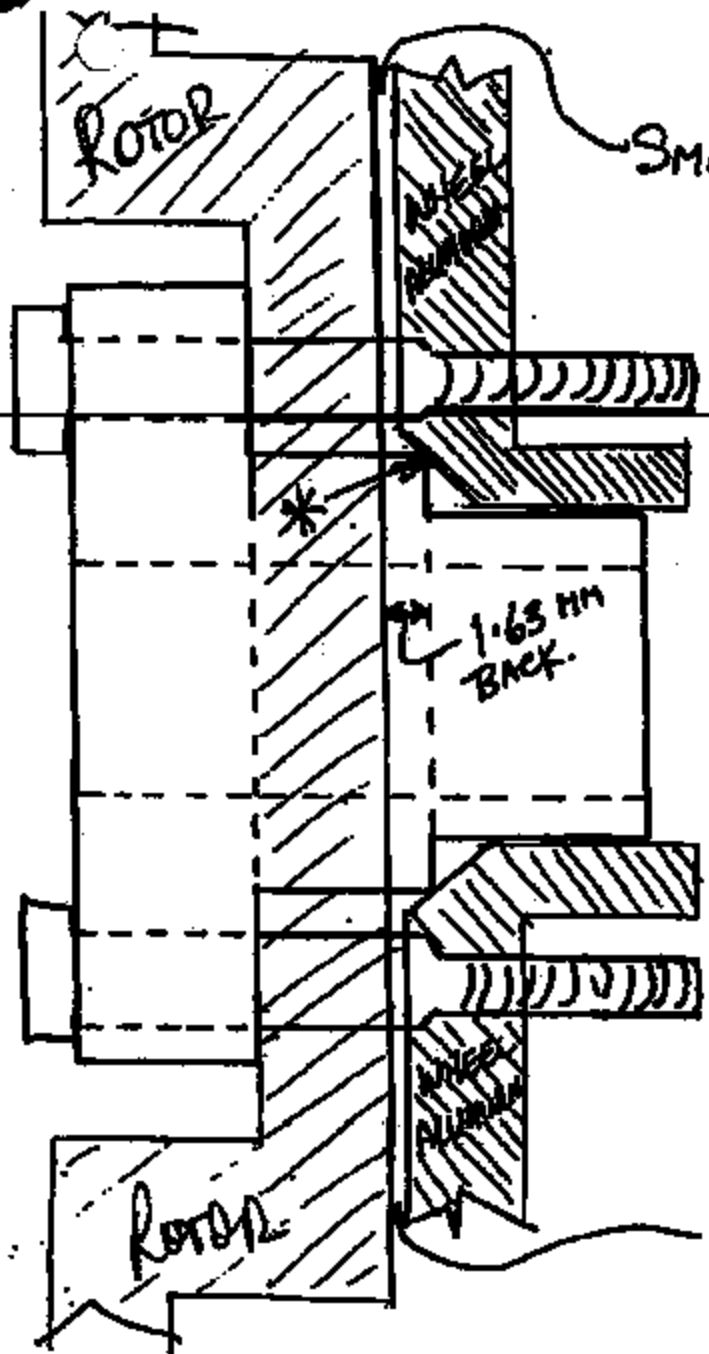
1996-98 HUB WITH FSBZ-11-5A ROTOR.

SMALL GAP

NOTE: WHEN THE WHEEL NUTS ARE TORQUED THE WHEEL IS TIGHT, ONCE THE CUSTOMER DRIVE VEHICLE FOR SOME TIME, THE METAL HUB WEARS INTO THE RIM. THEREFORE, TORQUE LOSS AND THEN
