PE03-044
FORD
5/13/2005
APPENDIX I
BOOK 12 OF 28
PART 4 OF 4

P131/U137 Adjustable Pedal Program

Subject: Request to have TSB for Wire Chafing Affecting Accelerator Pedal Failures

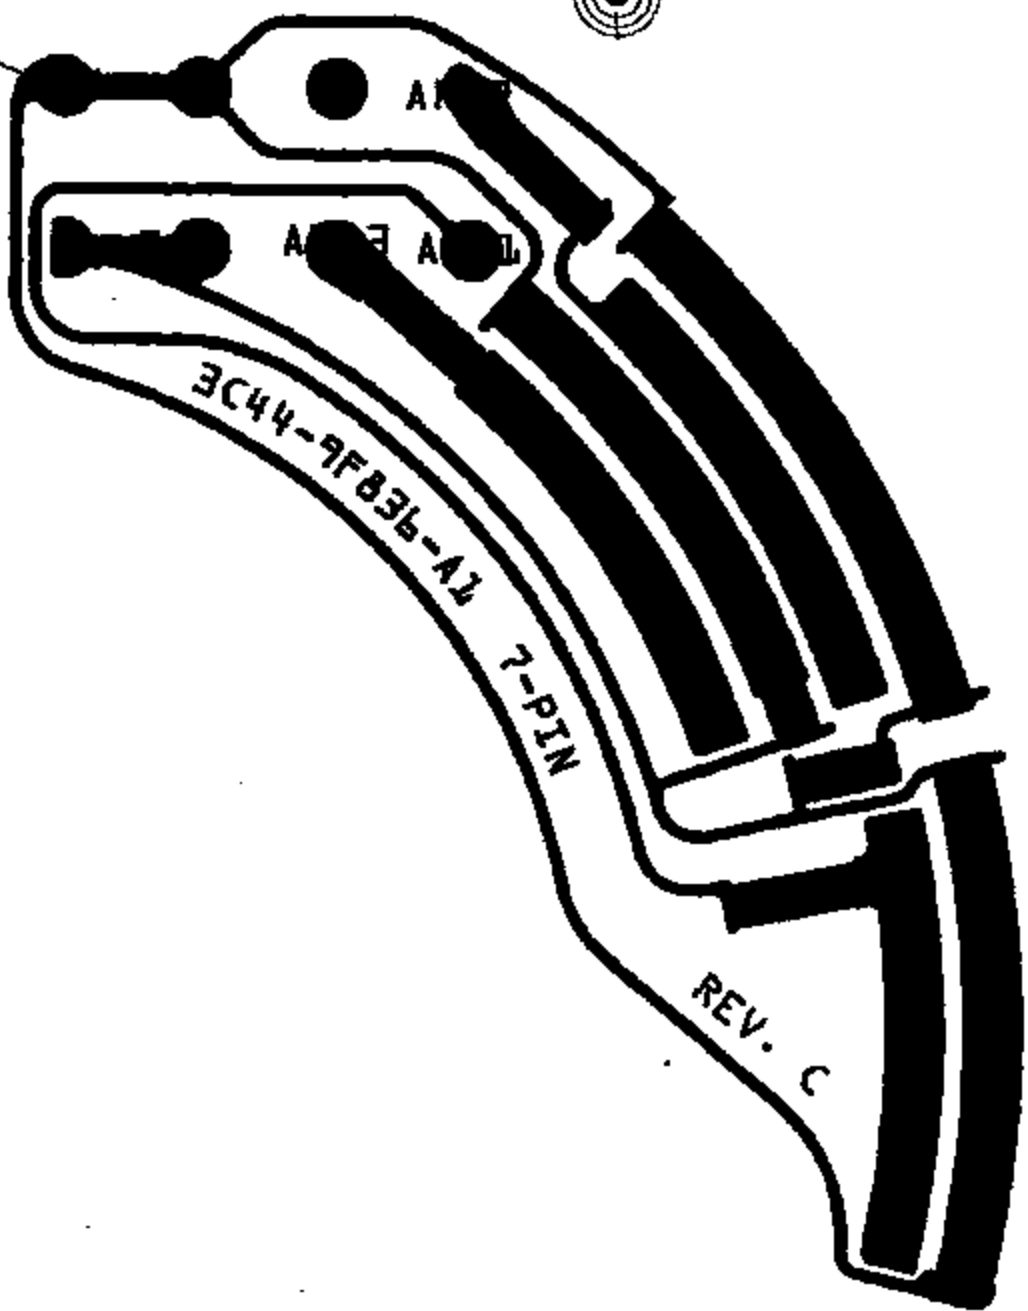
7-PIN

Even though the element says A1, it's the intended design for production.
