**FORD 12/12/03 LETTER  
TO ODI 4 BOOKS**

**ATTACHMENT L**

## BRAKE LAMP SWITCH REPLACEMENT

**SUBJECT:** Safety Recall 01908: Certain 2000 and 2001 Model Year Taurus and Sable Vehicles with Power Adjustable Foot Pedals – Brake Lamp Switch Replacement

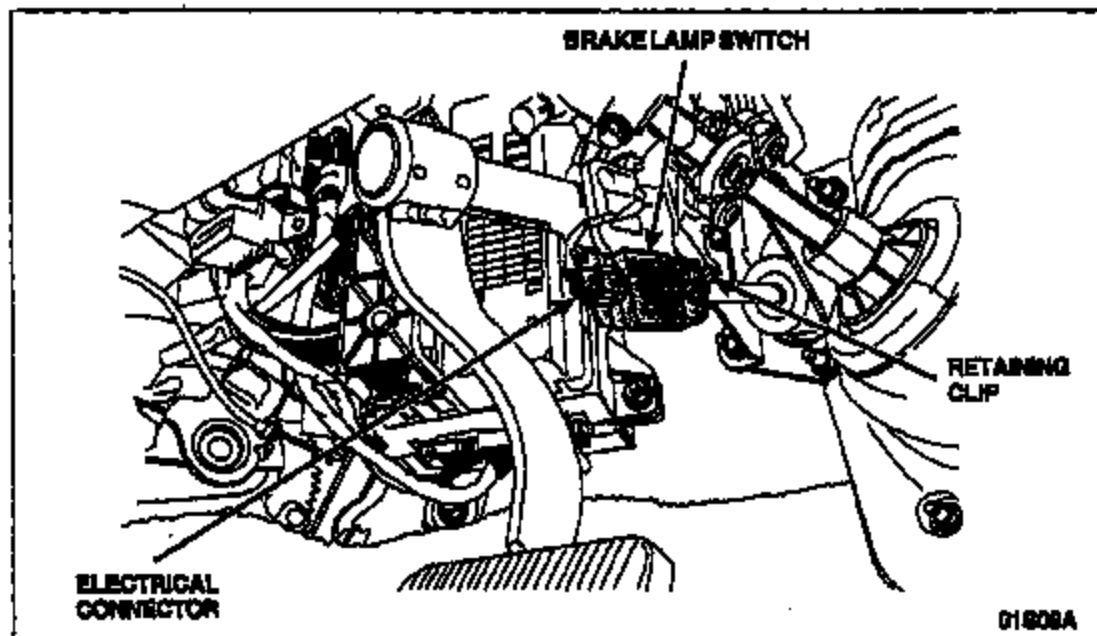
FIGURE 1

The brake lamp switch on the affected vehicles must be replaced. Lubricating grease applied to the power adjustable foot pedal assembly may have contaminated the brake lamp switch. Excess lubricating grease from the outer surfaces of the pedal assembly will be removed before a new switch is installed. This procedure will give the details for cleaning of the pedal assembly and replacement of the brake lamp switch.

1. Note the position of the power adjustable foot pedals then move the pedals to the full upward position.
2. Install a memory saver, then disconnect the battery negative cable.
3. Disconnect the electrical connector from the brake lamp switch. See Figure 1.
4. Remove the retaining clip, then remove and discard the brake lamp switch. See Figure 1.

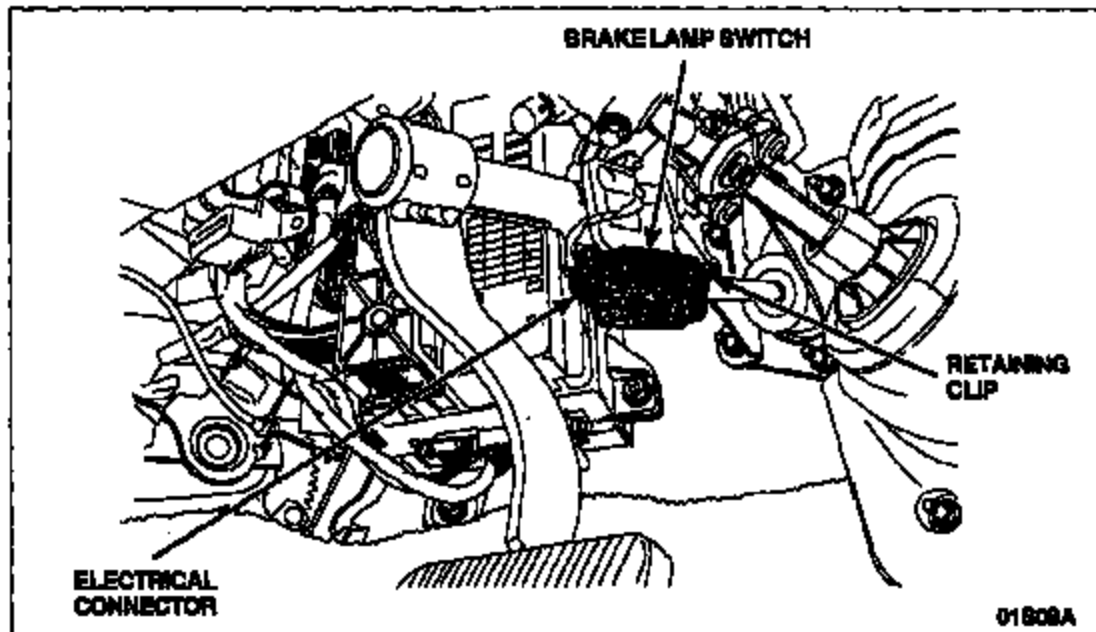
FIGURE 1

The brake lamp switch on the affected vehicles must be replaced. Lubricating grease applied to the power adjustable foot pedal assembly may have contaminated the brake lamp switch. Excess lubricating grease from the outer surfaces of the pedal assembly will be removed before a new switch is installed. This procedure will give the details for cleaning of the pedal assembly and replacement of the brake lamp switch.

1. Note the position of the power adjustable foot pedals then move the pedals to the full upward position.
2. Install a memory saver, then disconnect the battery negative cable.
3. Disconnect the electrical connector from the brake lamp switch. See Figure 1.
4. Remove the retaining clip, then remove and discard the brake lamp switch. See Figure 1.

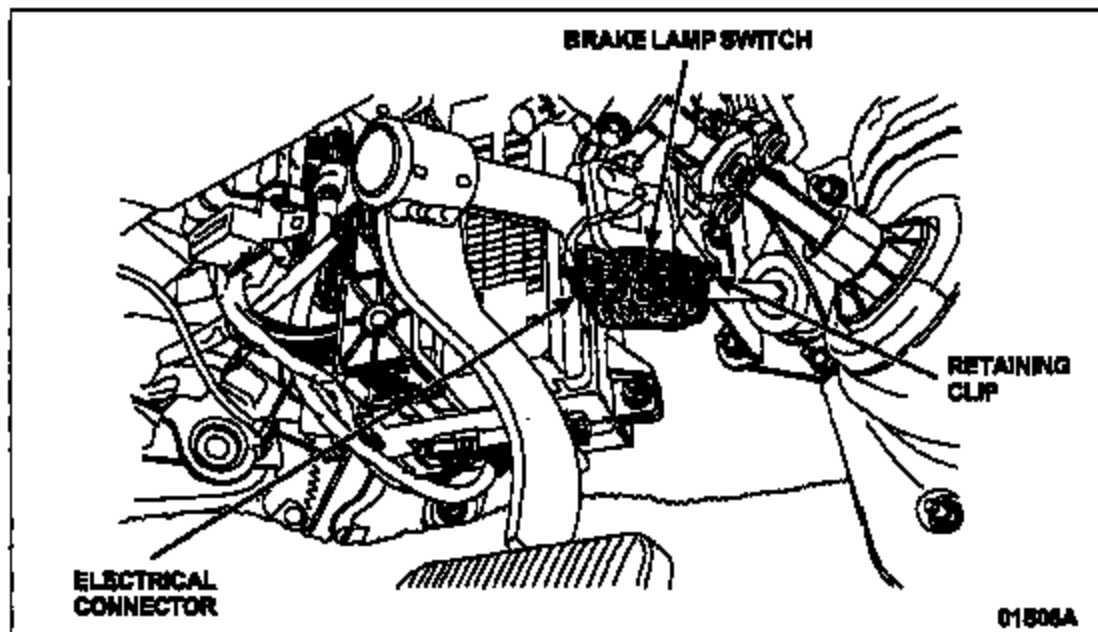
FIGURE 1

The brake lamp switch on the affected vehicles must be replaced. Lubricating grease applied to the power adjustable foot pedal assembly may have contaminated the brake lamp switch. Excess lubricating grease from the outer surfaces of the pedal assembly will be removed before a new switch is installed. This procedure will give the details for cleaning of the pedal assembly and replacement of the brake lamp switch.

1. Note the position of the power adjustable foot pedals then move the pedals to the full upward position.
2. Install a memory saver, then disconnect the battery negative cable.
3. Disconnect the electrical connector from the brake lamp switch. See Figure 1.
4. Remove the retaining clip, then remove and discard the brake lamp switch. See Figure 1.

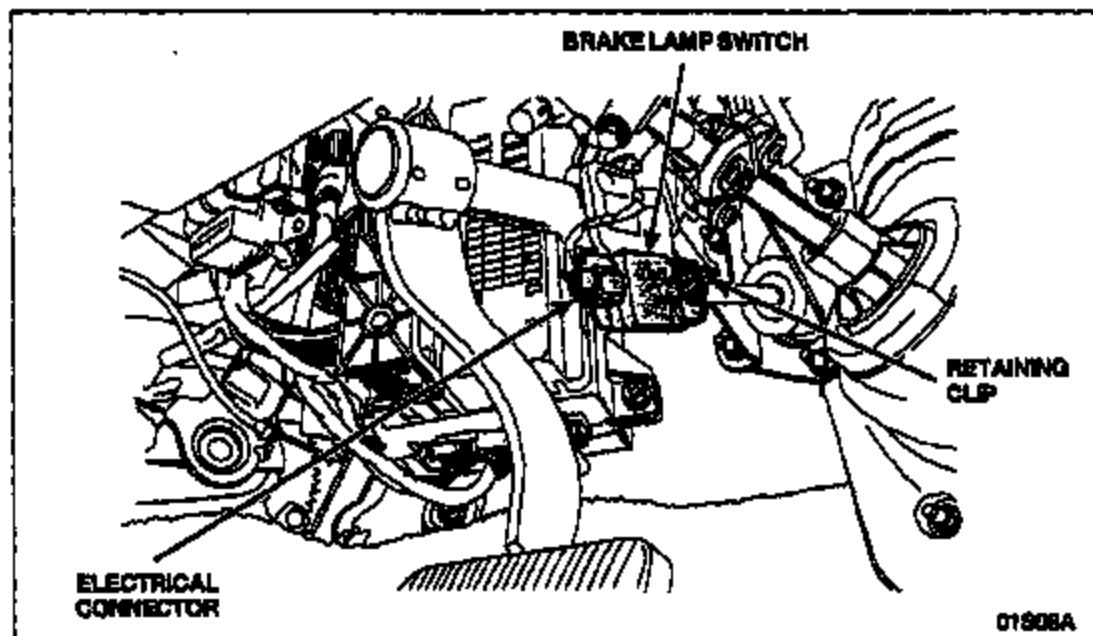
FIGURE 1

The brake lamp switch on the affected vehicles must be replaced. Lubricating grease applied to the power adjustable foot pedal assembly may have contaminated the brake lamp switch. Excess lubricating grease from the outer surfaces of the pedal assembly will be removed before a new switch is installed. This procedure will give the details for cleaning of the pedal assembly and replacement of the brake lamp switch.

1. Note the position of the power adjustable foot pedals then move the pedals to the full upward position.
2. Install a memory saver, then disconnect the battery negative cable.
3. Disconnect the electrical connector from the brake lamp switch. See Figure 1.
4. Remove the retaining clip, then remove and discard the brake lamp switch. See Figure 1.
