**FORD 12/12/03 LETTER
TO ODI 4 BOOKS**

ATTACHMENT L

**PART 3 OF 4
BOOK 2 OF 4**

Folder: 020054130000 2 2000 TS REPEAT BRAKE LIGHT SWITCH

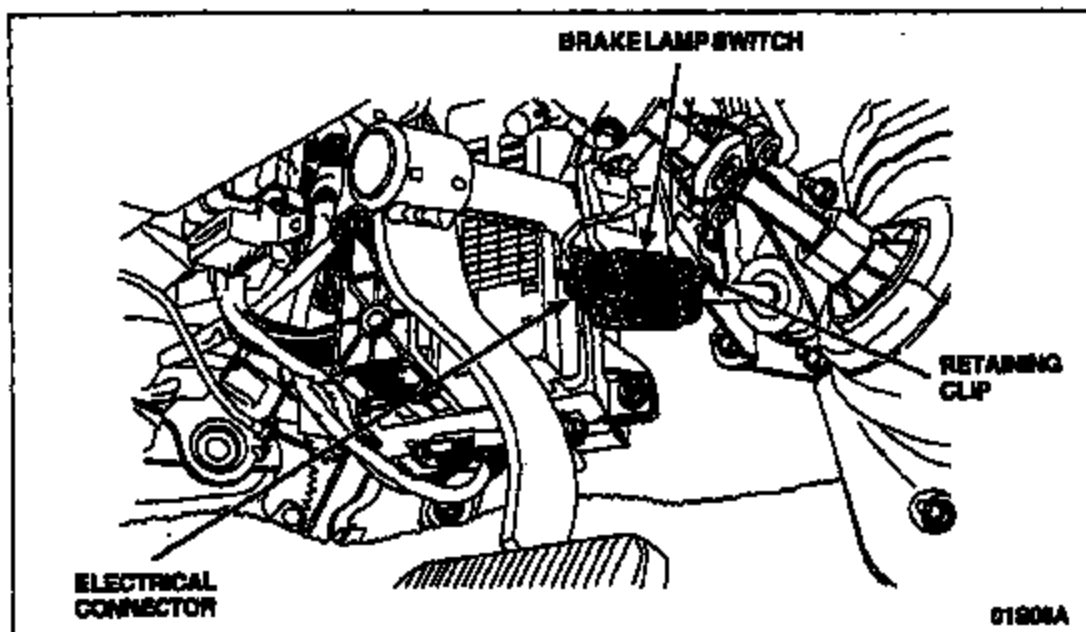
FIGURE 1

The brake lamp switch on the affected vehicles must be replaced. Lubricating grease applied to the power adjustable foot pedal assembly may have contaminated the brake lamp switch. Excess lubricating grease from the outer surfaces of the pedal assembly will be removed before a new switch is installed. This procedure will give the details for cleaning of the pedal assembly and replacement of the brake lamp switch.

1. Note the position of the power adjustable foot pedals then move the pedals to the full upward position.
2. Install a memory saver, then disconnect the battery negative cable.
3. Disconnect the electrical connector from the brake lamp switch. See Figure 1.
4. Remove the retaining clip, then remove and discard the brake lamp switch. See Figure 1.
