**FORD 12/12/03 LETTER
TO ODI 4 BOOKS**

ATTACHMENT L

**PART 4 OF 4
BOOK 2 OF 4**

Purpose: To Define Root Cause of Stop Lamp Switches that fall after the original switch was replaced on FSA 01808.

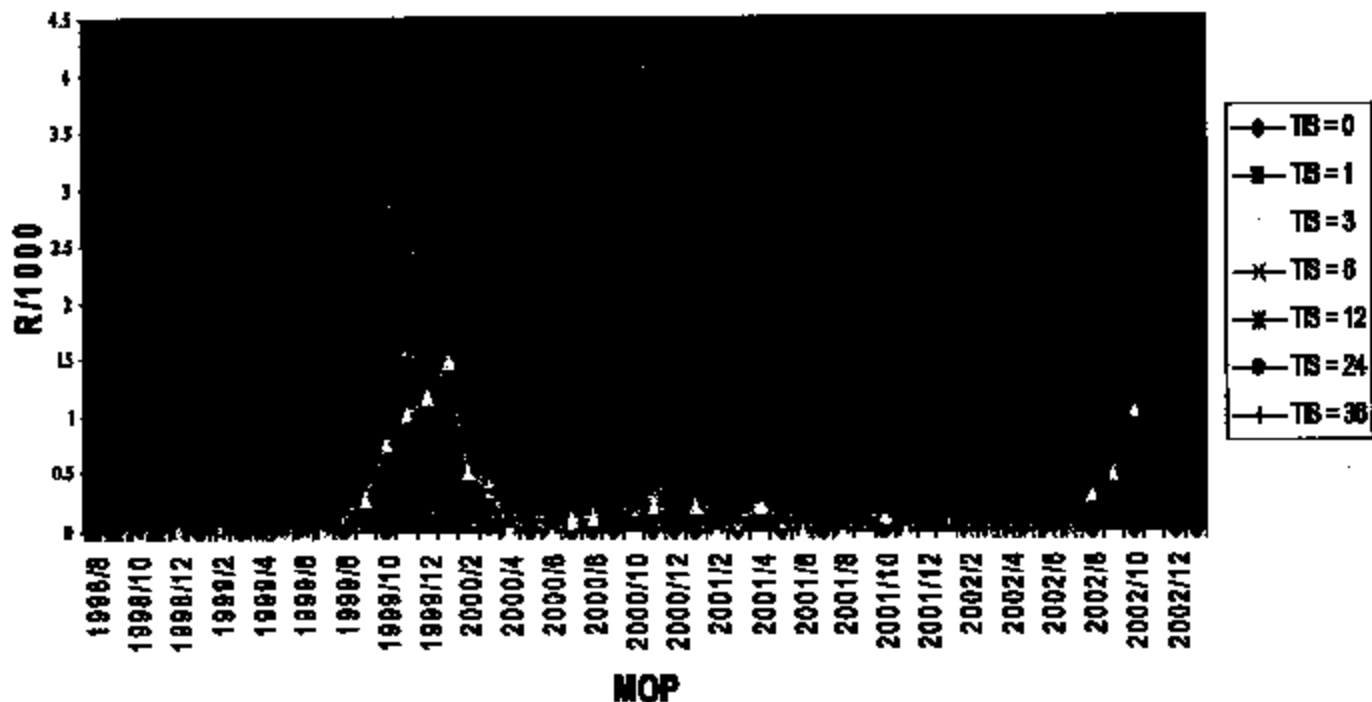
Ranger Door Ajar -Striker Adjust

Filtering L19 by Striker adjust reveals the extent of R/1000 diagnosed as striker problem

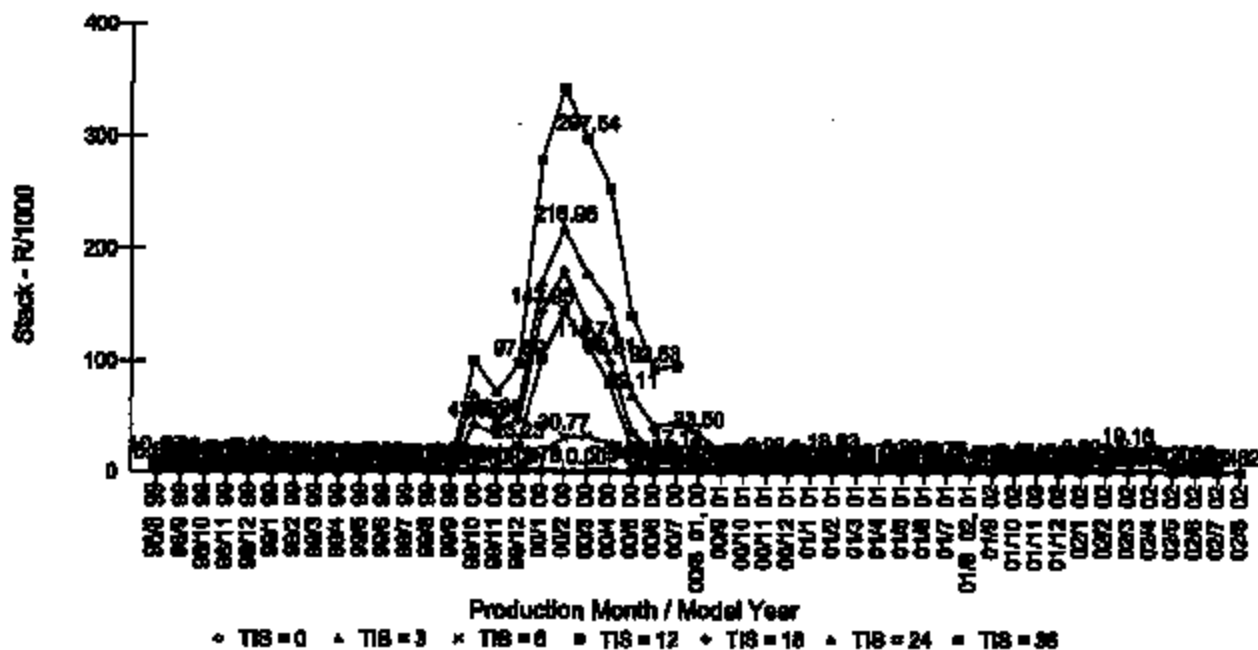
D186 Total BOO

D186 OOMY Design Overview:

- Wiring: issues due to pkg'g constraints; wiring gets caught in steering wheel shaft; routing & retaining finalized by 01MYJ1
- Sheetmetal: (cowl) sporadically in-control potentially impacting the anchoring of brake booster and pedal box- impacting booster rod alignment to pedal box mounting pin.
- Pedal box: D186 first platform with adjustable pedal. DV testing identified known lateral lash which worsens over time. Many (38) changes occurred on the design over 2.5yrs.
- Brake booster: Wagon & Sedan booster rods are unique due to brake ratios.
- Pollak switch: First platform with 2 terminal design.

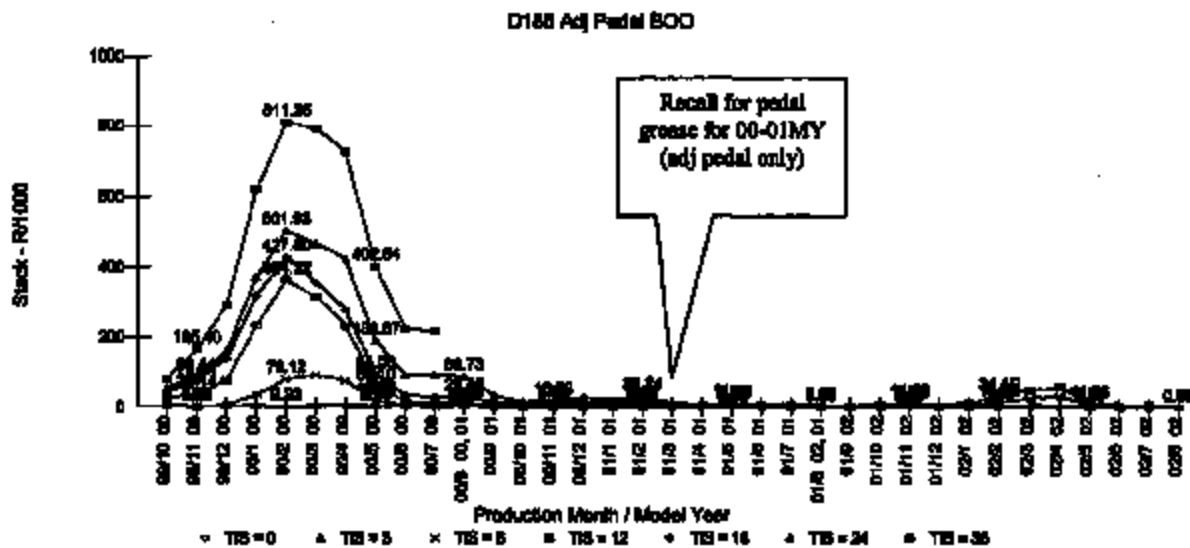
D186 Adj Pedal Design Summary

- 99/10 CAP&Pollak identified fixed terminal distance not matching go/no go gage resulting in lower actuation (its on)
- 00/8 J1 Fork yoke switches (mounting)
- 02/2 Plating extended to quieten the switch.
- 02/2 Low end shifted from 0.706 to 0.709.
- 03/11 Shift in range on all 2 terminal application. Also changed radius on terminal due to stress fractures.

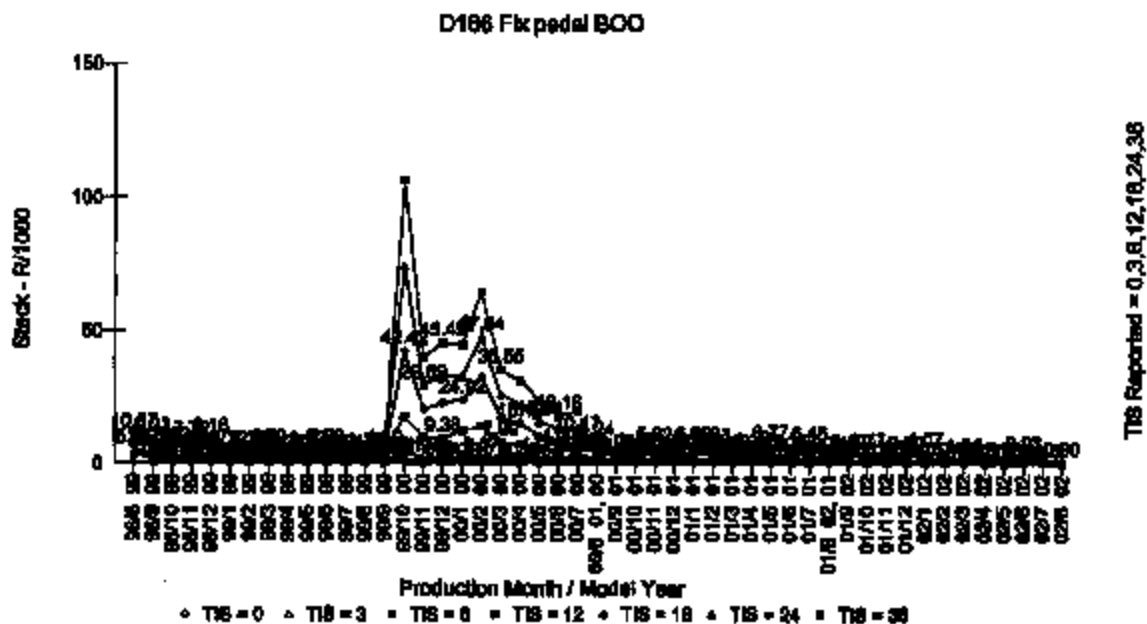
D186 Fix Pedal Design Summary

-03/11 Shift in range on all 2 terminal application. Also changed radius on terminal due to stress fractures.
