Subject: FINAL REPORT: VRTC-DCD3060 "Leak Tests on Fuel Tanks from 1995-96 Volvo 850 Vehicles (EA03-008)" Date: JUN 08 2004

# **Leak Tests of Fuel Tanks from 1995-96 Volvo 850 Vehicles**

FINAL REPORT  
JUNE 2004

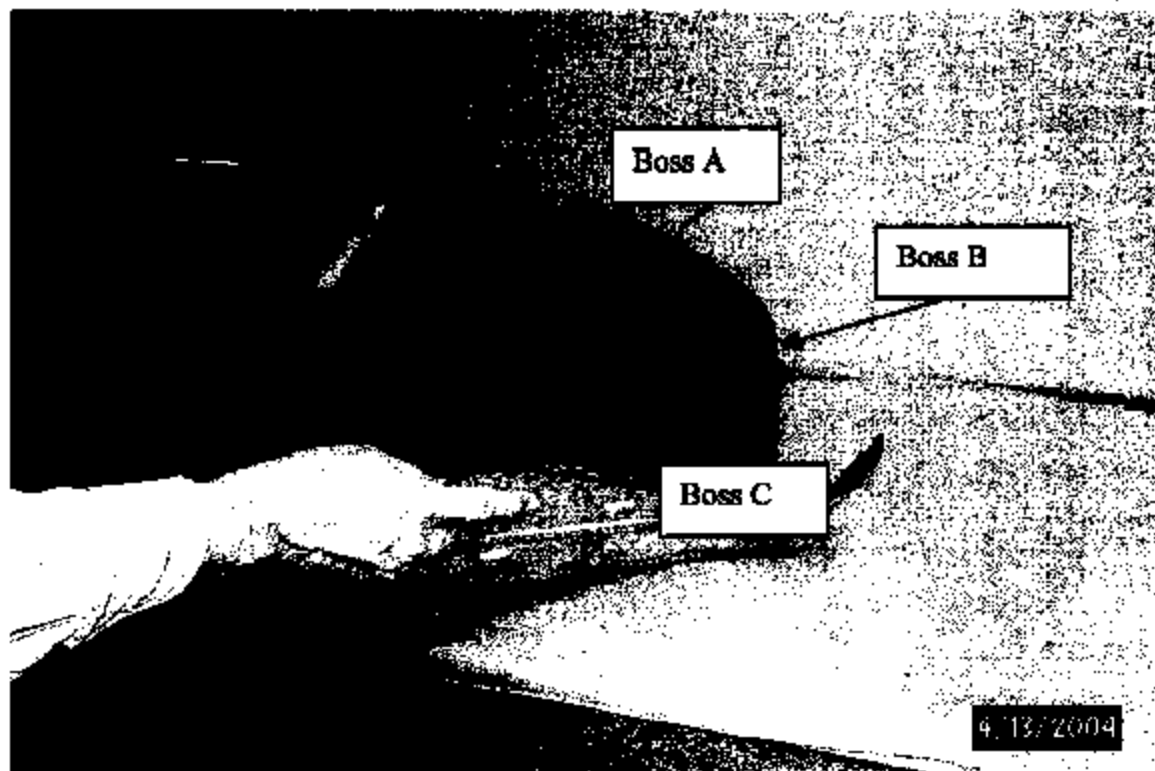
Other complaints indicated that cracks developed in the plastic fuel tanks near the "seam," allowing fuel to leak out. Some noted leaks onto the exhaust pipe or from a heat shield mounting boss that is attached to the fuel tank. The orientation of the exhaust heat shield to its three mounting bosses (labeled A, B, and C) is shown in Figure 1.1 for a typical "complaint" fuel tank.

**Figure 1.1 - Orientation of Heat Shield and Mounting Bosses on a Subject Fuel Tank**
